# The religious heritage of Cyprus

a survey in the districts of Kyrenia and Larnaca

Dr. Thorsten Kruse, M.A.  
Institut für Interdisziplinäre Zypern-Studien  
Westfälische Wilhelms-Universität Münster  
Schlaunstr. 2  
48143 Münster  
Germany  
Email: Th.Kruse@wwu.de

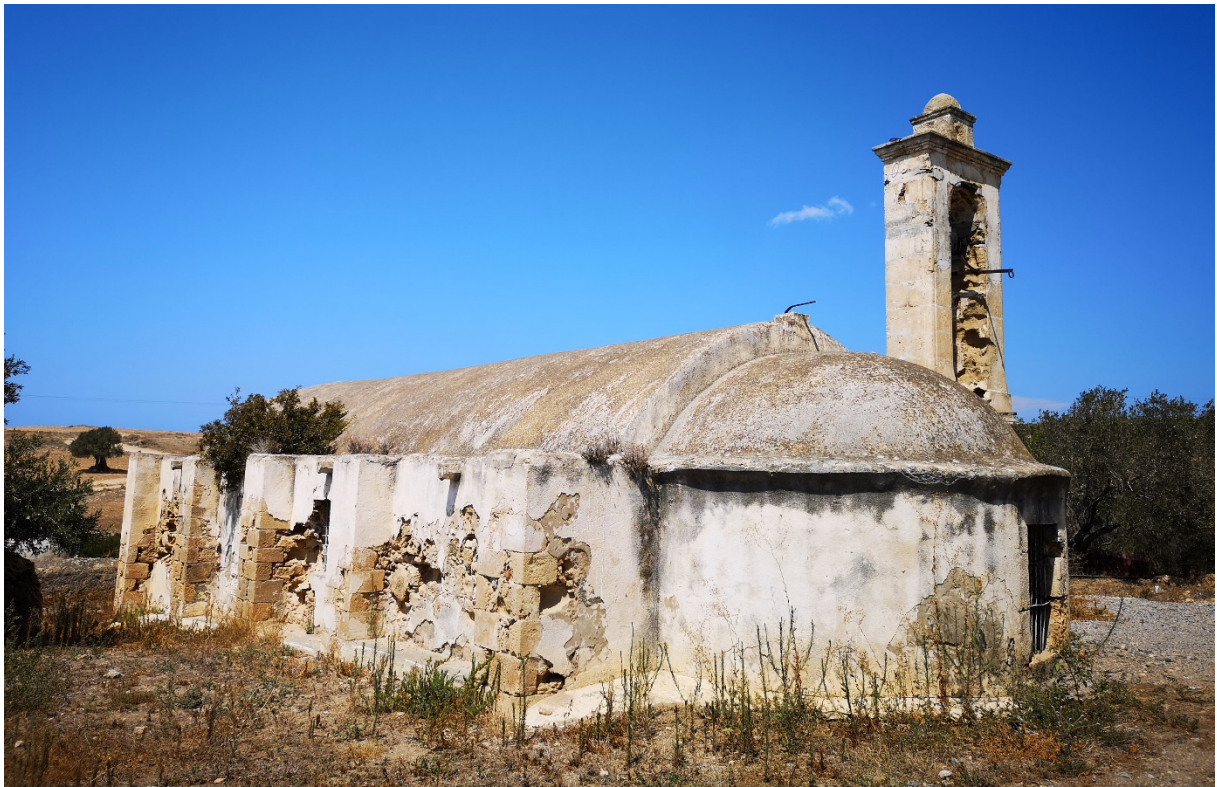
External condition: *poor*; the bell and the cross on top of the bell tower were removed; walls and bell tower show strong signs of decay; during the last years, new wooden doors were installed which are locked – with one exception: door to the west.

Fig. KYR-A1a: Agia Eirini church (view from southeast; Sept. 2018)

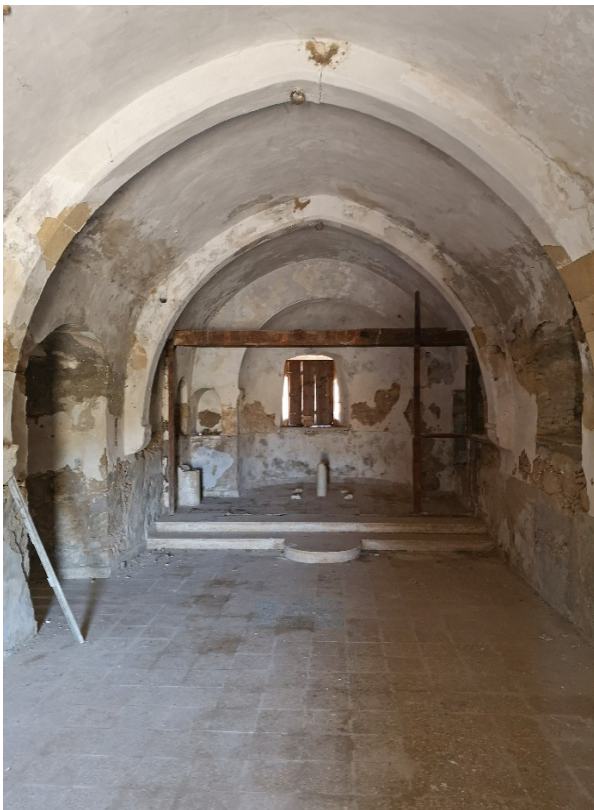
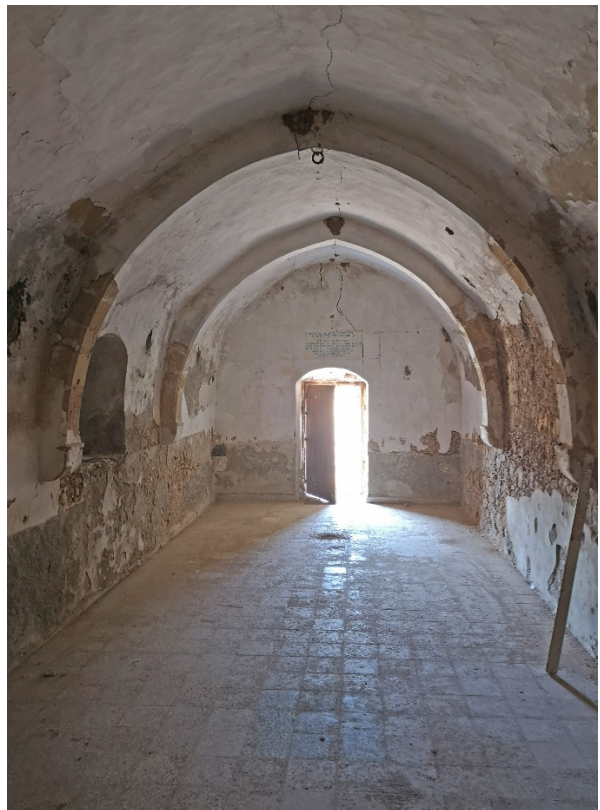
Interior condition: *poor*; all furnishings of a Greek Orthodox church have been removed.

Figs. KYR-A1b-c: Agia Eirini church (Sept. 2018)

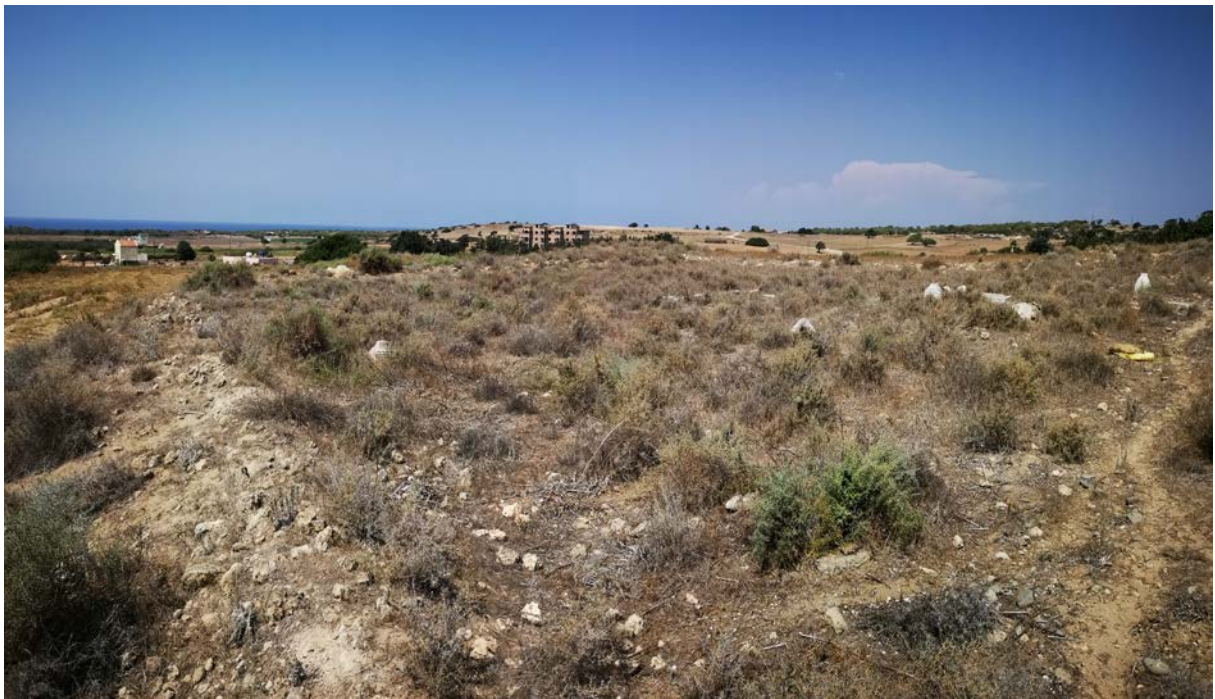
Condition: *ruin*; only the foundation of the former enclosure wall is visible; the cemetery itself is overgrown by weeds and shrubs.

Fig. KYR-A1d: Greek Orthodox cemetery (view from southeast; Sept. 2018)

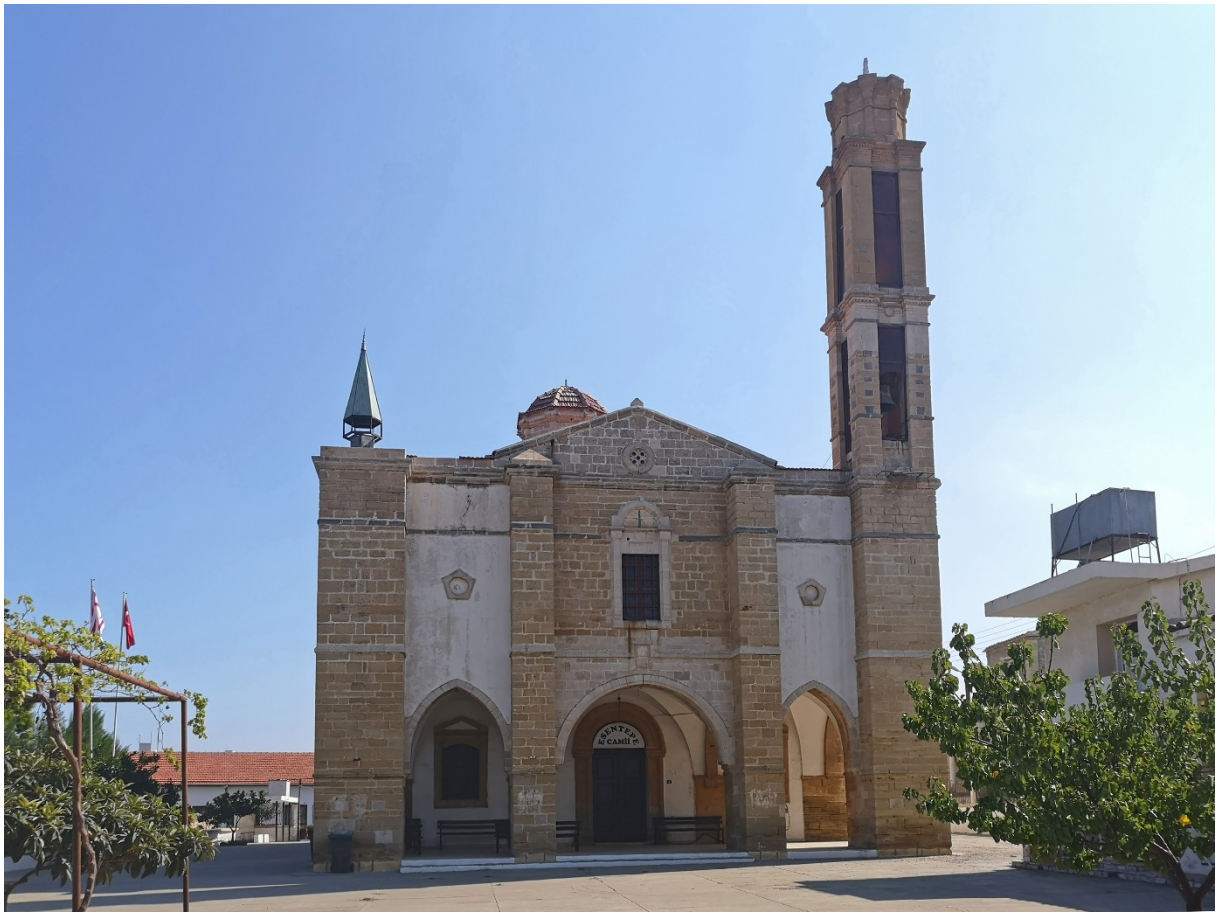
Fig. KYR-A2a: Church, converted into a mosque (view from west; Sept. 2018)

External condition: *good*; the bell is still in the bell tower; crosses on the roof and bell tower were removed; a small metallic minaret was added on the top of the southwest corner.

Interior condition: *good*; all walls inside are painted in white distemper; the iconostasis is missing.

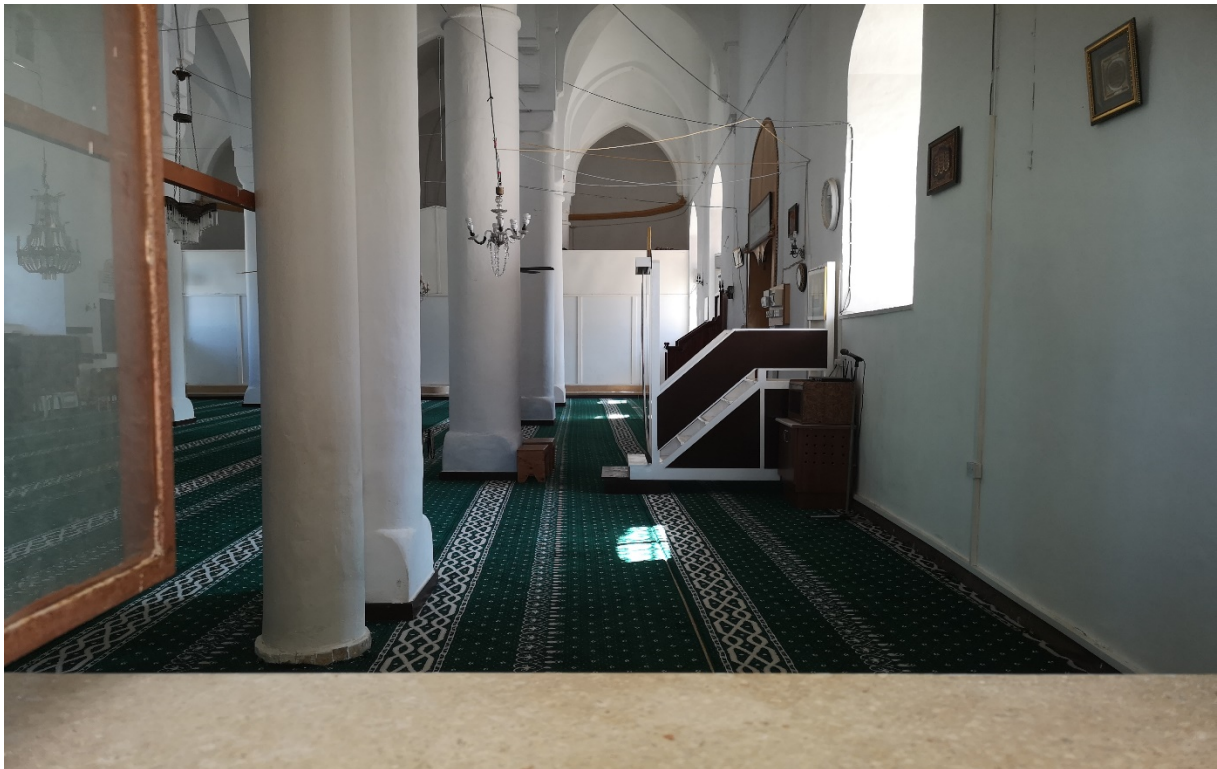
Fig. KYR-A2b: Church, converted into a mosque (Sept. 2018)

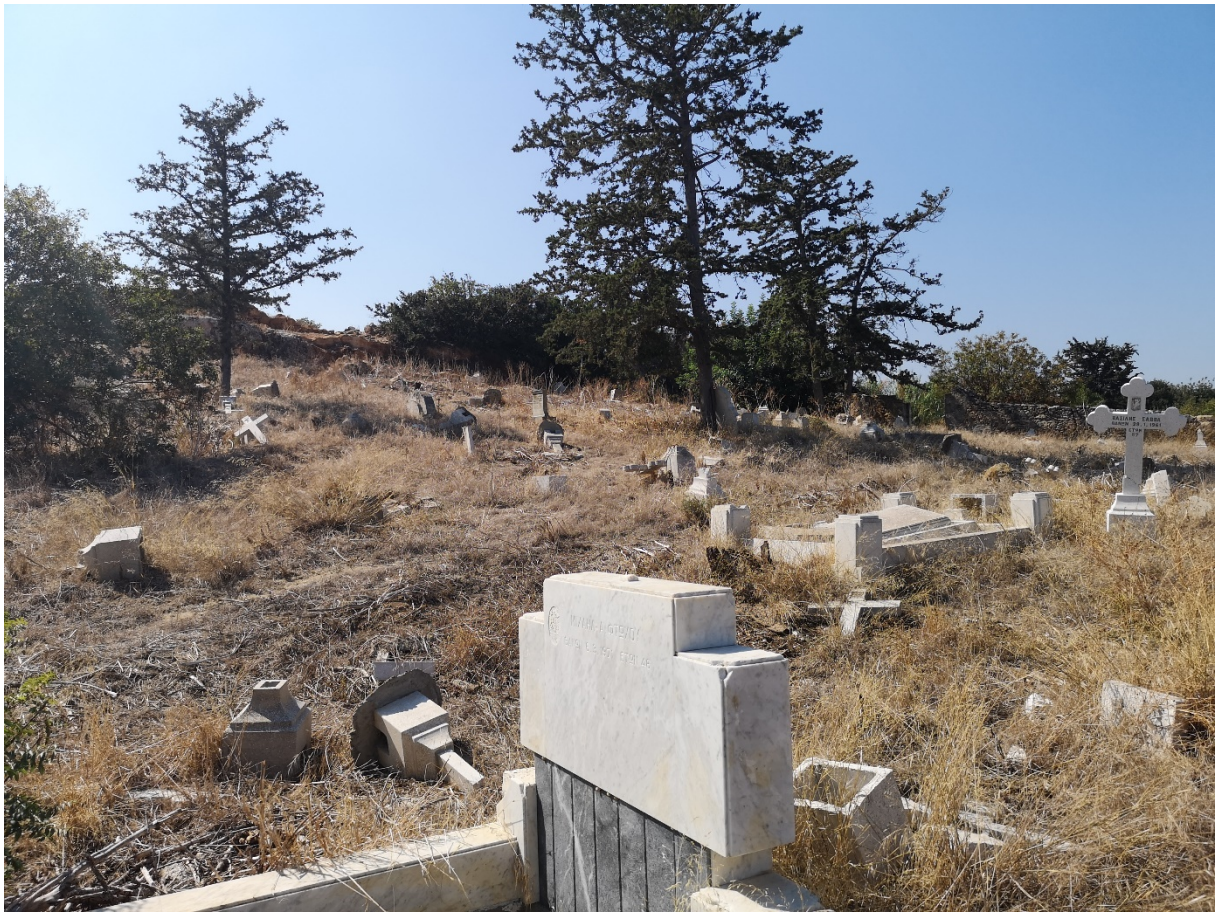
Fig. KYR-A2c: Greek Orthodox cemetery (view from northeast; Sept. 2018)

Condition: *poor*; the enclosure wall has partly collapsed, and the entrance gates are missing; the cemetery itself is overgrown by weeds and shrubs and shows signs of erosion; the bigger sepulchres are in a poor state and many of the traditional grave crosses are scattered around.

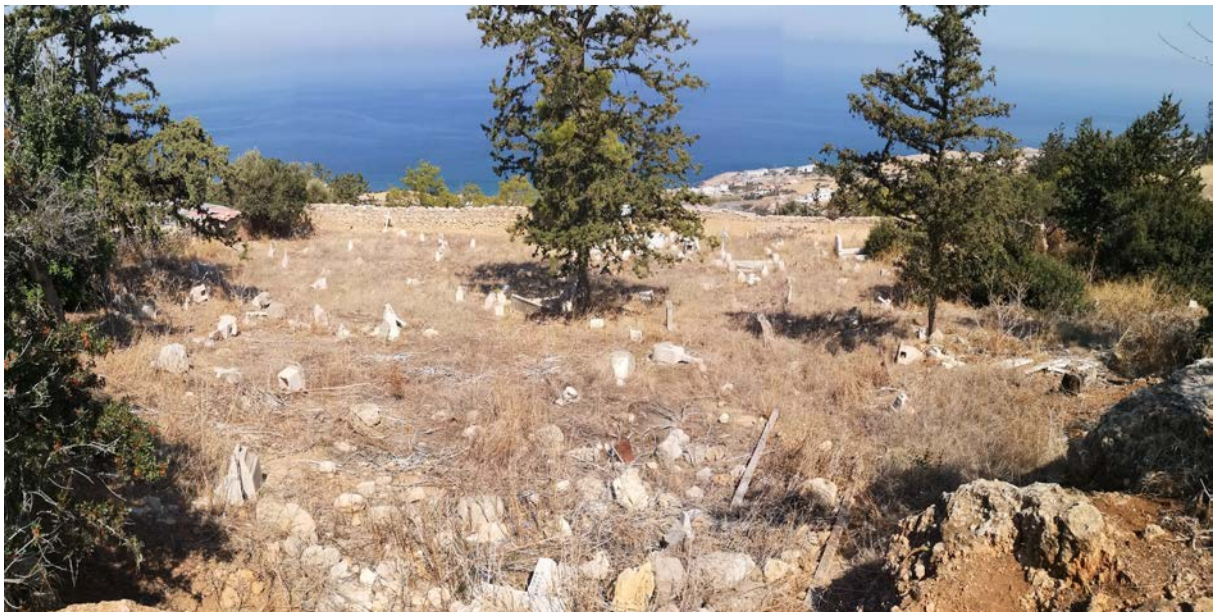
Fig KYR-A2d: Greek Orthodox cemetery (view from south; Sept. 2018)

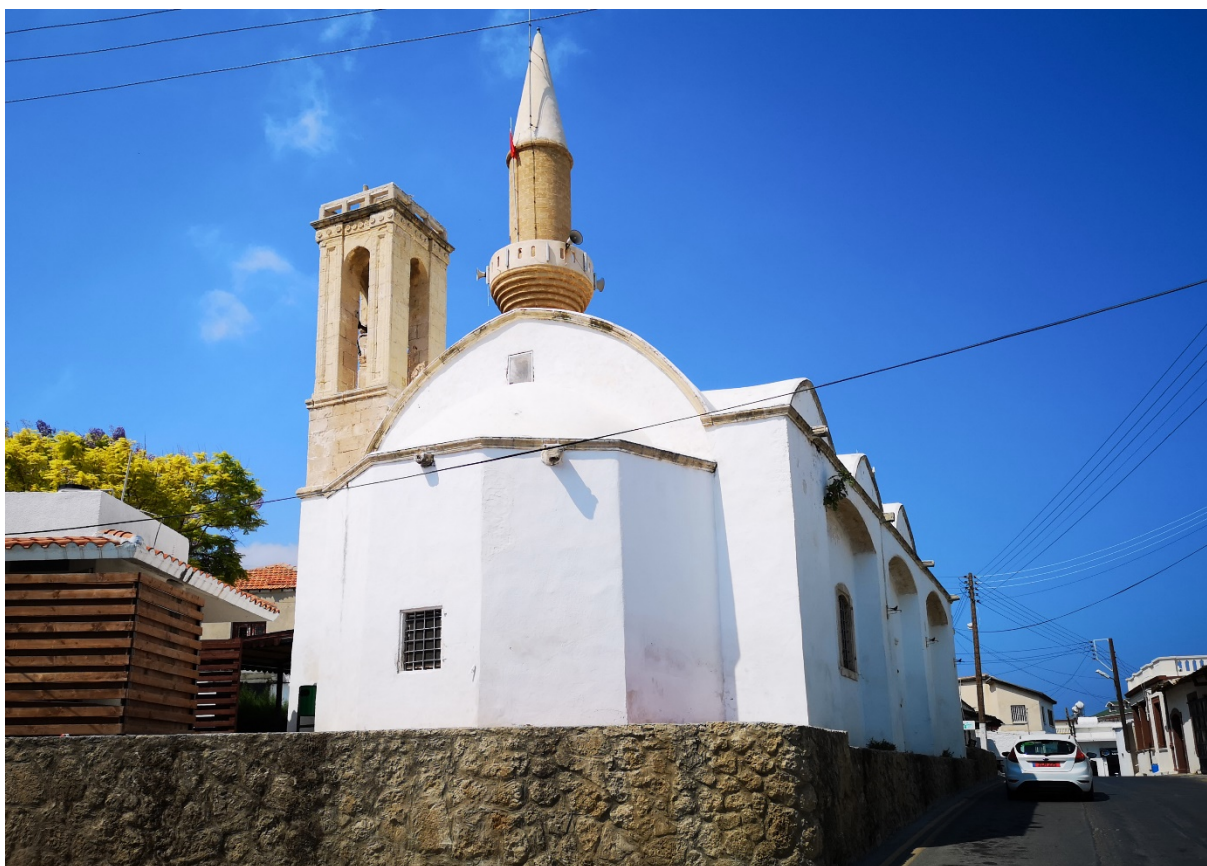
Fig. KYR-A3a: Church, converted into a mosque (view from east; Sept. 2018)

External condition: *good*; the crosses on the roof and bell tower were removed; a tall minaret was added at the southwest corner.

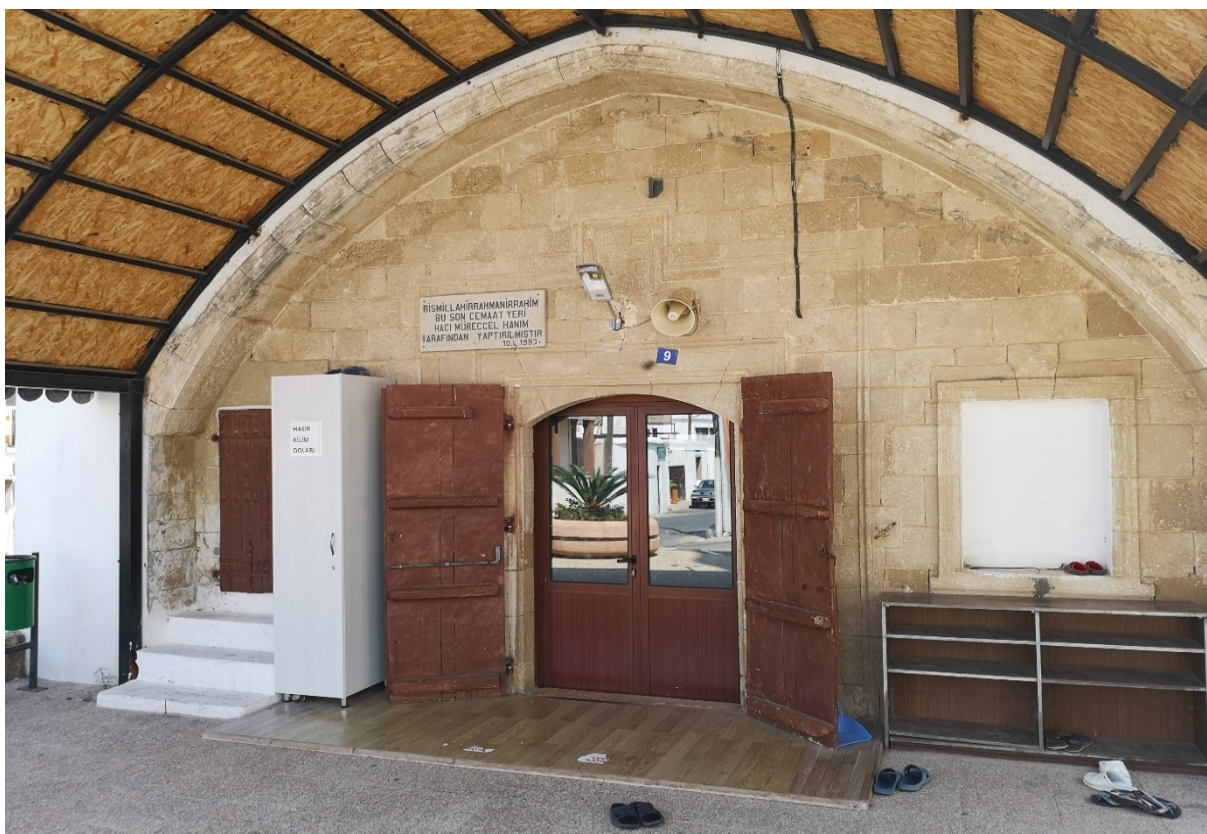
Fig. KYR-A3b: Church, converted into a mosque (view from west; Sept. 2018)

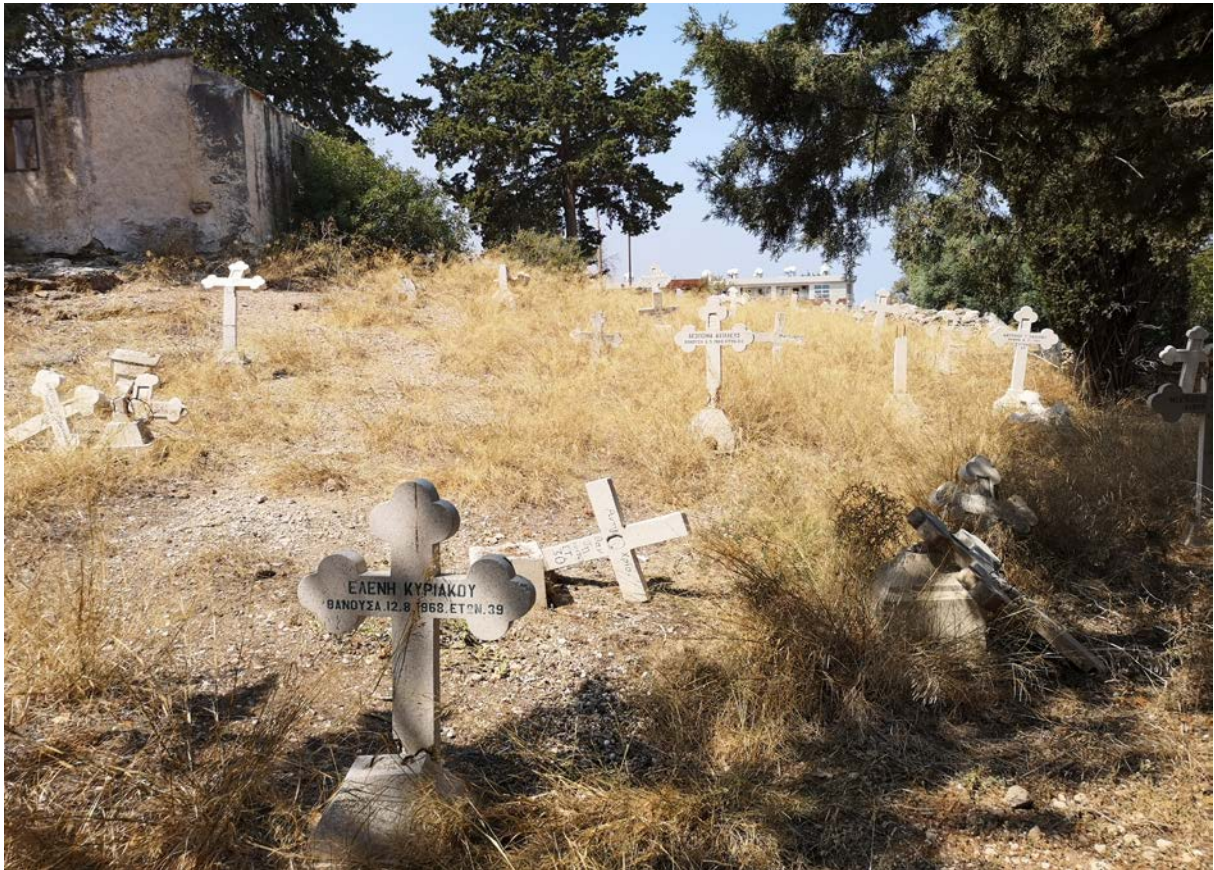
Fig. KYR-A3c: Greek Orthodox cemetery (view from northeast; Sept. 2018)

Condition: *poor*; the enclosure wall has partly collapsed and the entrance gates are missing; the cemetery itself is overgrown by weeds and shrubs and shows signs of erosion; the sepulchres are in a poor state; some crosses seem to be re-erected in their original places. The *Agia Stephani* church at the cemetery lies in ruins.

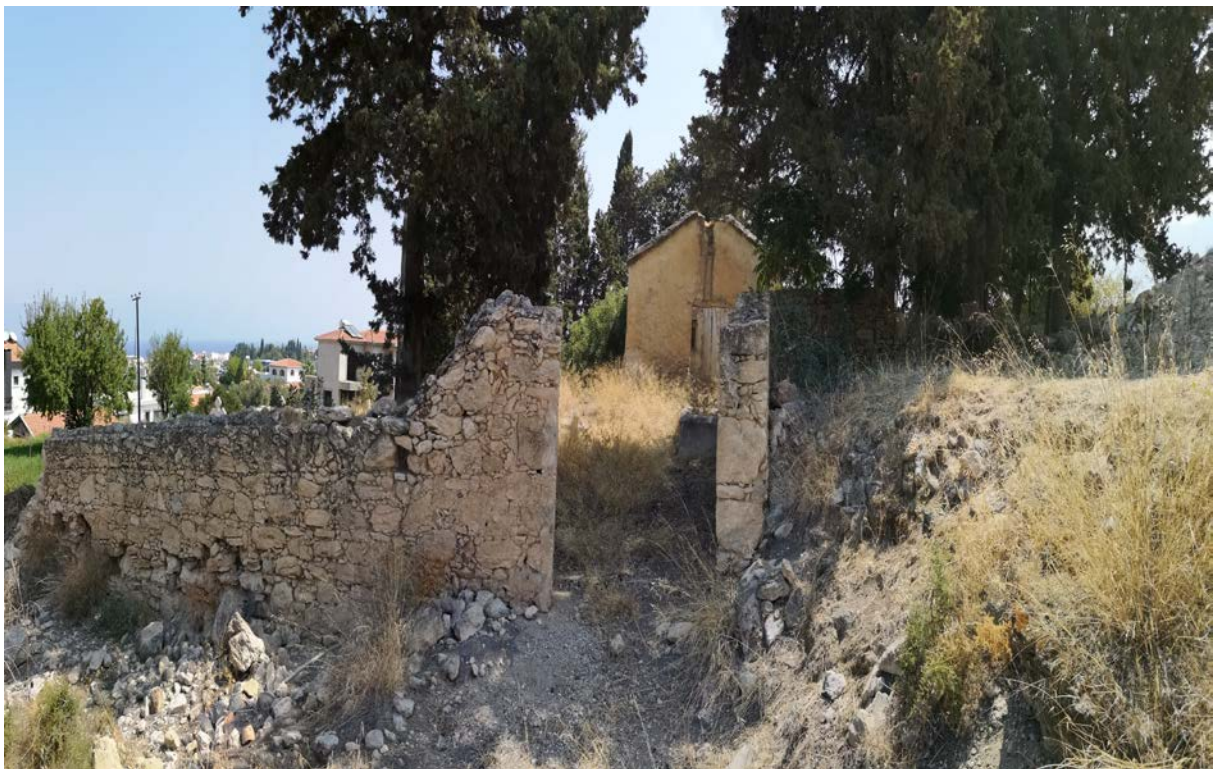
Fig KYR-A3d: Greek Orthodox cemetery (view from west; Sept. 2018)

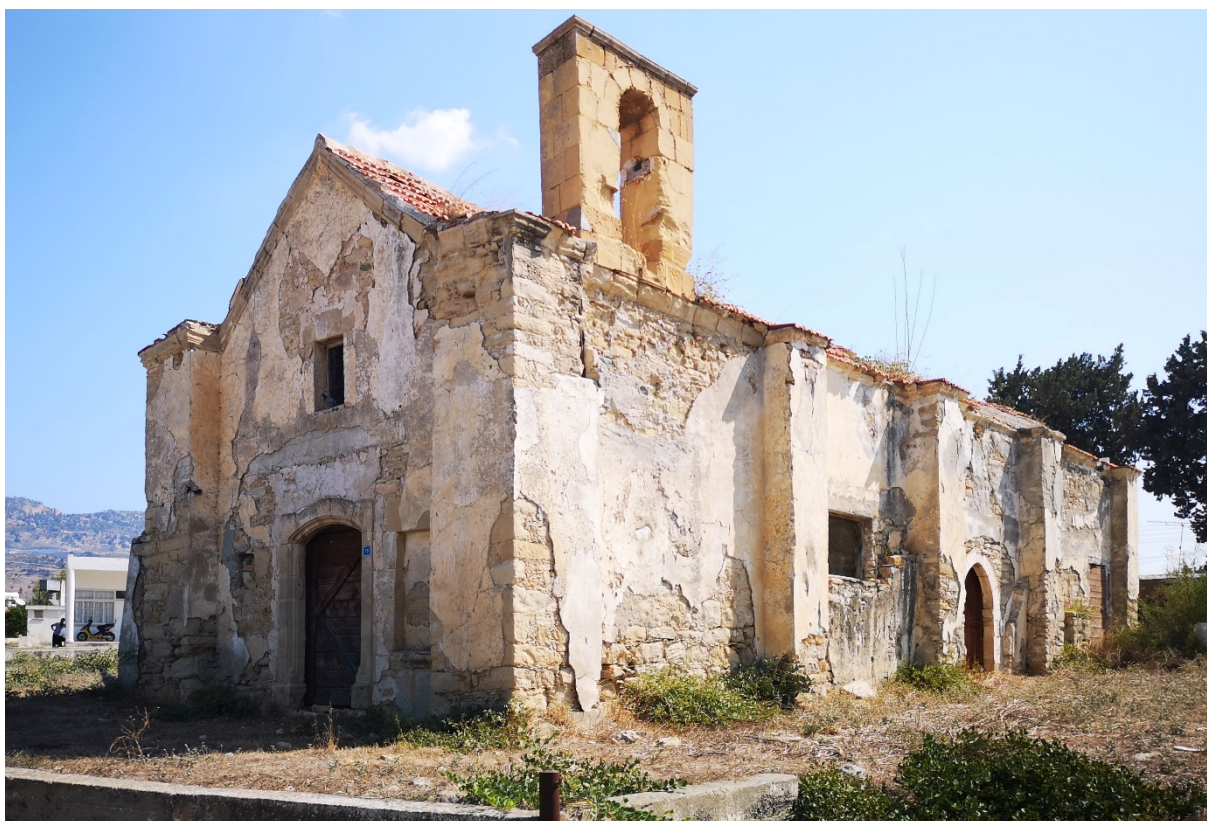
External condition: the condition of the old parish church (OPC) is on the way from *poor* to *ruin*; advanced deterioration is visible on all parts of the building; the bell is missing, and no crosses are visible; new doors – which are locked – were installed some time ago. The new parish church (NPC) has been converted into a mosque. The bell and all crosses were removed. The condition of the building is *good*.

Fig. KYR-A4a: Old parish church (view from south; Sept. 2018)

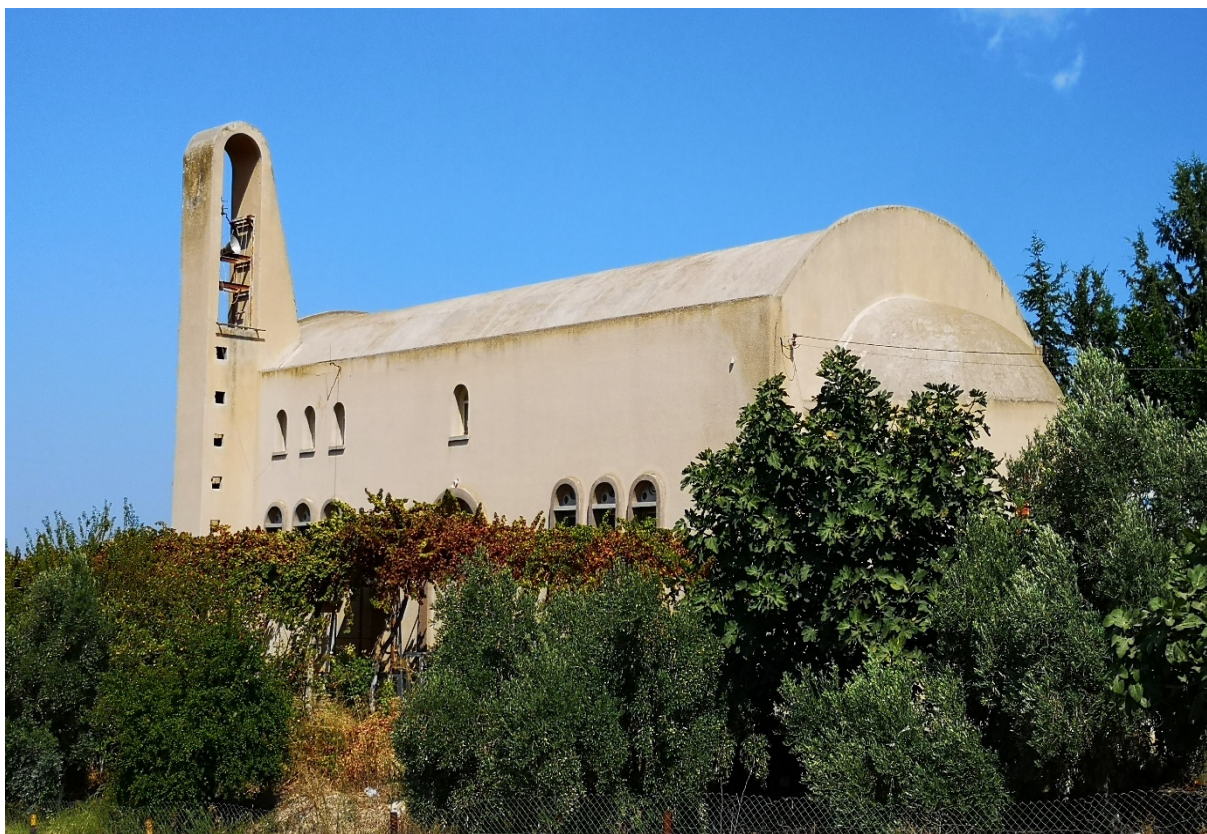
Interior condition: the interior of the old church could not be inspected. The condition of the interior of the new parish church is *good*; but since it is used as a mosque all furnishings of a Greek Orthodox church have been removed; furthermore, the walls are painted in white and turquoise.

Fig. KYR-A4b: New parish church, converted into a mosque (view from southeast; Sept. 2018)

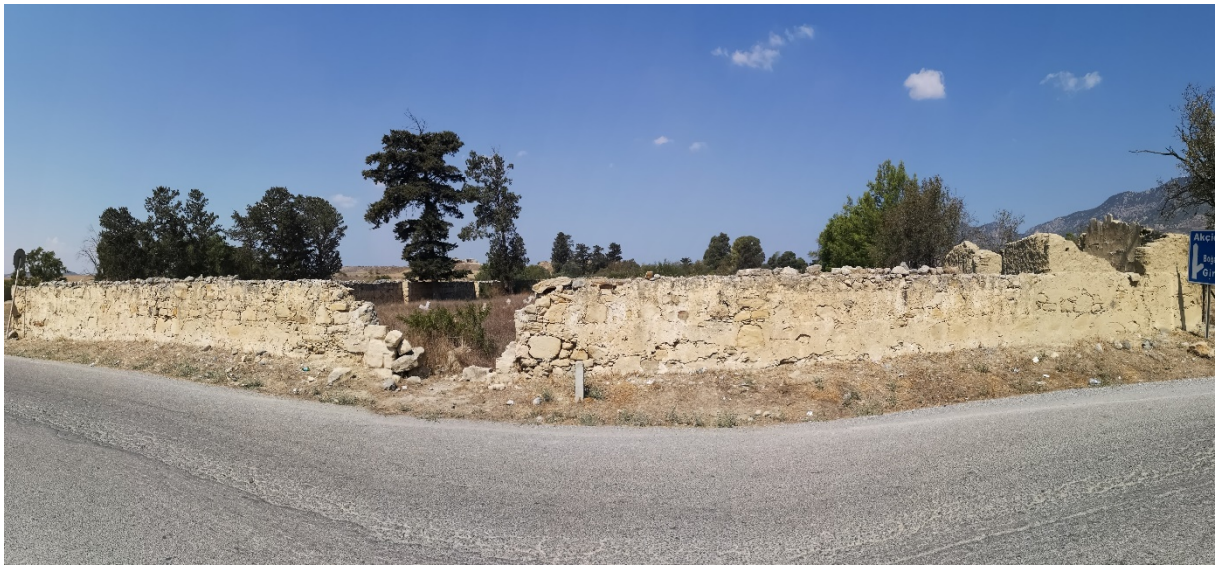
Condition: *fair to poor*; the enclosure wall has partly collapsed, and the entrance gates are missing; the cemetery itself is overgrown by weeds and shrubs; the bigger sepulchres are in a poor state; most of the traditional grave crosses seems to be re-erected.

Fig. KYR-A4c: Greek Orthodox cemetery (view from east; Sept. 2018)

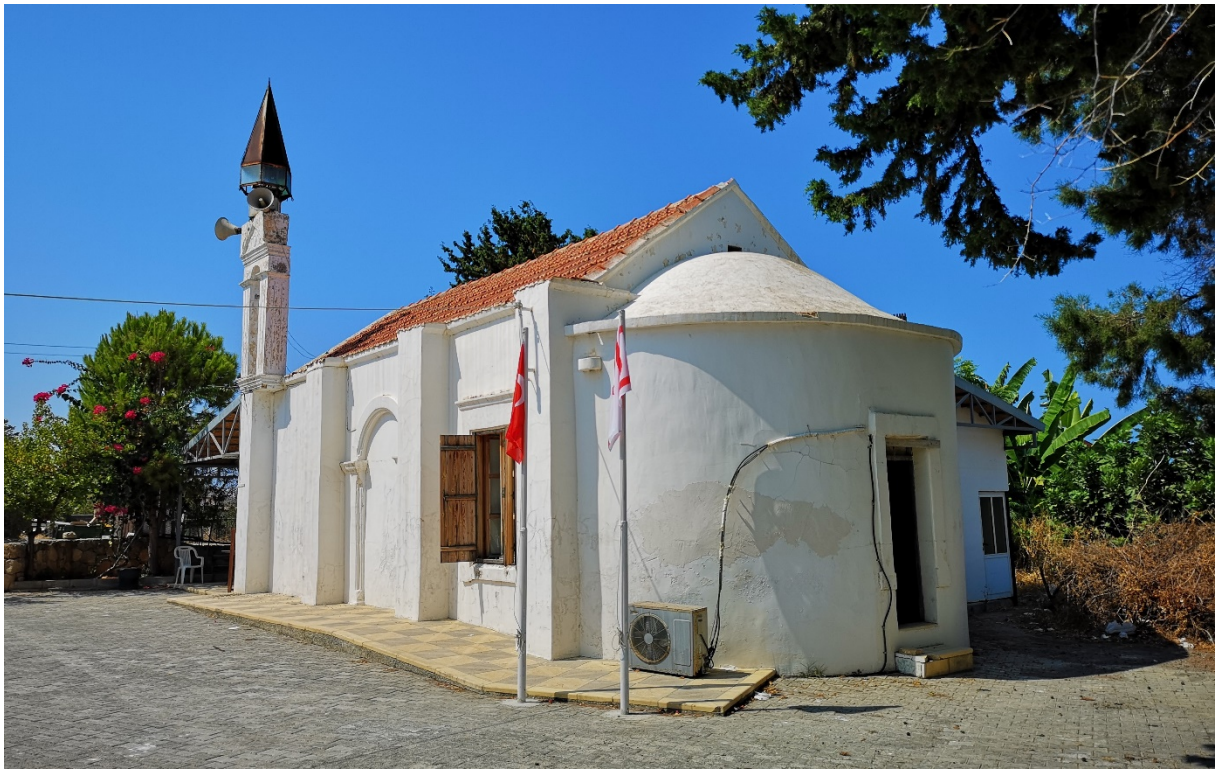
External condition: *good*; crosses on the roof and the bell were removed; a small metallic minaret was put on the bell tower.

Fig. KYR-A5a: Church of Agios Georgios, converted into a mosque (view from southeast; Sept. 2018)

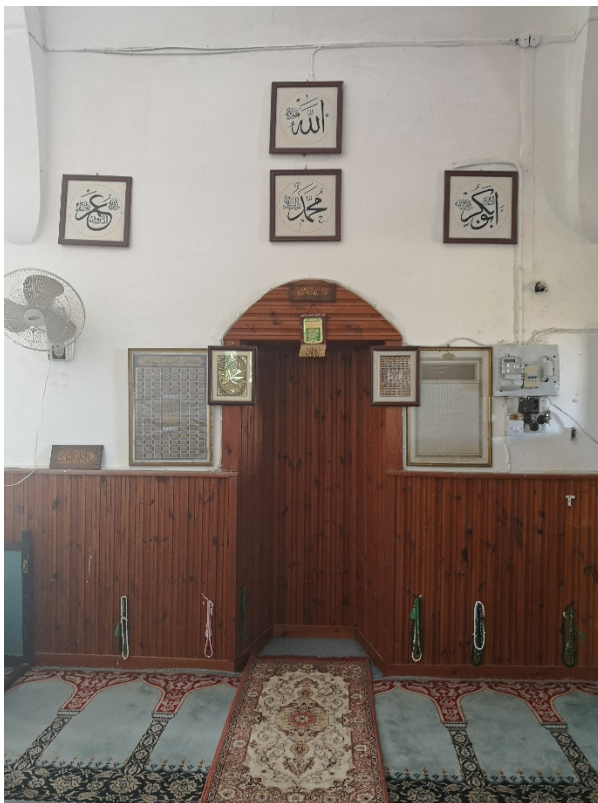
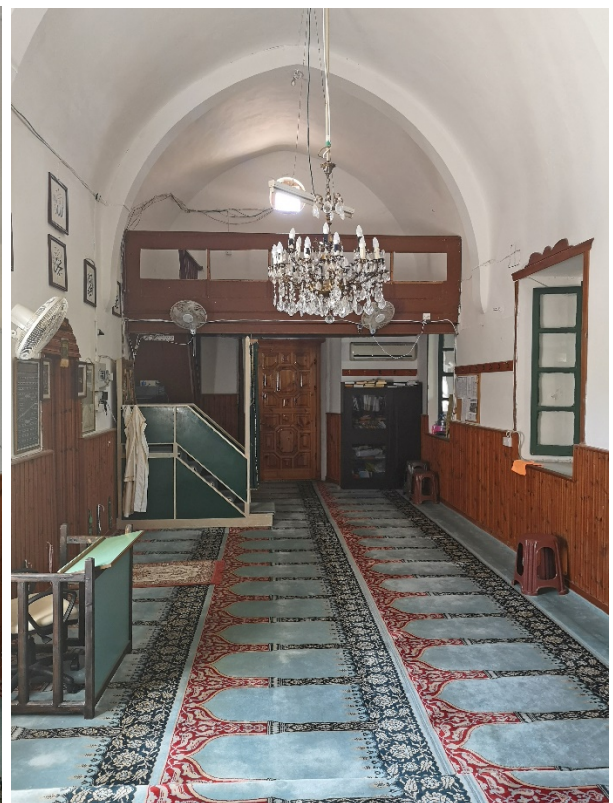
Interior condition: *good*; the condition of the interior of the church is good; since it is used as a mosque, all furnishings of a Greek Orthodox church have been removed. The interior is painted in white and the lower parts of the walls has been equipped with wood panelling.

Fig. KYR-A5b-c: Church of Agios Georgios, converted into a mosque (Sept. 2018)

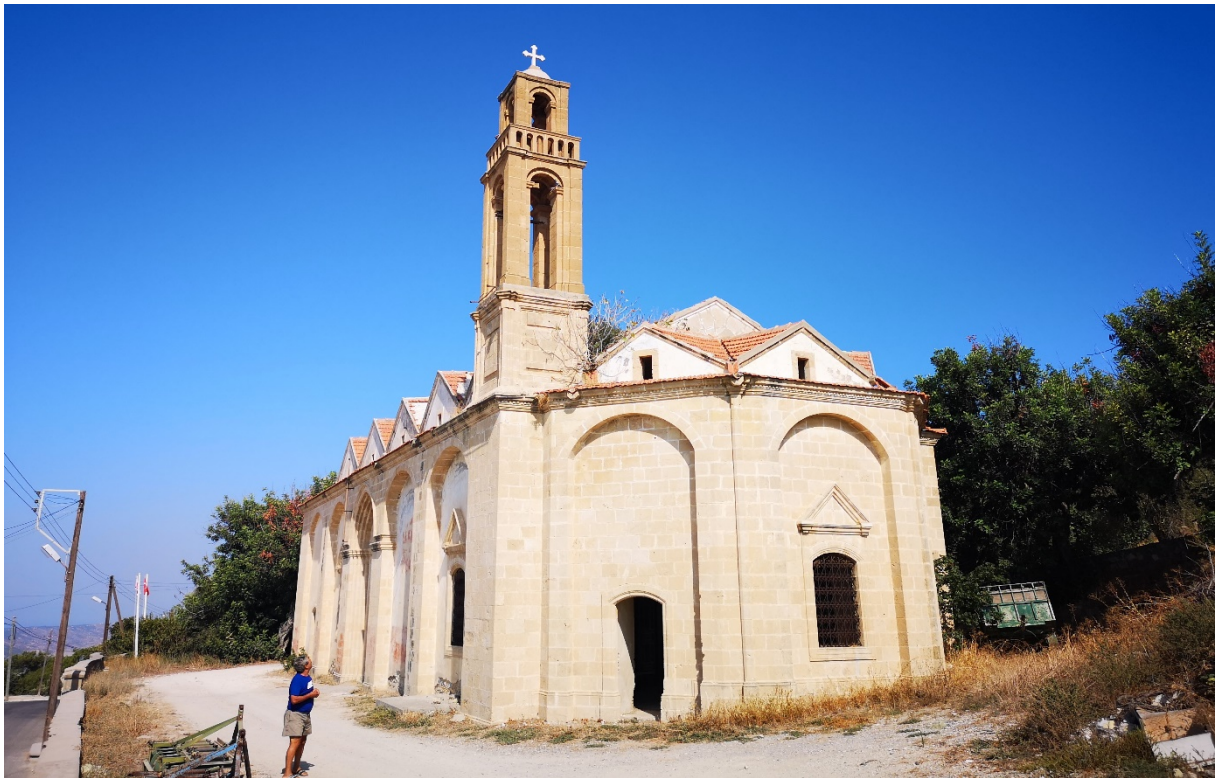
External condition: *good*; the bell was removed, the cross on the bell tower is still intact. The roof shows signs of decay, caused inter alia by scrub and small trees which are growing on the roof.

Fig. KYR-A6a: Agios Charalambous church (view from southeast; Sept. 2018)

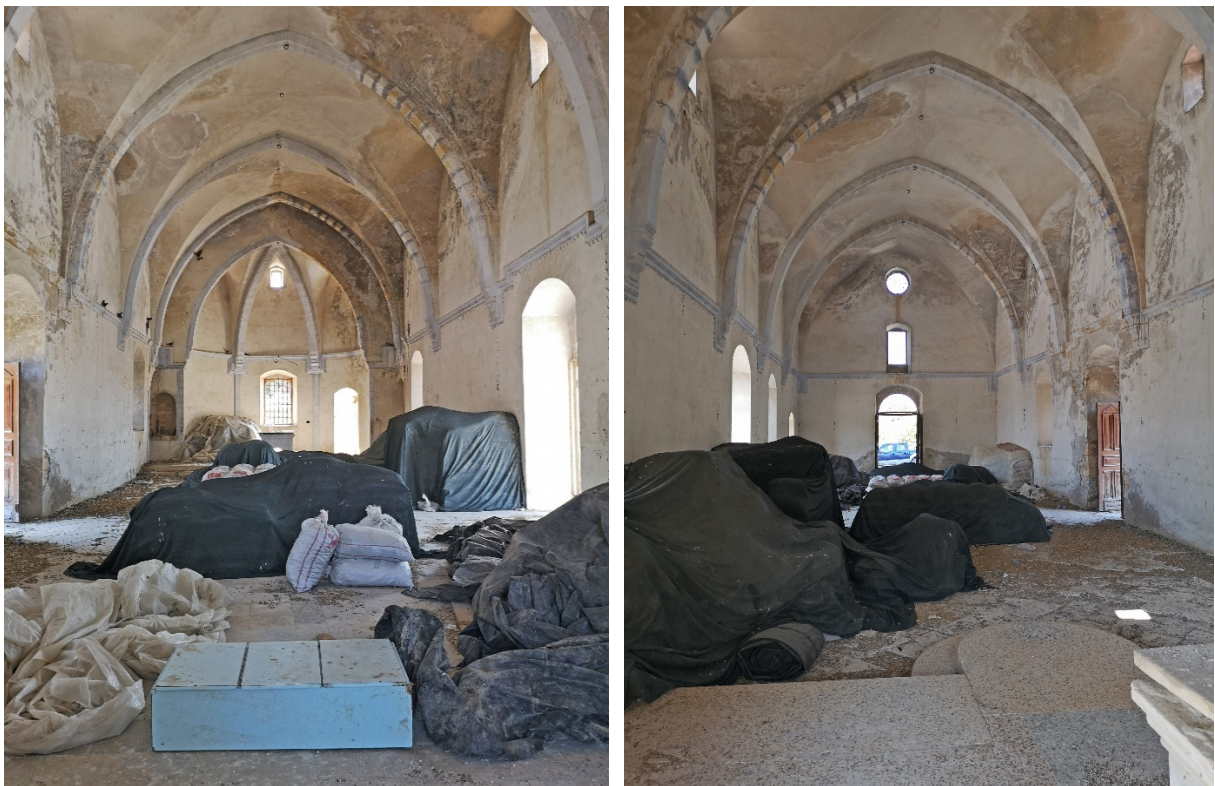
Interior condition: *fair*; all furnishings of a Greek Orthodox church except the altar have been removed. There are clear signs of damp on the ceiling. The building is used as a barn/warehouse at present.

Fig. KYR-A6b-c: Agios Charalambous church (Sept. 2018)

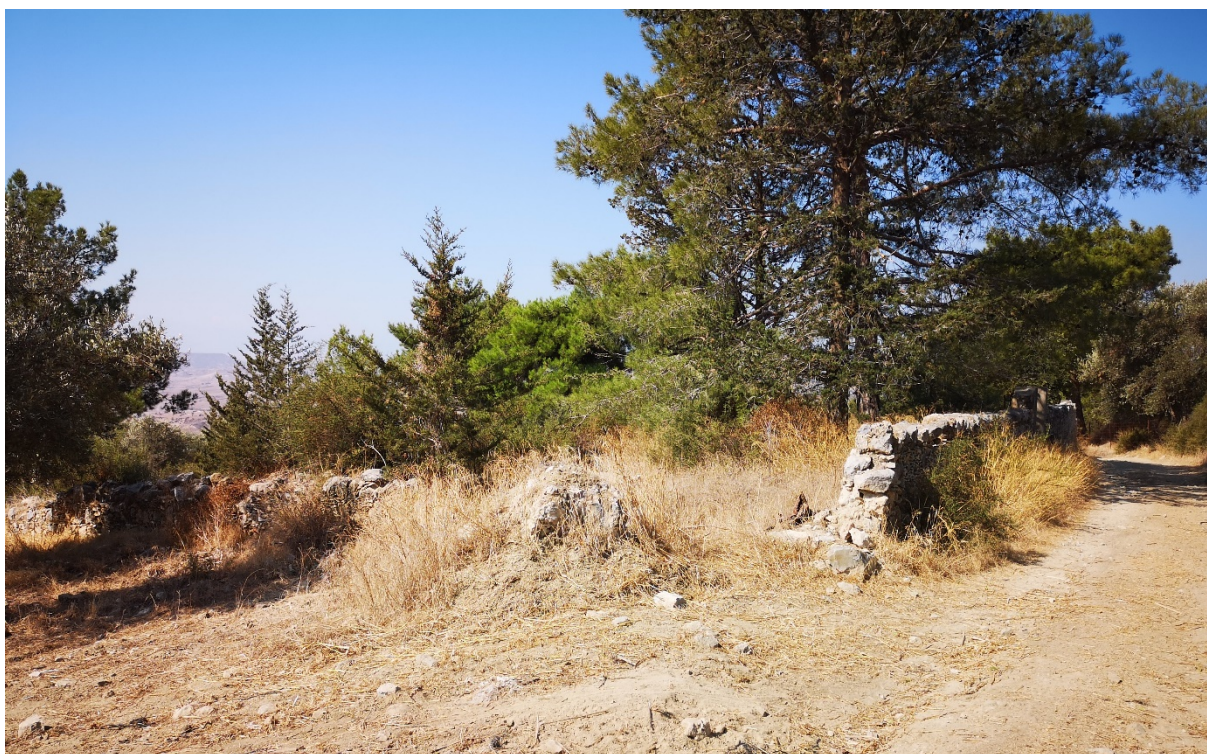
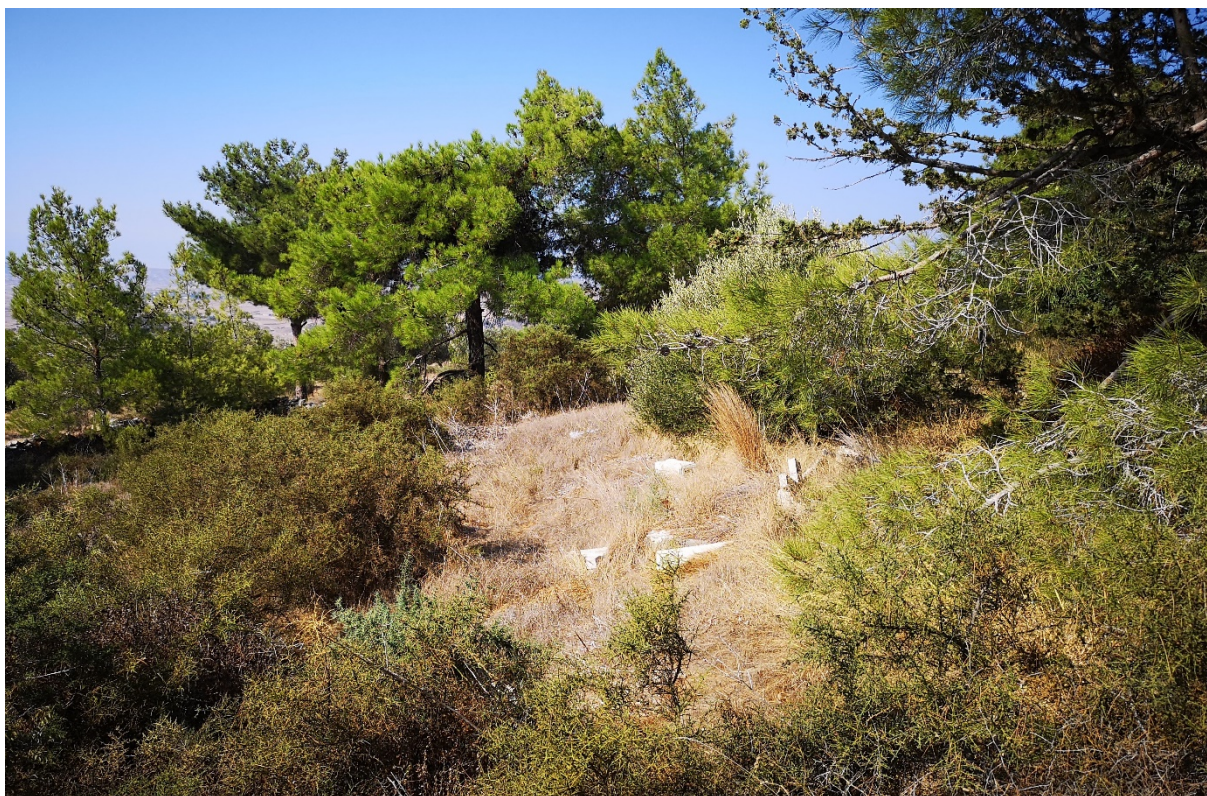
Condition: *poor*; the cemetery is near to ruin, the enclosure wall has partly collapsed; the cemetery itself is totally overgrown by weeds, shrubs, and trees; so, it is difficult to identify individual graves.

Fig. KYR-A6d: Cemetery (view from northeast; Sept. 2018)

Fig. KYR-A6e: Cemetery (view from northeast; Sept. 2018)

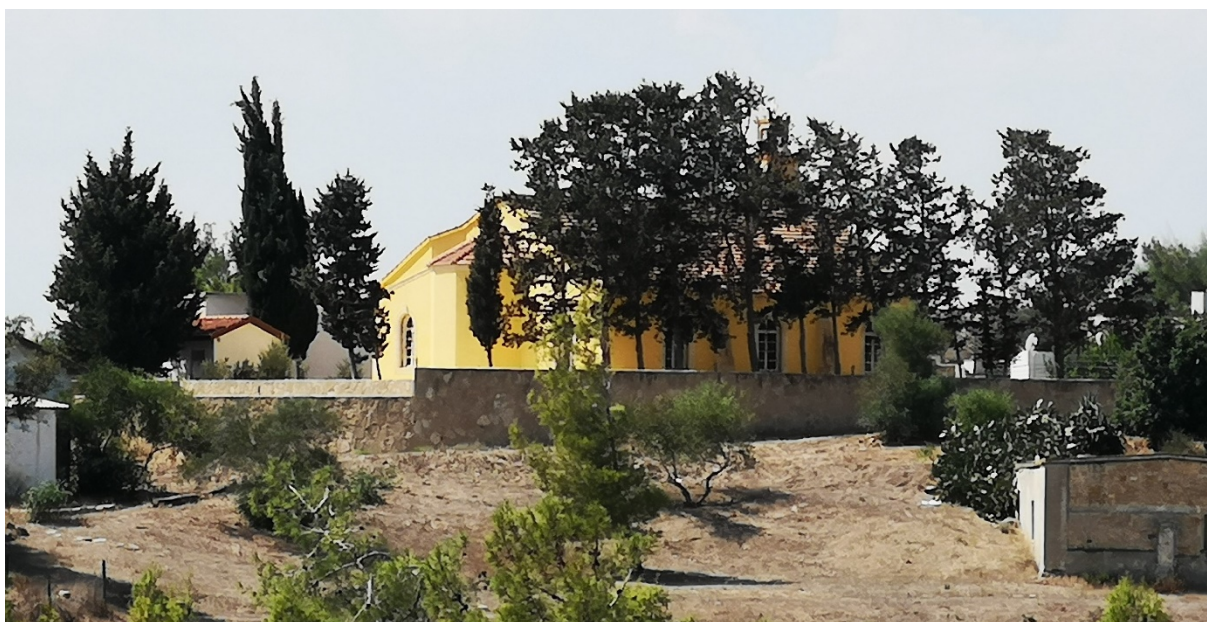
Fig. KYR-A7a: Church of St. Michael the Archangel (view from north; Sept. 2018)

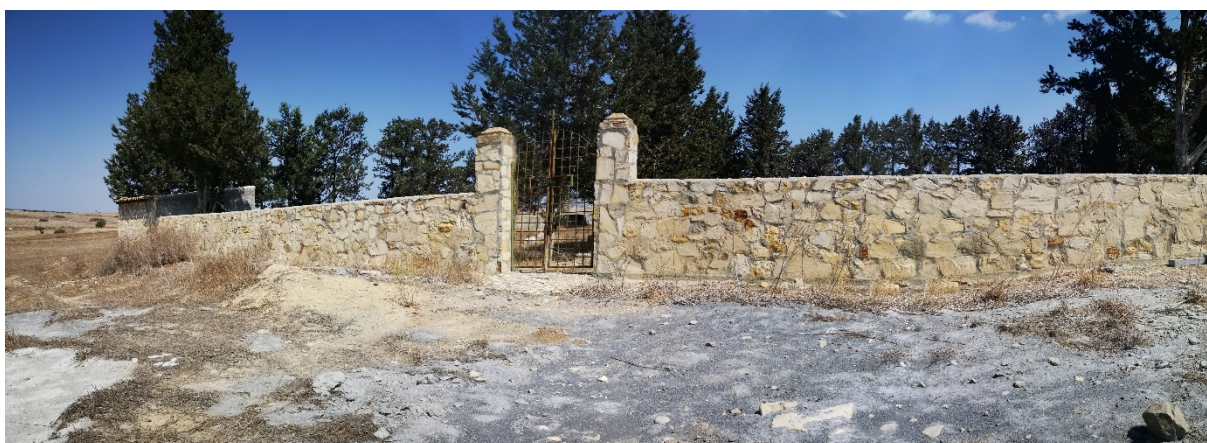
Fig. KYR-A7b: Cemetery (view from southeast; Sept. 2018)

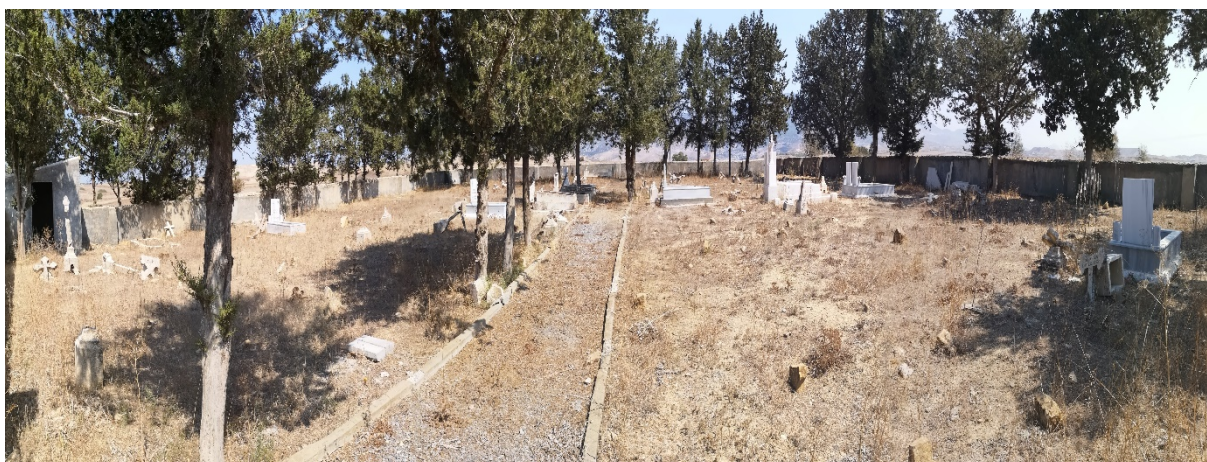
Fig. KYR-A7c: Cemetery (view from south; Sept. 2018)
