# The religious heritage of Cyprus

a survey in the districts of Kyrenia and Larnaca

Dr. Thorsten Kruse, M.A.  
Institut für Interdisziplinäre Zypern-Studien  
Westfälische Wilhelms-Universität Münster  
Schlaunstr. 2  
48143 Münster  
Germany  
Email: Th.Kruse@wwu.de

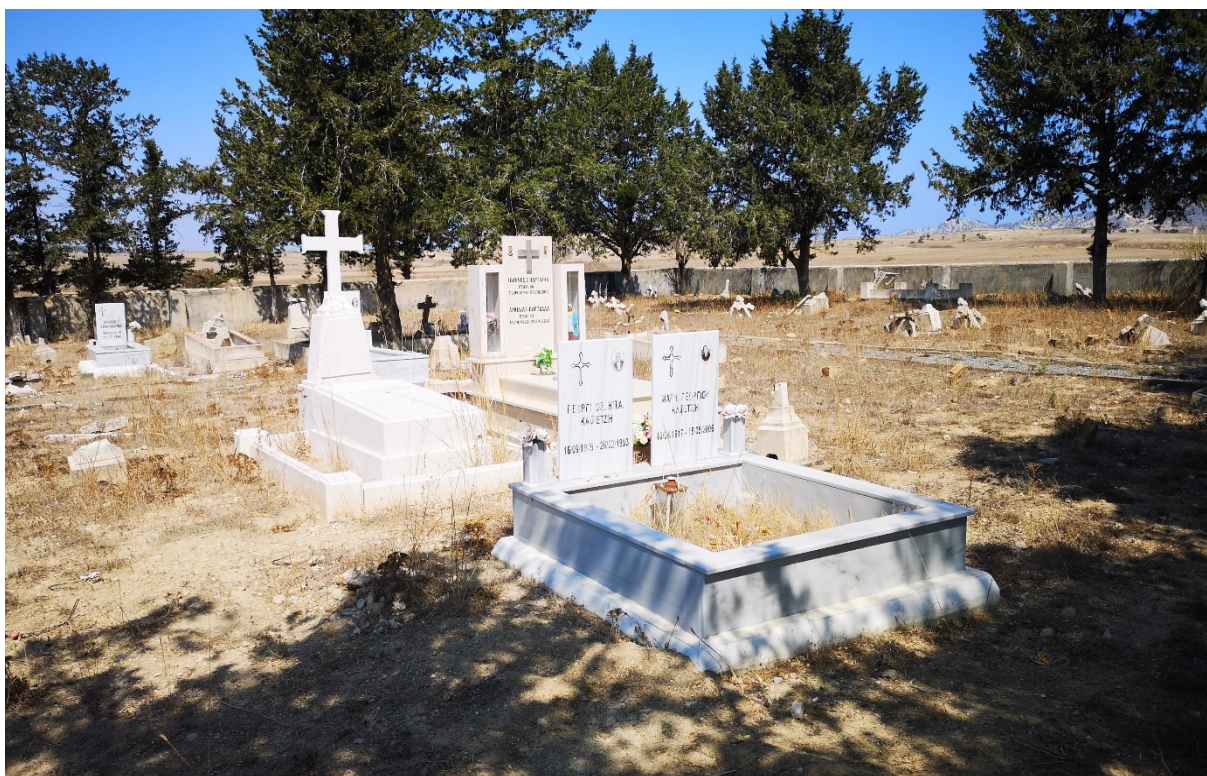
Fig. KYR-A7d: Cemetery (view from southeast; Sept. 2018)

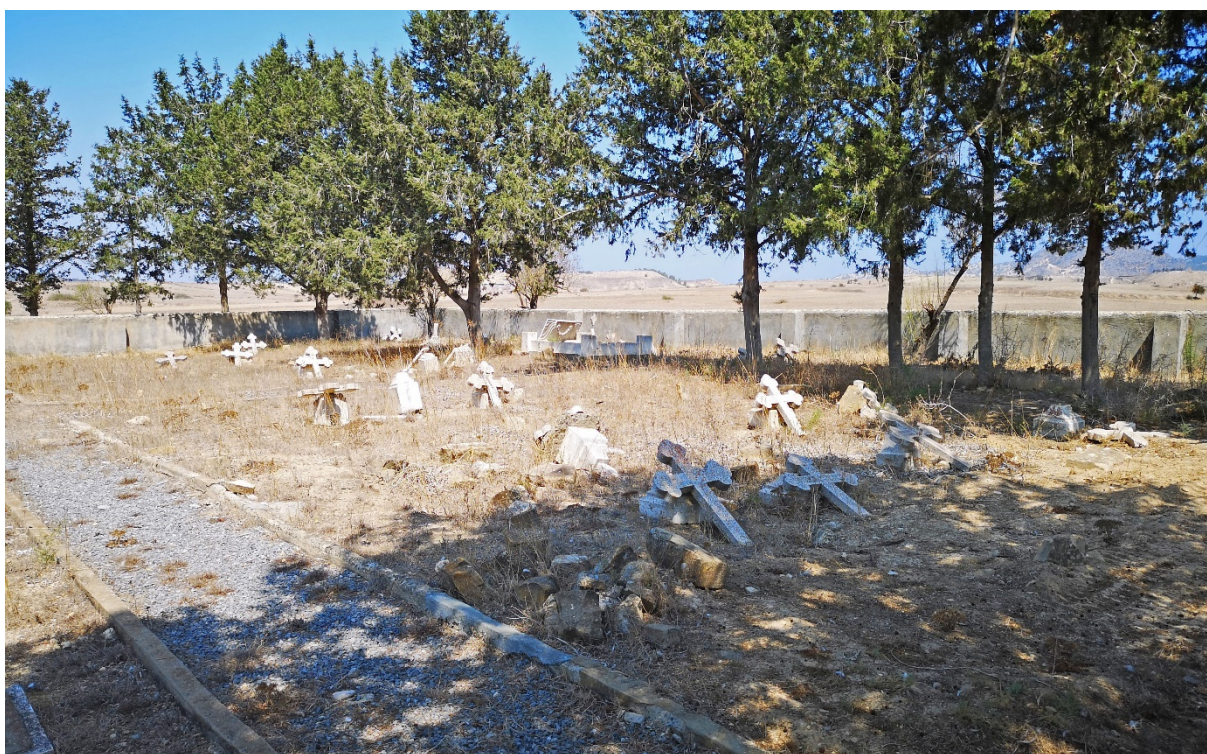
Fig. KYR-A7e: Cemetery (view from southeast; Sept. 2018)

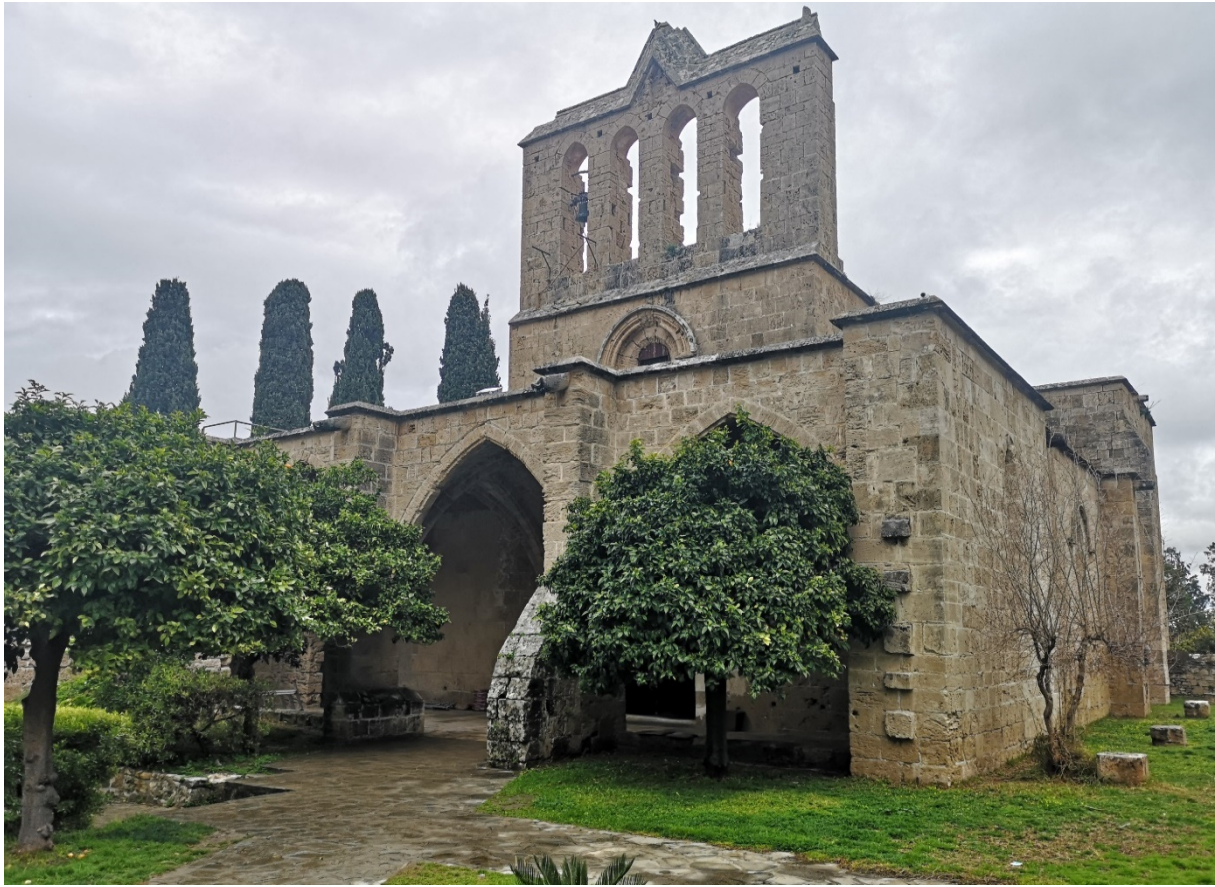
Fig. KYR-B1a: Panagia Asproforousa church (view from southwest; March 2019)

External condition: The *Agios Georgios* church is in a *good* condition. The church has been converted into a mosque; the bell is still in the bell tower. The *Panagia Asproforousa* church is also in a *good* condition; it has been converted into a museum.

Interior condition: The interior of the *Agios Georgios* church is in a *good* condition. Although it is now used as a mosque no mihrab was added. All interior walls were painted in white. The *Panagia Asproforousa* is in a *good* condition as well.

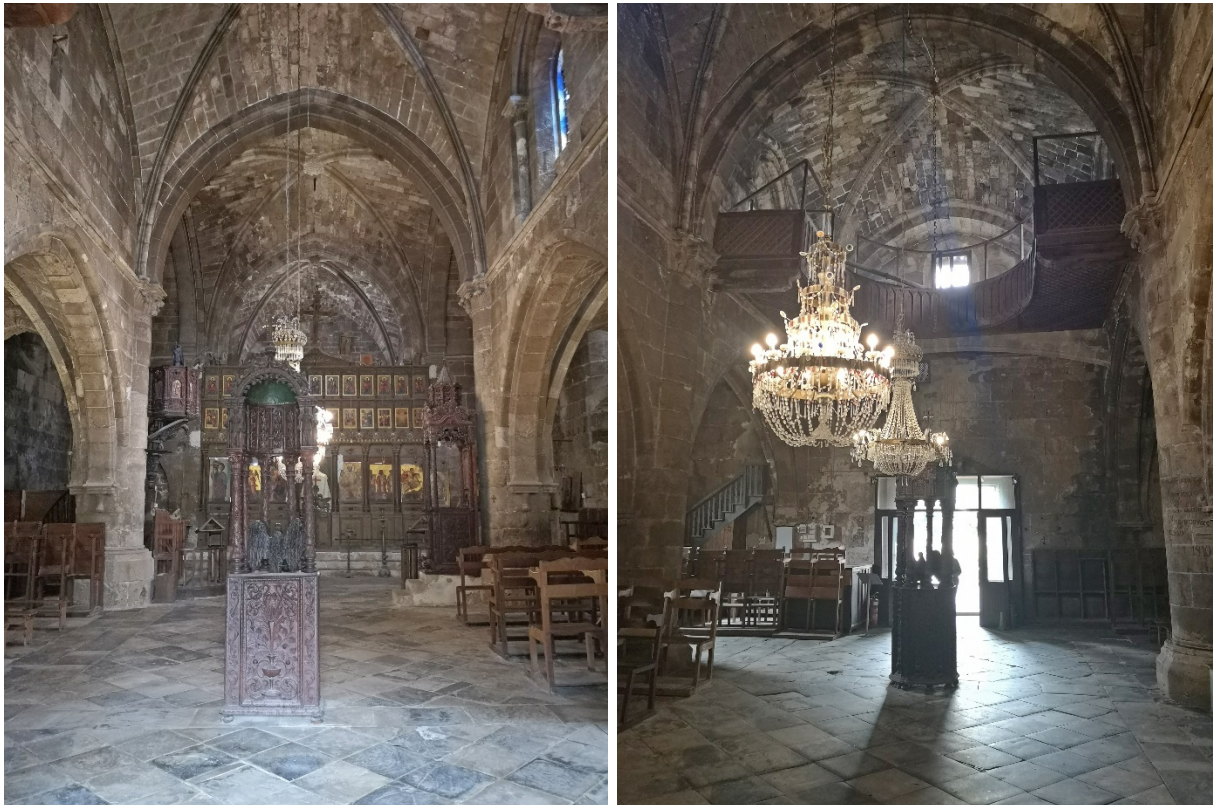
Fig. KYR-B1: Panagia Asproforousa church (March 2019)

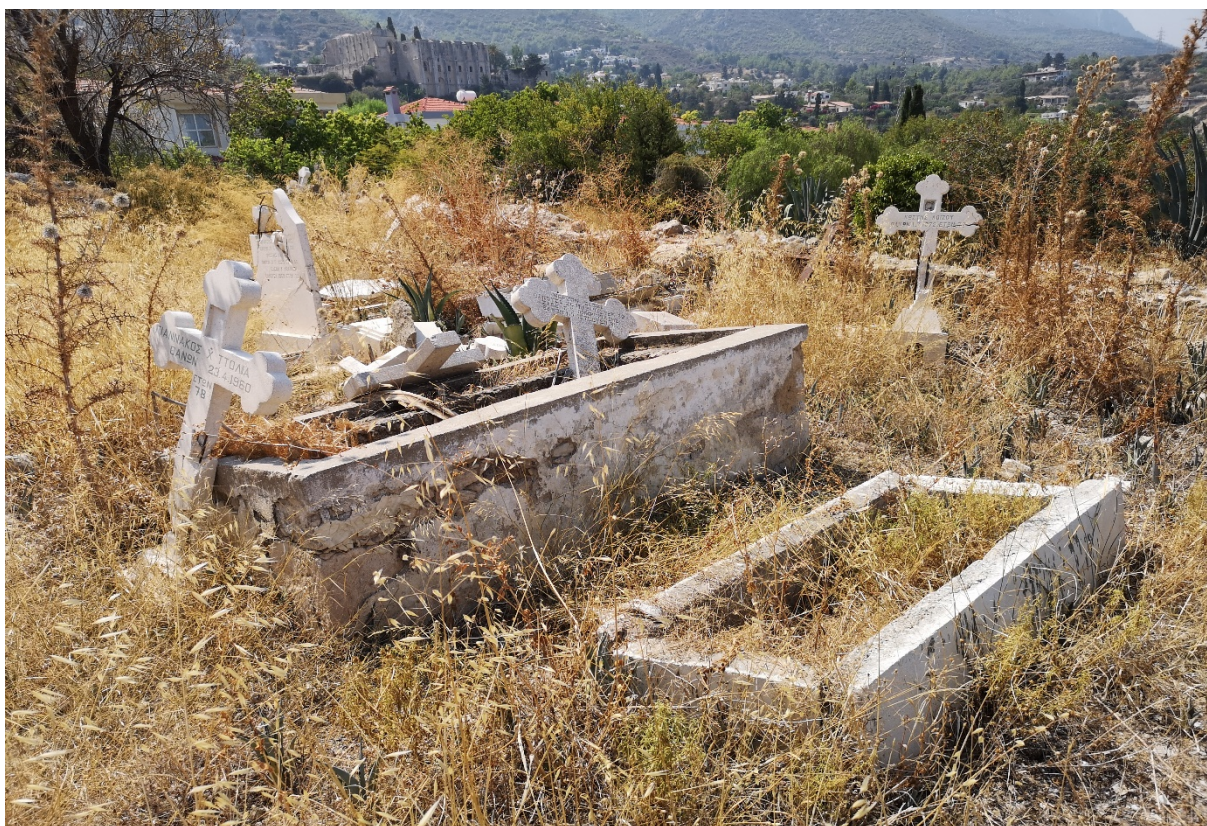
Fig. KYR-B1: Cemetery (view from northeast; Sept. 2018)

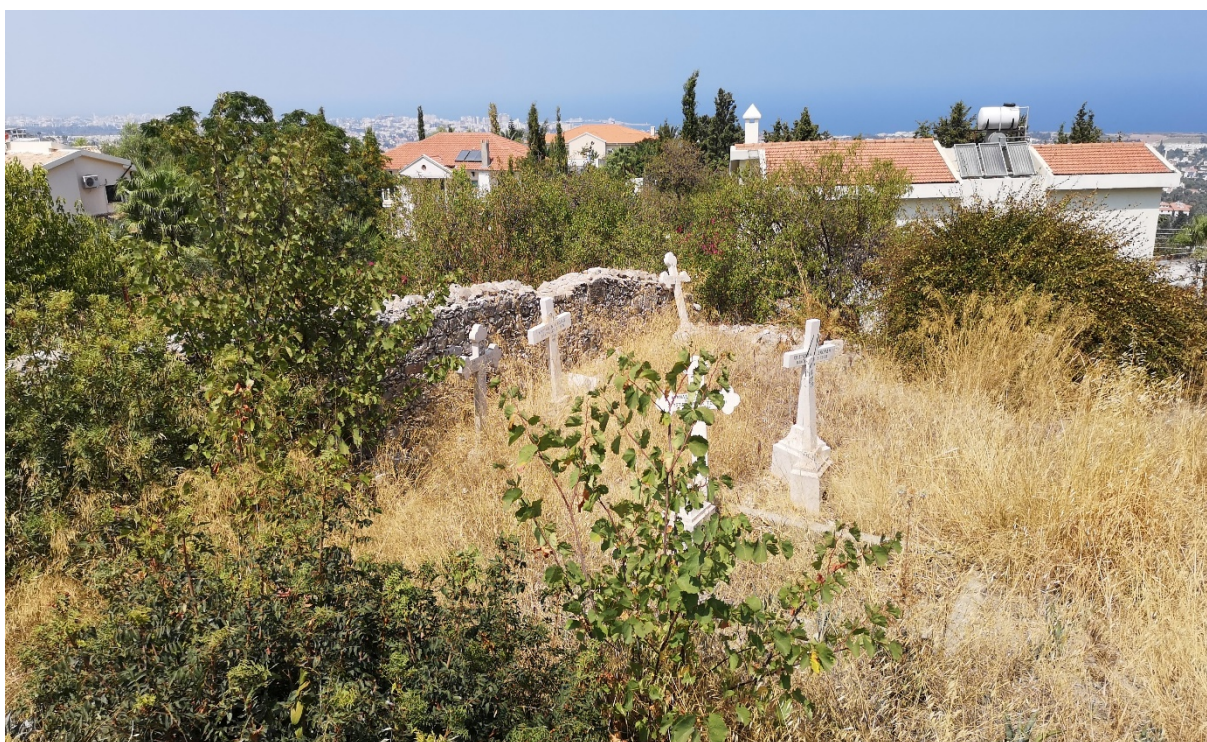
Fig. KYR-B1: Cemetery (view from southeast; Sept. 2018)

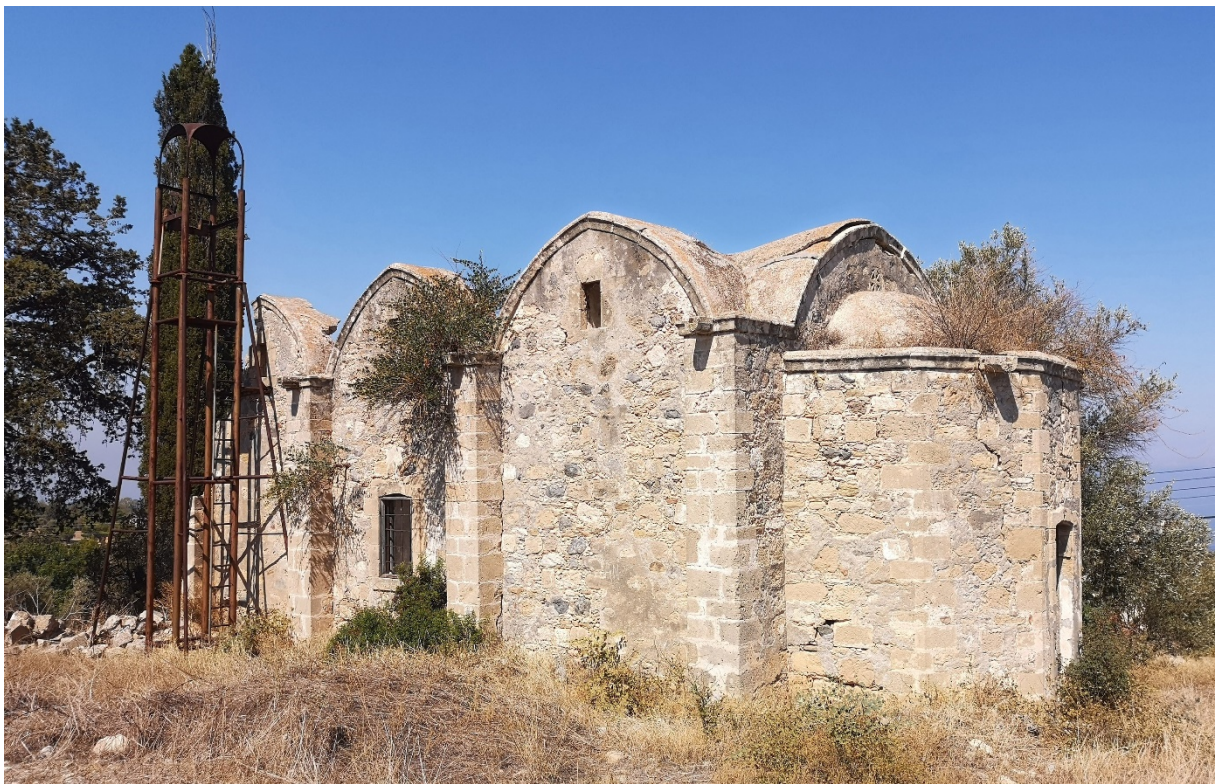
Fig. KYR-C1a: Church (view from southeast; Sept. 2018)

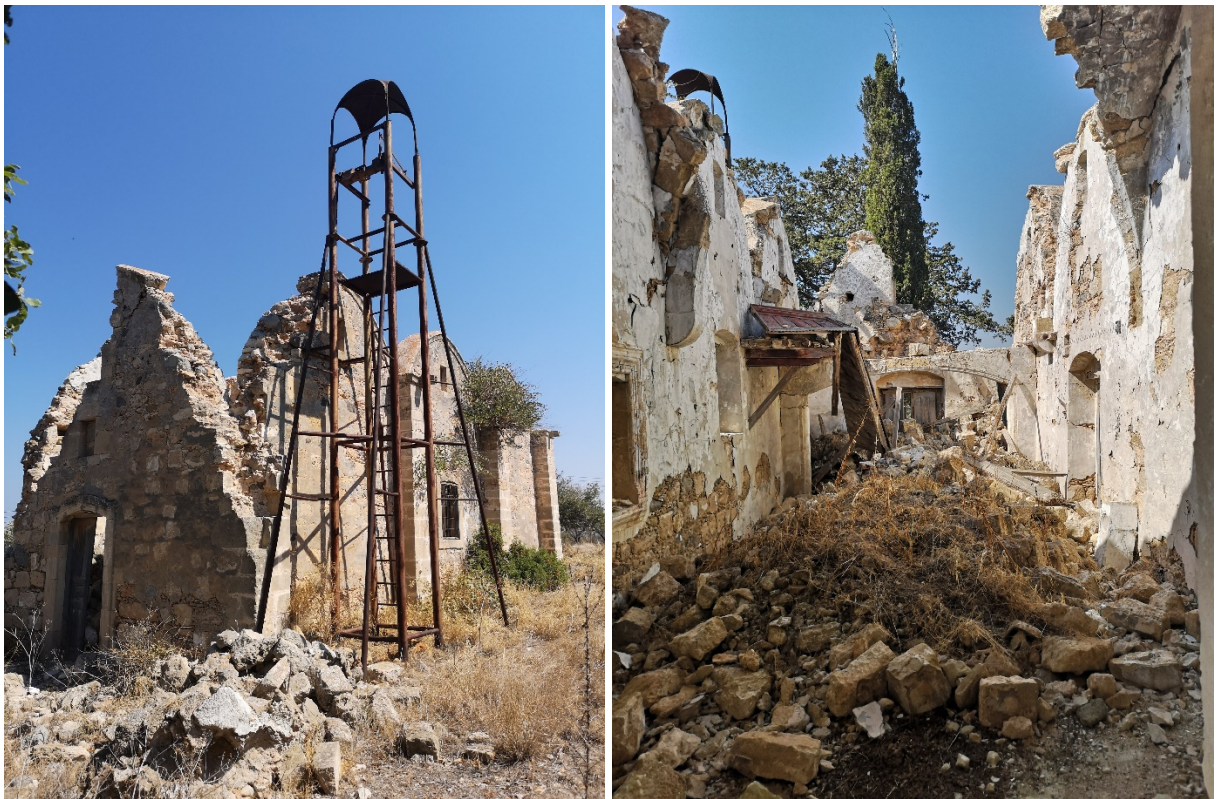
Fig. KYR-C1b-c: Church (Sept. 2018)

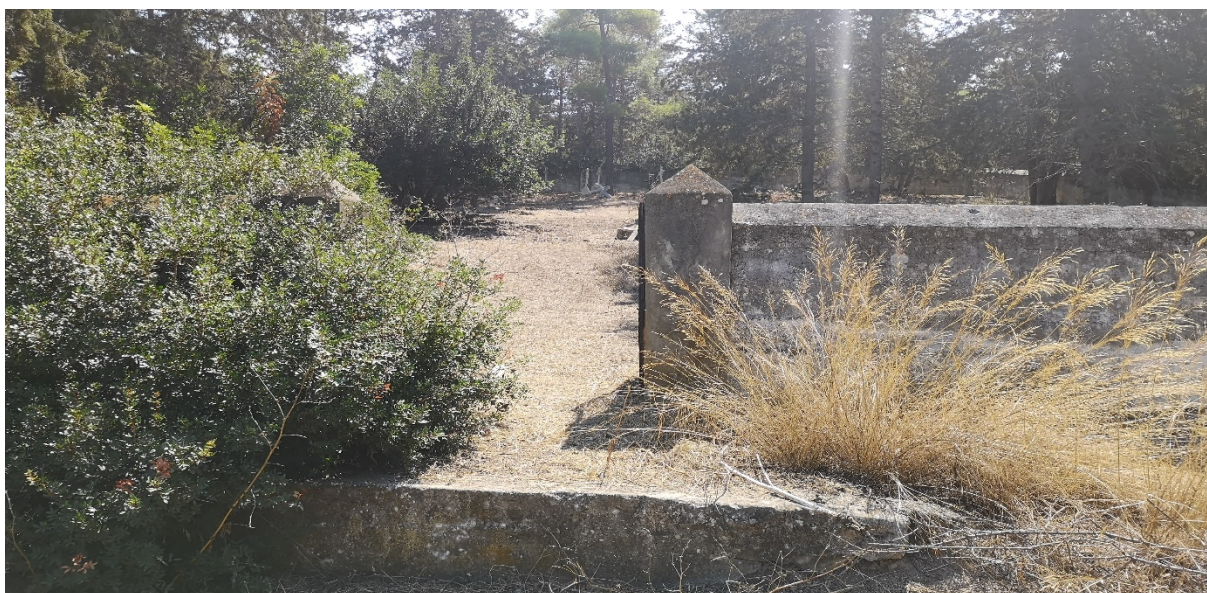
Fig. KYR-C1d: New cemetery (view from north; Sept. 2018)

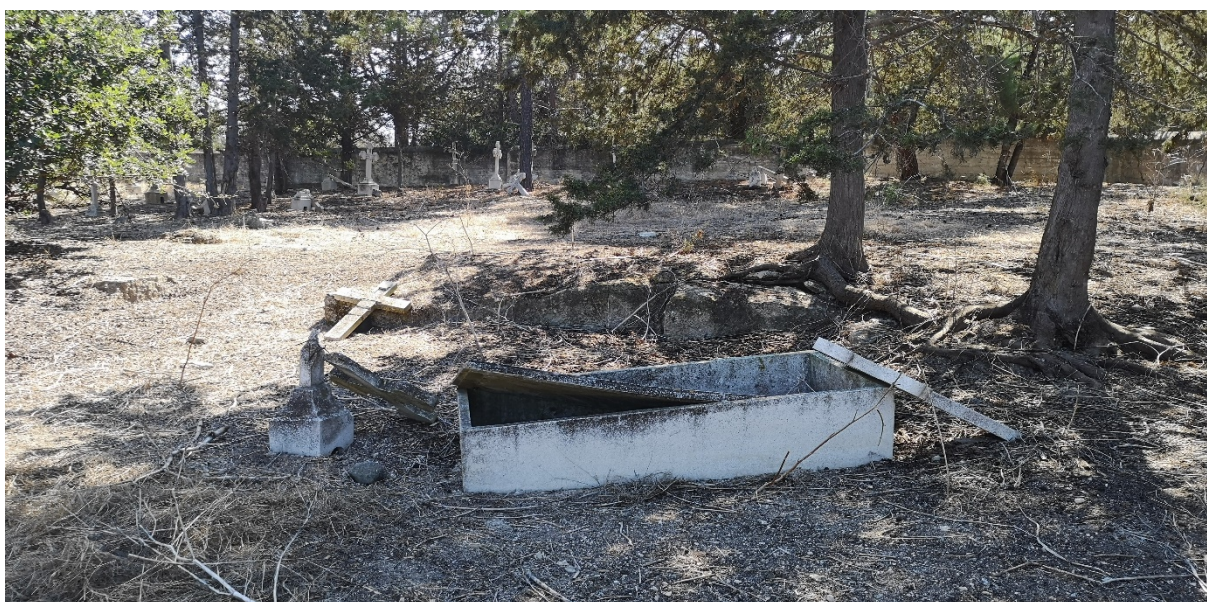
Fig. KYR-C1d: New cemetery (view from northeast; Sept. 2018)

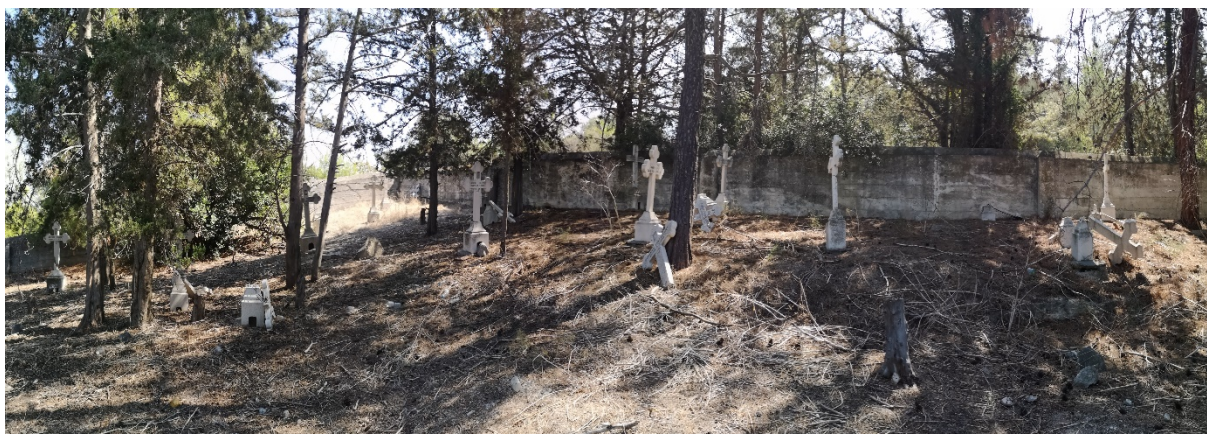
Fig. KYR-C1e: New cemetery (view from northwest; Sept. 2018)

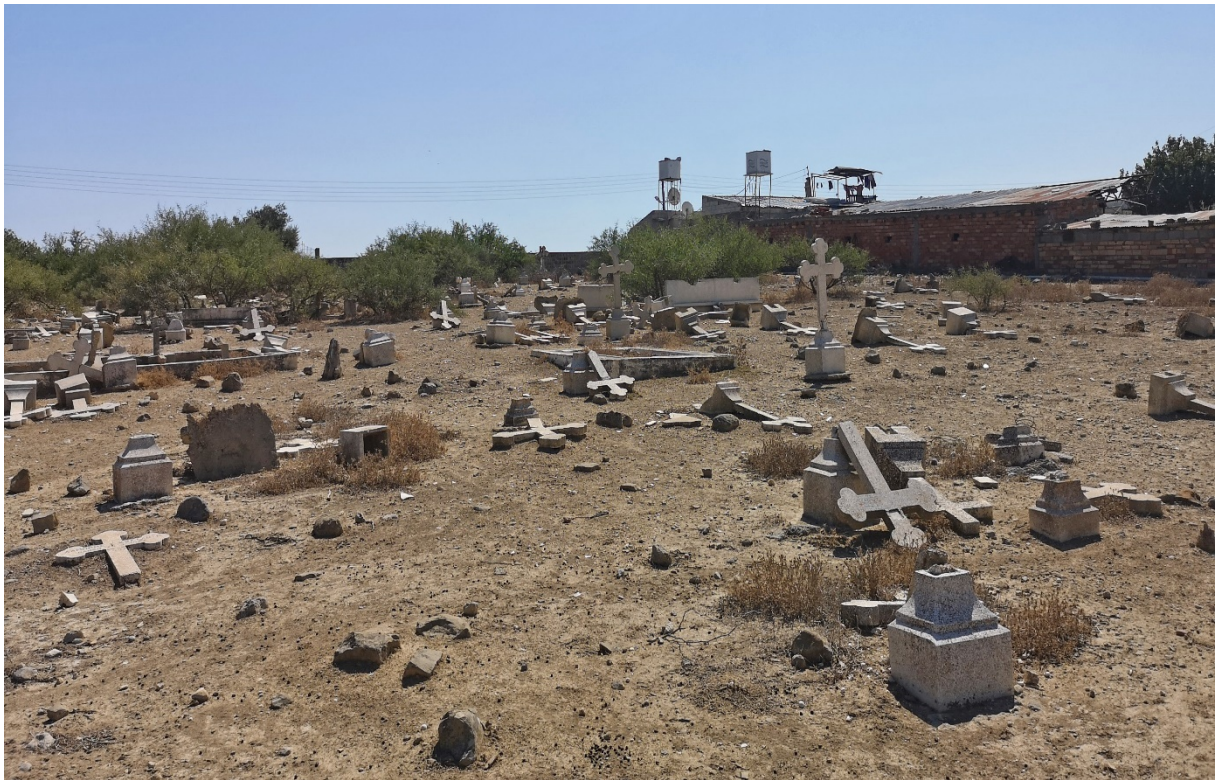
Fig. KYR-D1c: Cemetery (view from west; Sept. 2018)

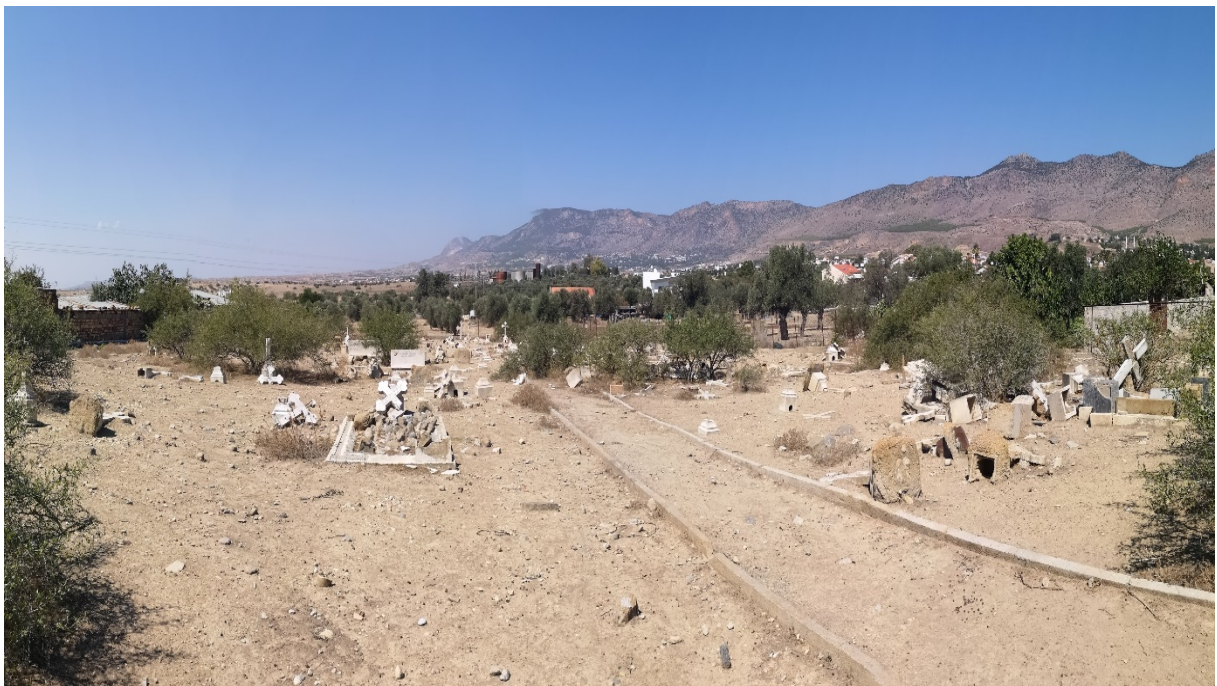
Fig. KYR-D1d: Cemetery (view from east; Sept. 2018)

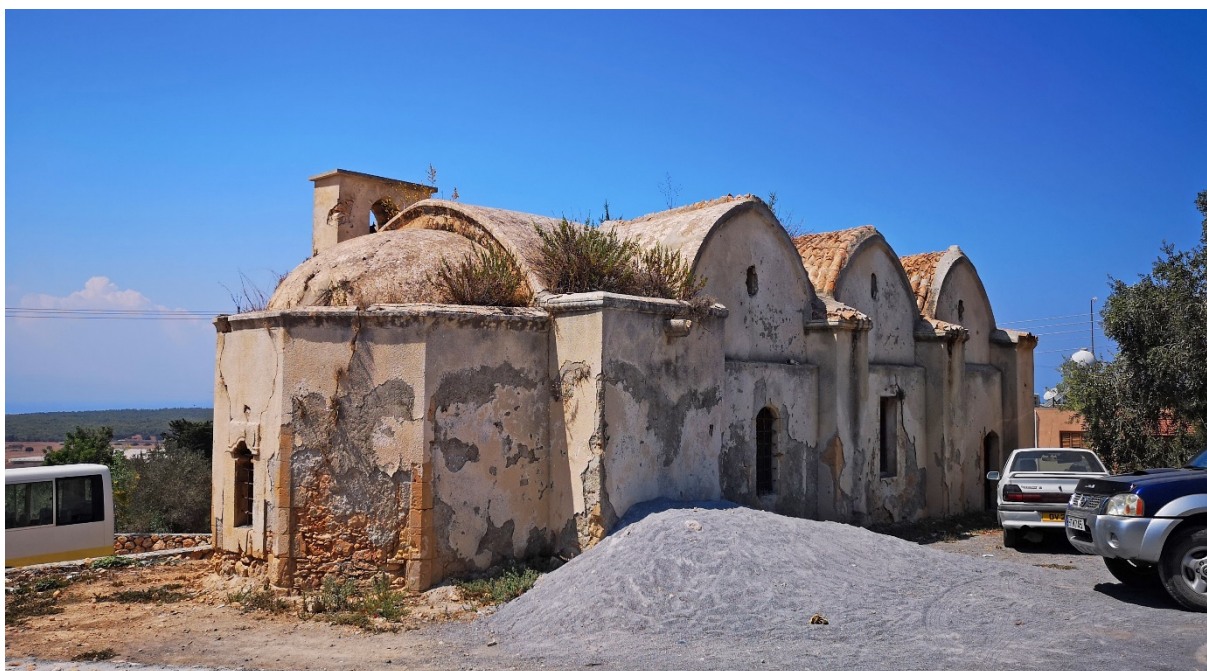
Fig. KYR-D2a: Old Agia Marina church (view from northeast; Sept. 2018)

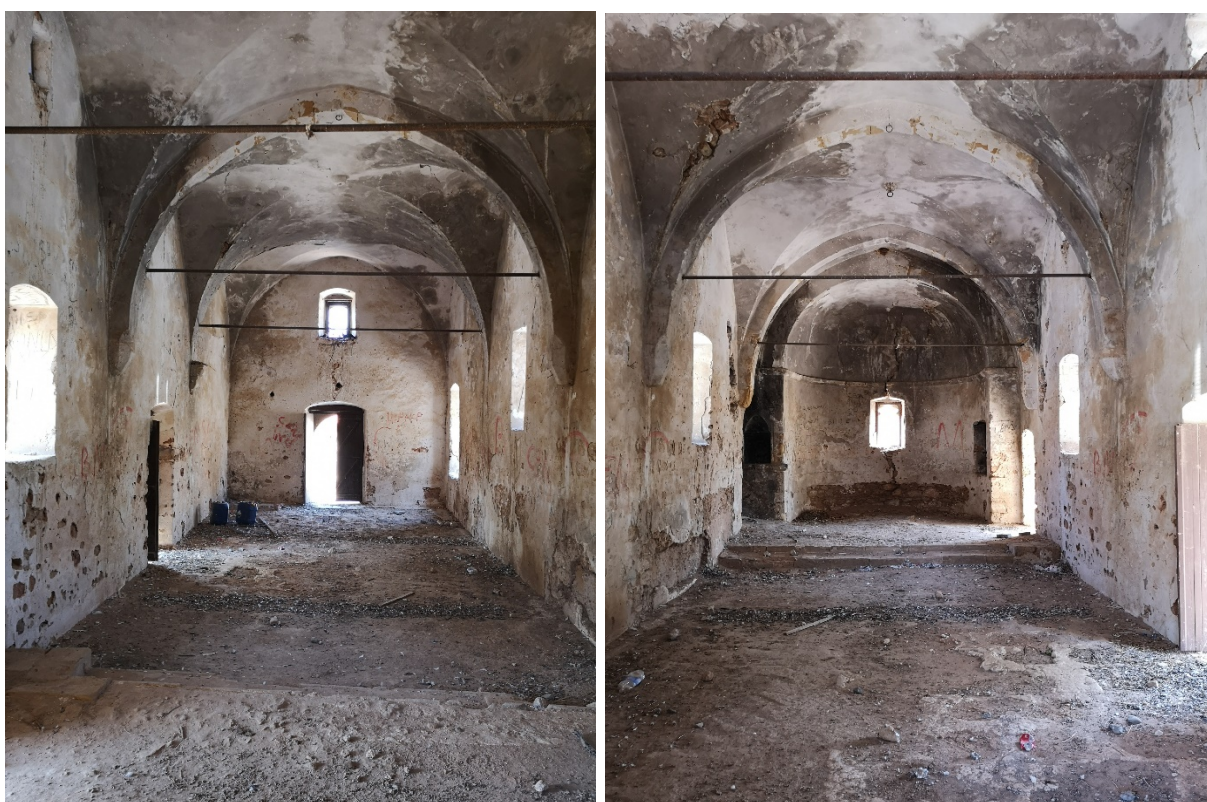
Fig. KYR-D2b-c: interior of the old Agia Marina church (Sept. 2018)

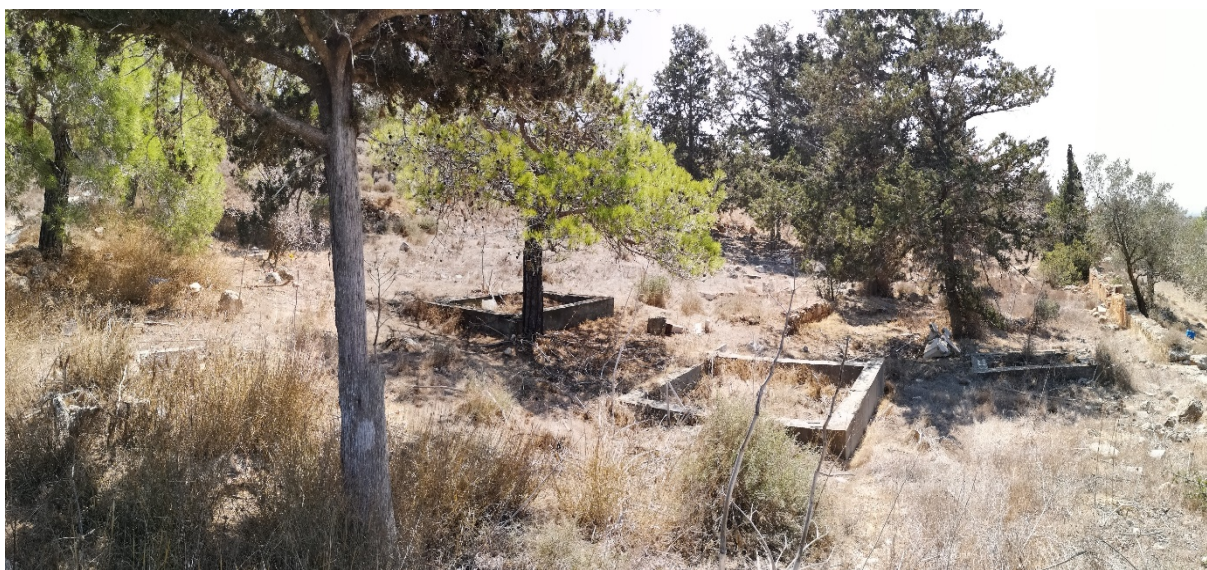
Fig. KYR-D2d: Cemetery (view from north; Sept. 2018)

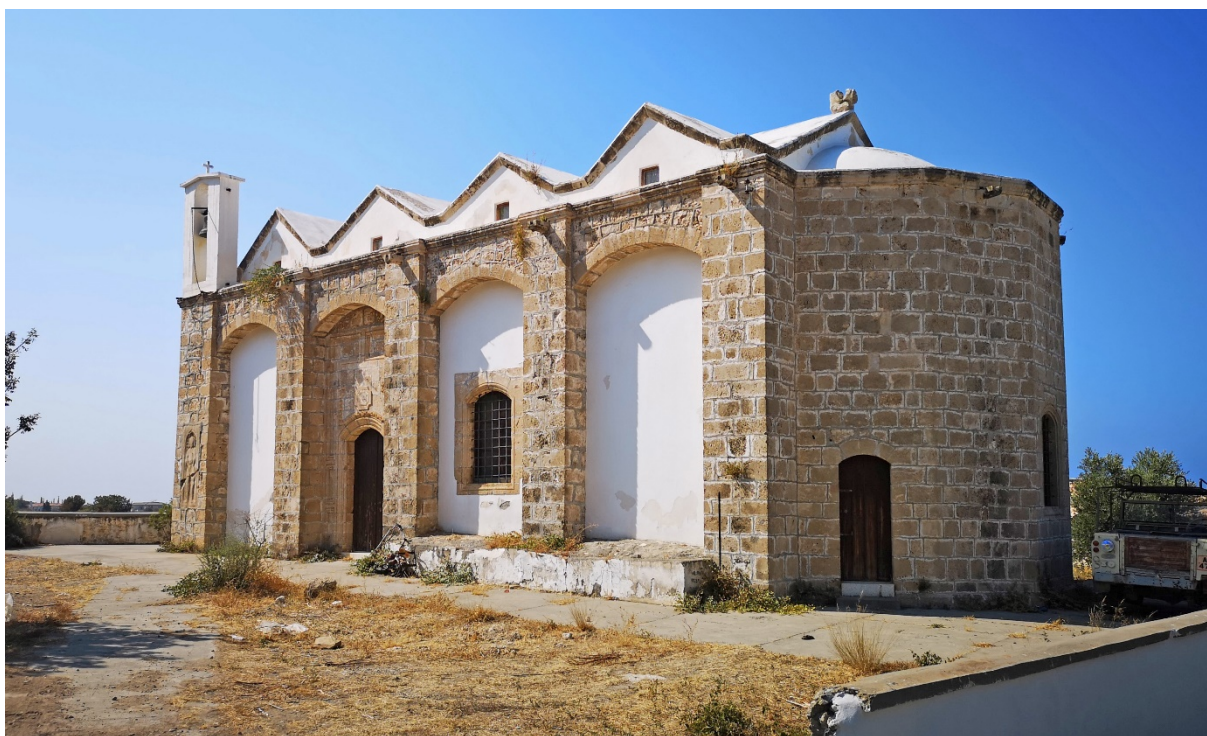
Fig. KYR-E1a: Ag. Nikolaos church (view from southeast; Sept. 2018)

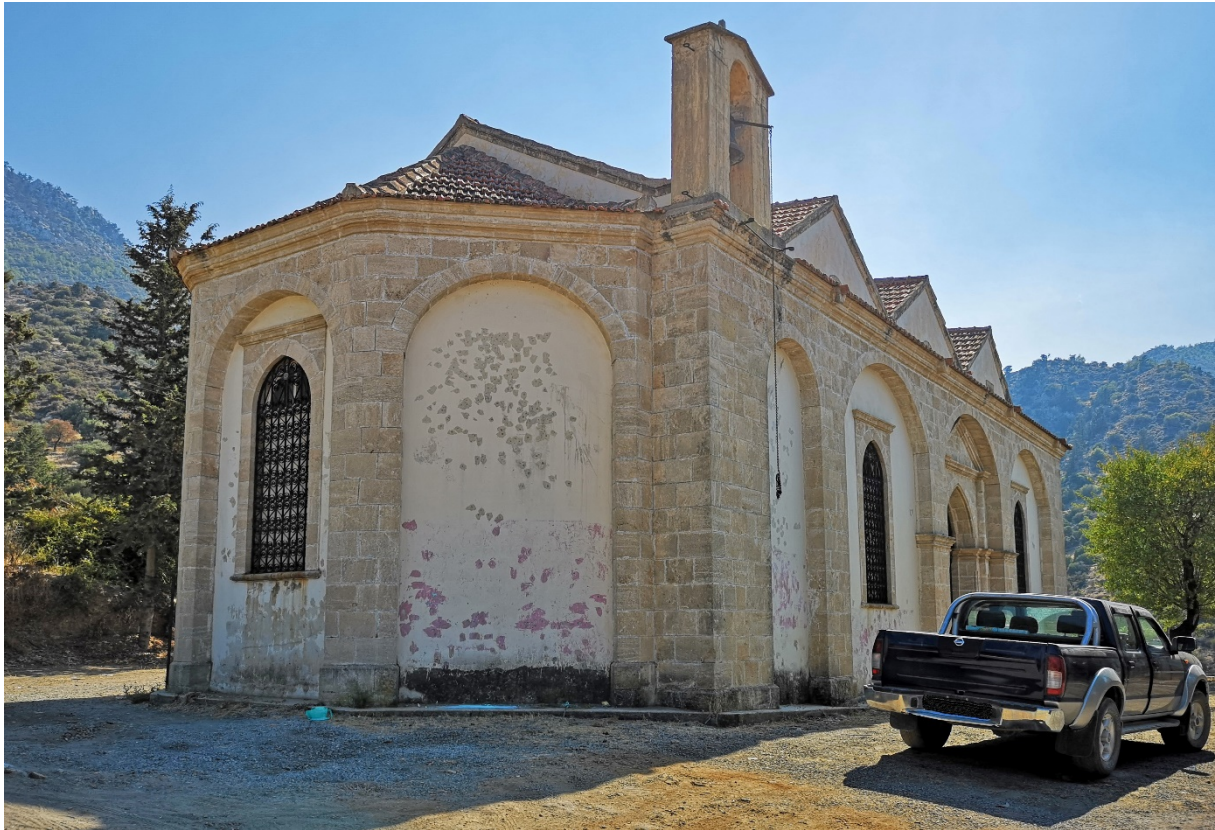
Fig. KYR-F1a: Ss. Peter and Paul Church (view from northeast; Sept. 2018)

External condition: *good*; the bell is still in the bell tower and the cross on top is intact. The building itself is in a good condition.

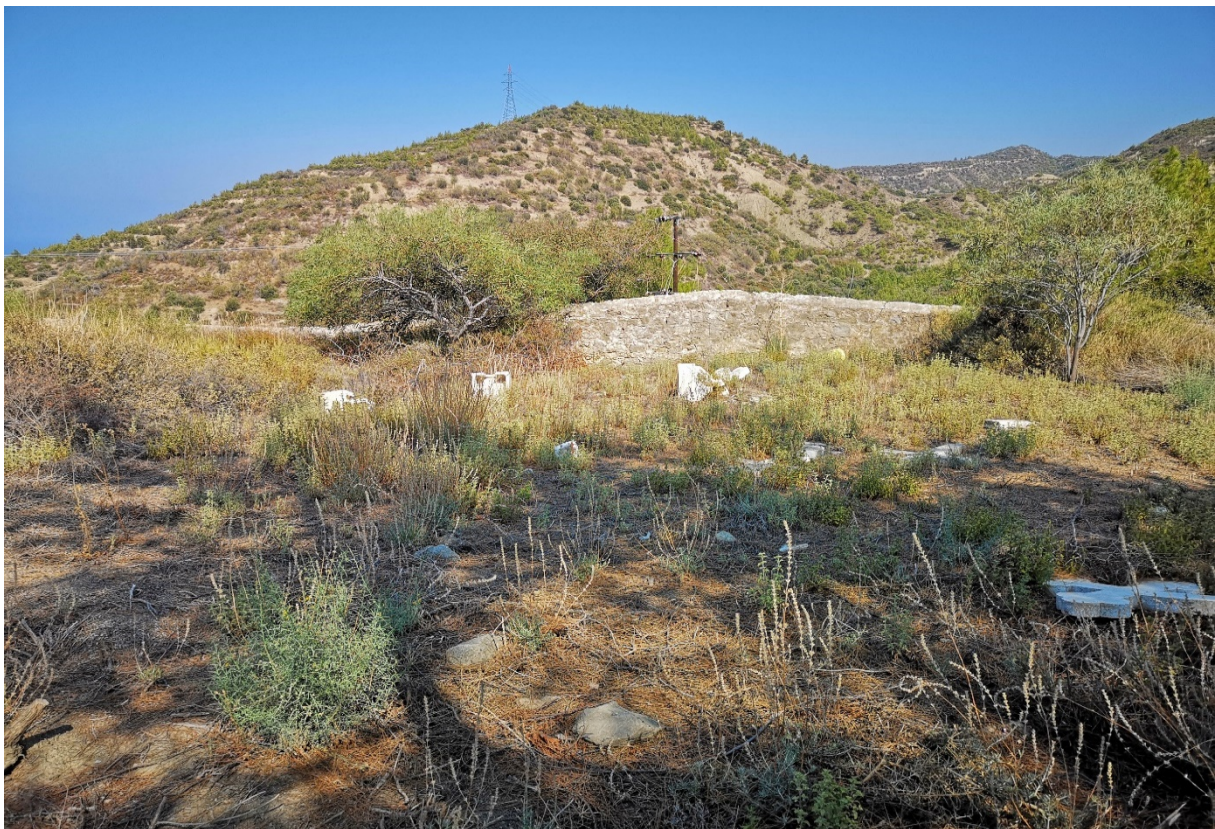
Fig. KYR-F1c: Cemetery (view from west; Sept. 2018)

Condition: *poor*; the enclosure wall and the entrance gates are intact; the cemetery itself is overgrown by weeds and scrub; also, debris is visible. The traditional crosses and the related foundations are scattered around, so it is difficult to locate individual graves.

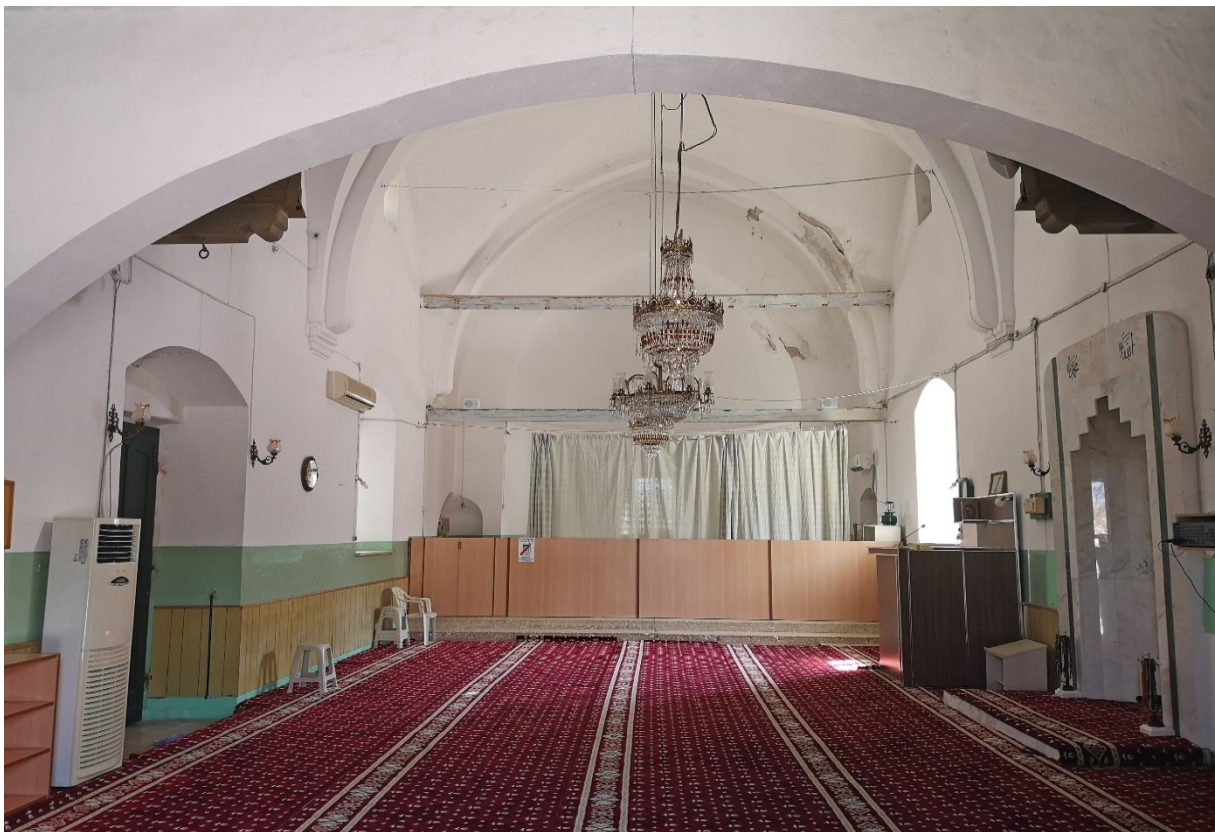
Fig. KYR-K1b: Ag. Mamas Church, converted into a mosque (Sept. 2018)

External condition: *good*; the bell is still in the bell tower; the crosses on the roof and bell tower were removed. The southern entrance has been bricked-up and is now used as mihrab.

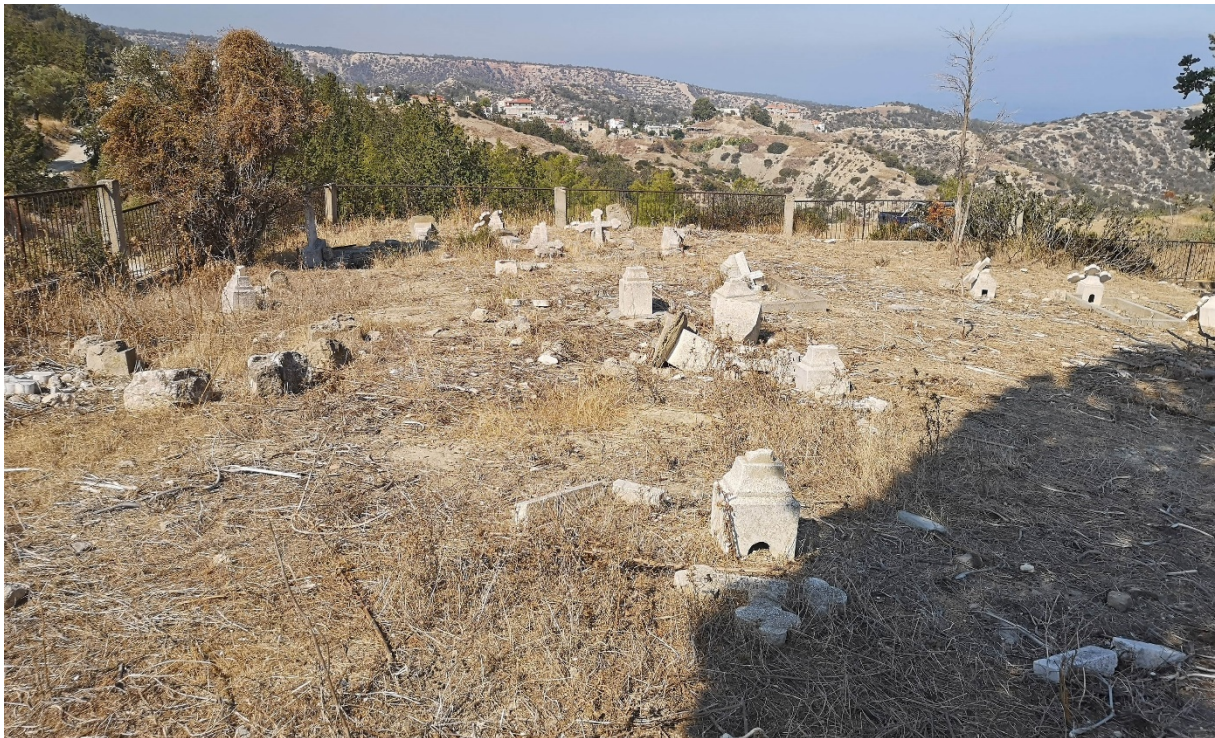
Fig. KYR-K1c: Greek Orthodox cemetery (view from east; Sept. 2018)

*Condition: poor*; the enclosure wall to the north and east has partly collapsed; the metal grid fence to the south and west is in a fair condition. On the cemetery itself, weeds and shrubs are growing and there are signs of erosion; the bigger sepulchres are in a poor state and many of the traditional grave crosses are scattered around. Some crosses seem to be put on their corresponding place, but not re-erected. The cemetery chapel lies in ruins.

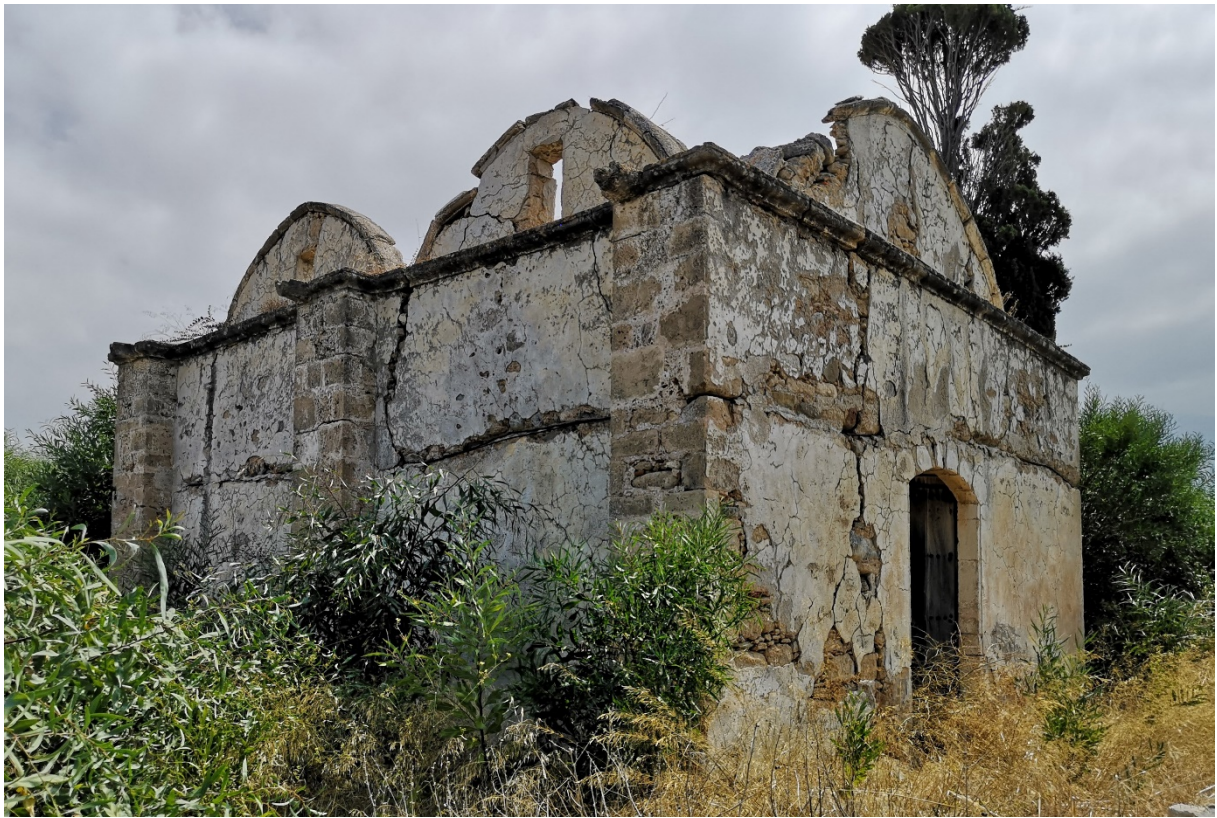
Fig. KYR-K2a: Ag. Vasilios Church (view from northwest; Sept. 2018)

External condition: *ruin*; the roof collapsed some time ago. There are large cracks in the outer walls.

Interior condition: *ruin*; weeds and trees are growing inside the church.

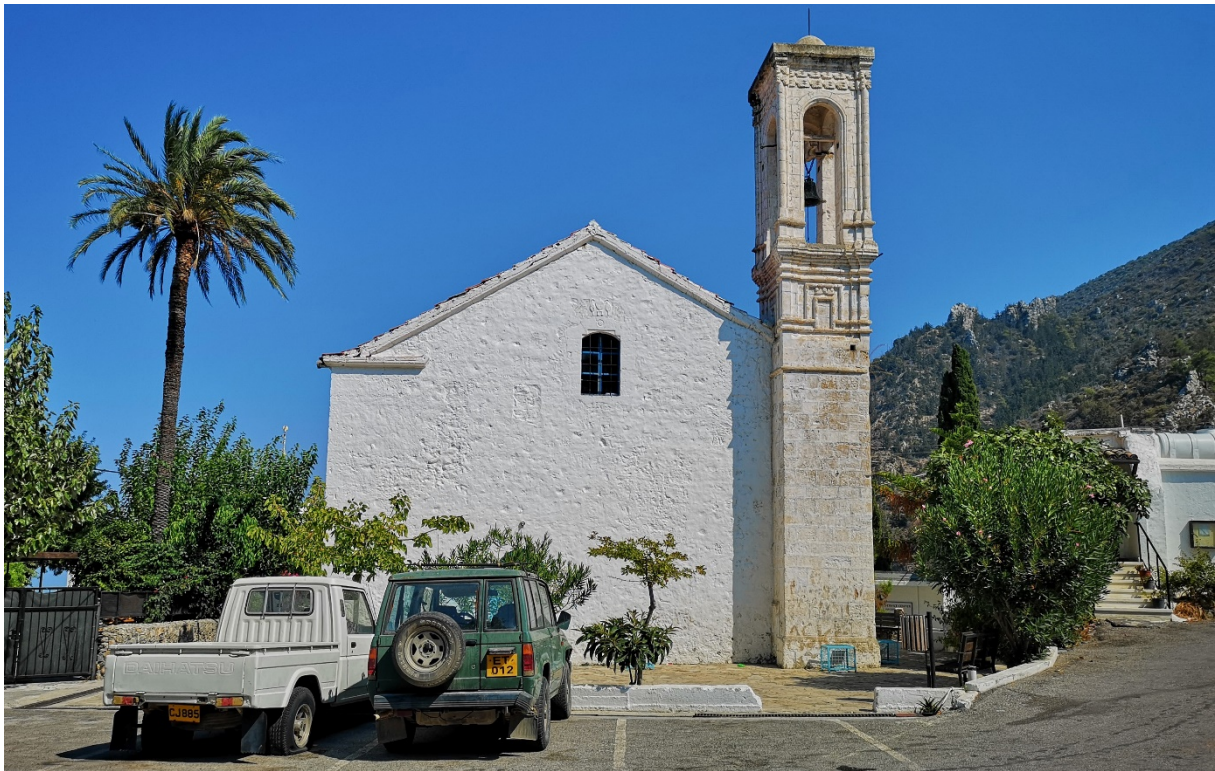
Fig. KYR-K4a: Panagia Karmiotissa Church (view from west; Sept. 2018)

External condition: *good*; the crosses on the roof and the bell tower were removed; the bell is still in the bell tower.

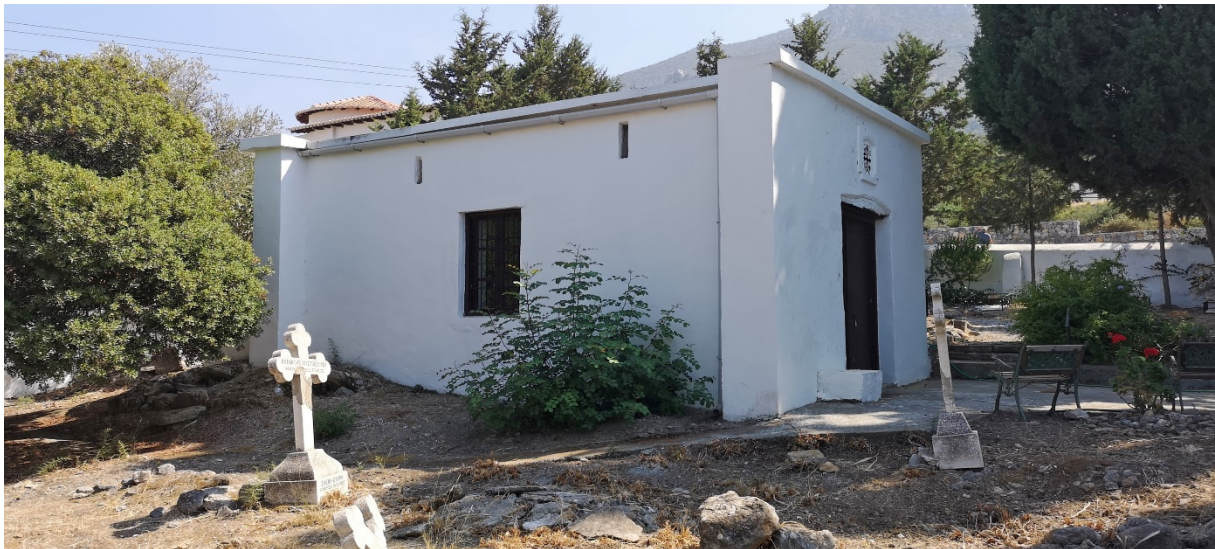
Fig. KYR-K4d: Cemetery (view from northwest; Sept. 2018)

Condition: *good*; the cemetery is clean and nearly all grave crosses seem to be re-erected. The small chapel within the cemetery, built in 1905, is in a good condition (doors locked).
