# The religious heritage of Cyprus

a survey in the districts of Kyrenia and Larnaca

Dr. Thorsten Kruse, M.A.  
Institut für Interdisziplinäre Zypern-Studien  
Westfälische Wilhelms-Universität Münster  
Schlaunstr. 2  
48143 Münster  
Germany  
Email: Th.Kruse@wwu.de

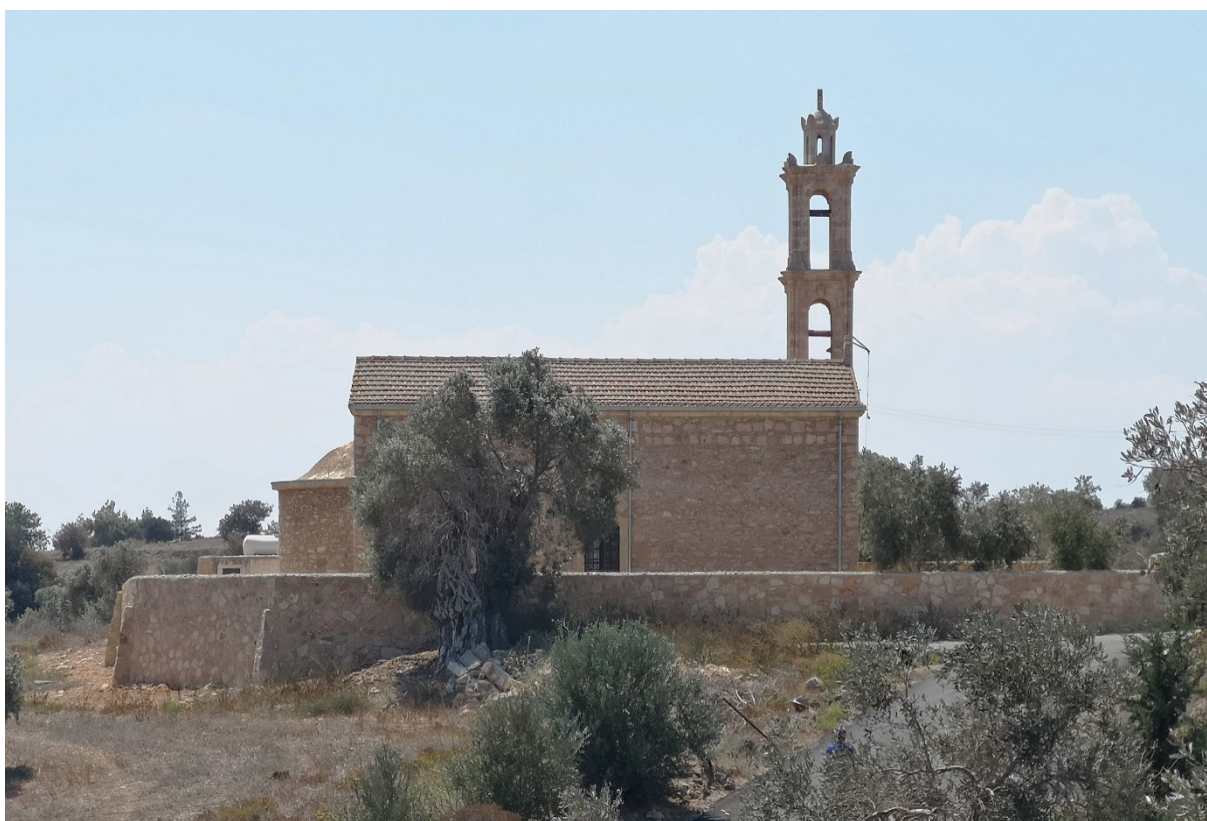
Fig. KYR-K5b: Church of the Holy Cross (view from north; Sept. 2018)

External condition: *good*; the external condition is excellent.

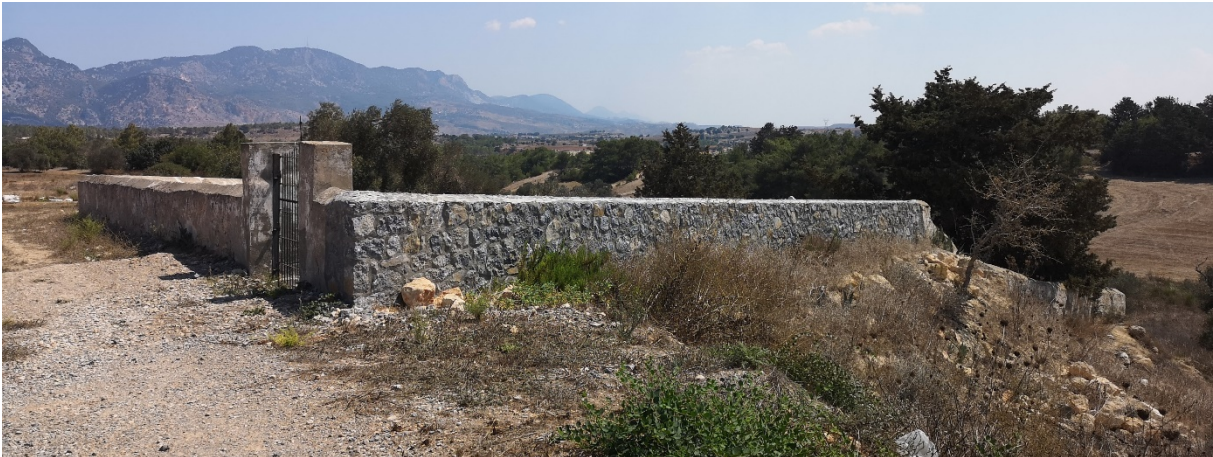
Fig. KYR-K5c: Maronite cemetery (view from west; Sept. 2018)

Condition: *good*; the enclosure wall and the gates are sound; most of the traditional grave crosses are in its original places.

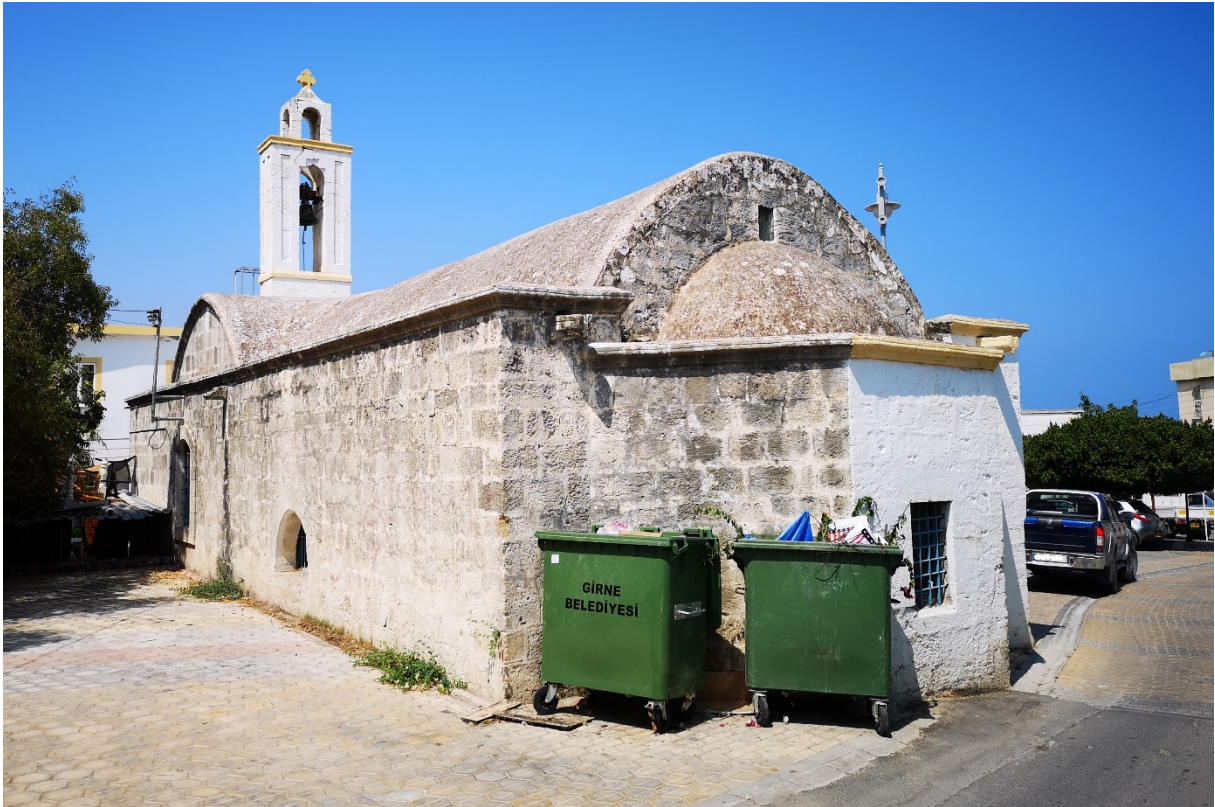
Fig. KYR-K6a: Archangelos Michael Church (view from southeast; Sept. 2018)

External condition: *good*; the bell is still bell tower also the cross on its top; the doors were locked, but the windows were open.

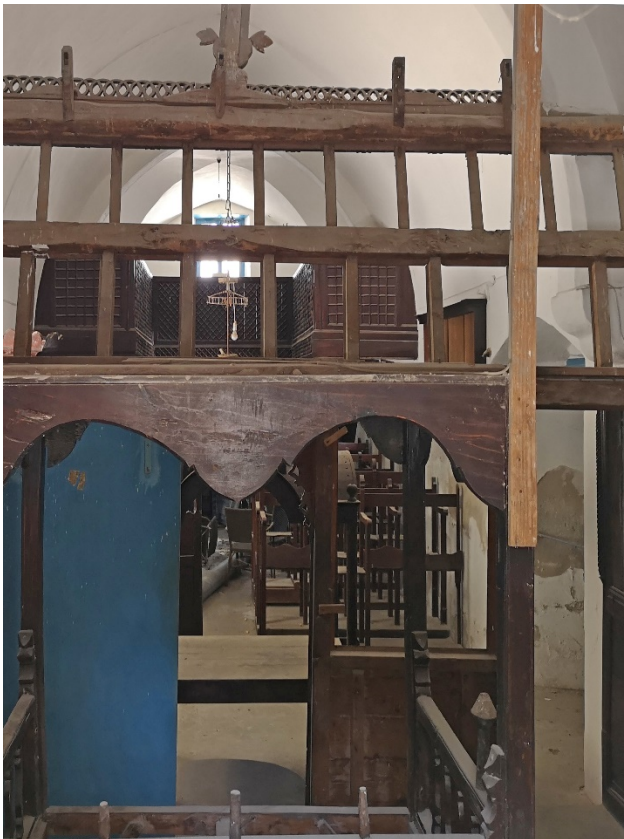
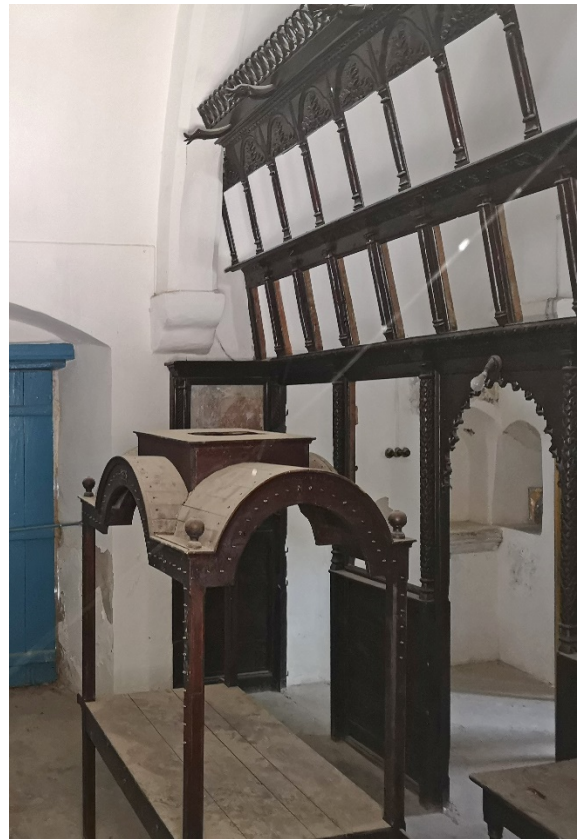
Figs. KYR-K6b-c: Archangelos Michael Church (Sept. 2018)

Interior condition: *good*; most of the original furnishings are still in place.

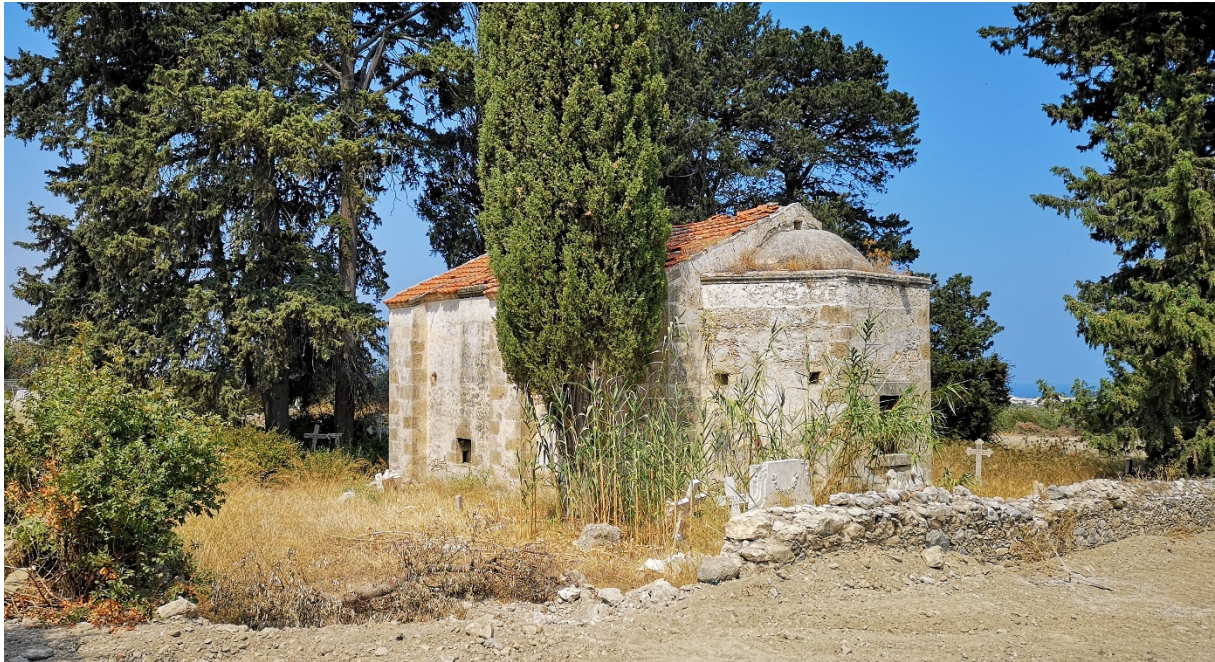
Fig. KYR-K6d: Greek Orthodox cemetery with Ag. Georgios chapel (view from southeast; Sept. 2018)

Condition: *poor*; entrance gates are missing and the enclosure wall is partly damaged; most of the traditional crosses are scattered around; the cemetery itself is overgrown by weeds and shrubs; the small *Agios Georgios* chapel is near to ruin. The roof has partly collapsed and cracks are visible on the walls.

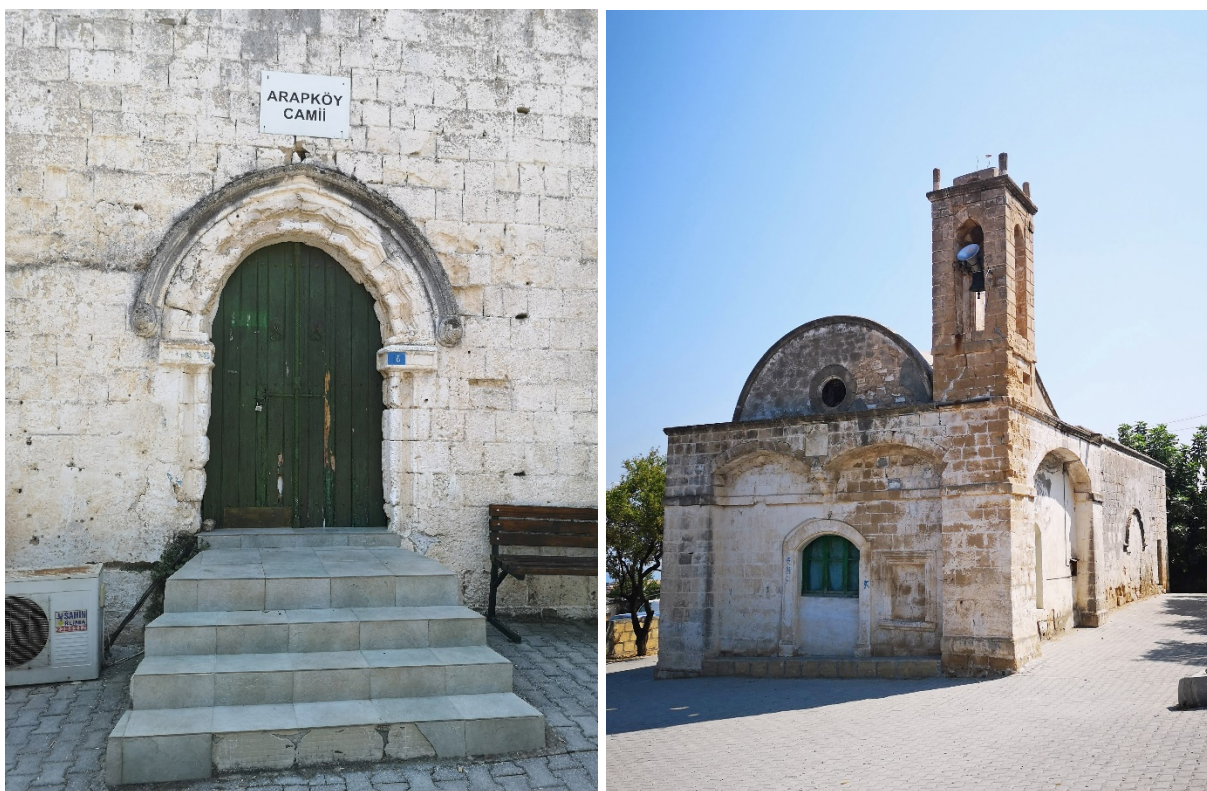
Fig. KYR-K7b-c: Ag. Loukas church (view from north / southwest; Sept. 2018)

External condition: *good*; the external condition is good, although some cracks and the results of natural decay are visible. All crosses were removed from the building. The bell is still in the bell tower.

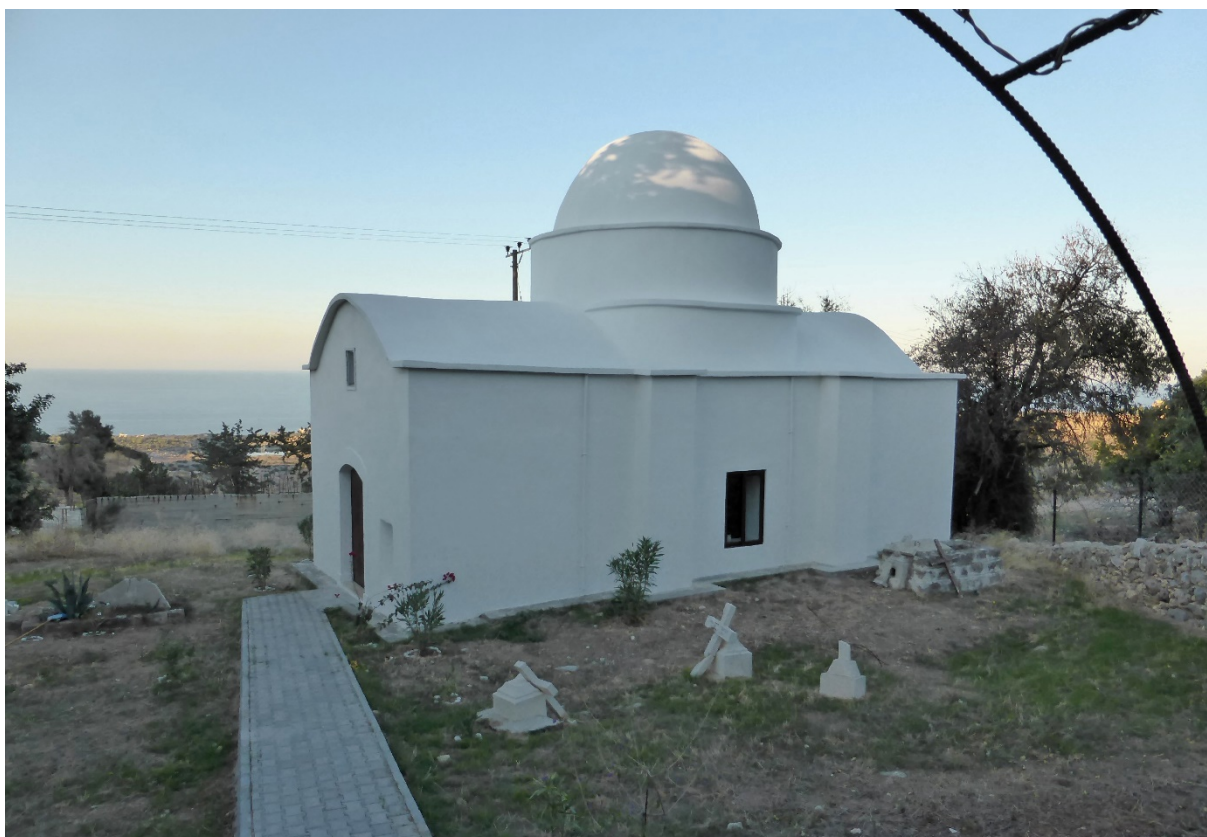
Fig. KYR-K7d: Greek Orthodox cemetery with Panagia Klepiniotissa chapel (view from south; Nov. 2015)

Condition: *good*; the enclosure wall is sound and the gates are intact. The area is fairly kept. It is obvious that most of the traditional crosses have been re-erected or positioned on its original places. The small cemetery chapel named *Panagia Klepiniotissa* was renovated some time ago.

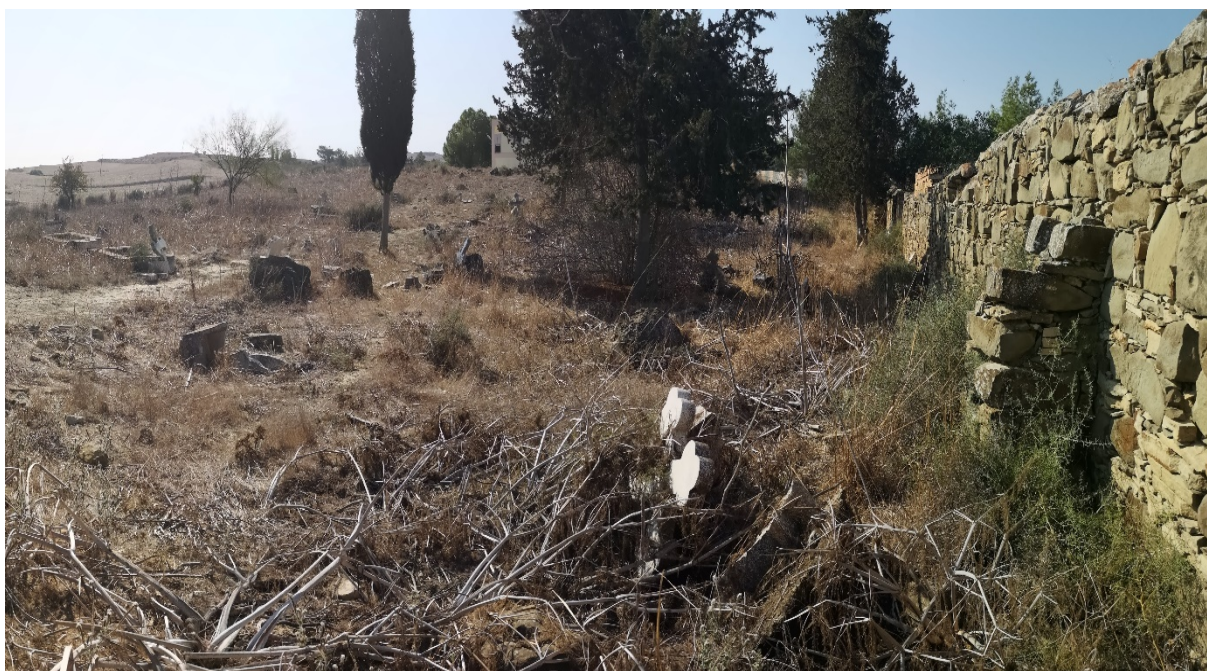
Fig. KYR-K8a: Greek Orthodox cemetery (view from north; Sept. 2018)

Condition: *ruin*; only a part of the western enclosure wall still exists. On the cemetery itself, weeds and shrubs are growing and there are signs of erosion; only a few basements of bigger sepulchres are visible. Some of the traditional grave crosses could be found in the area. Most of them are scattered around.

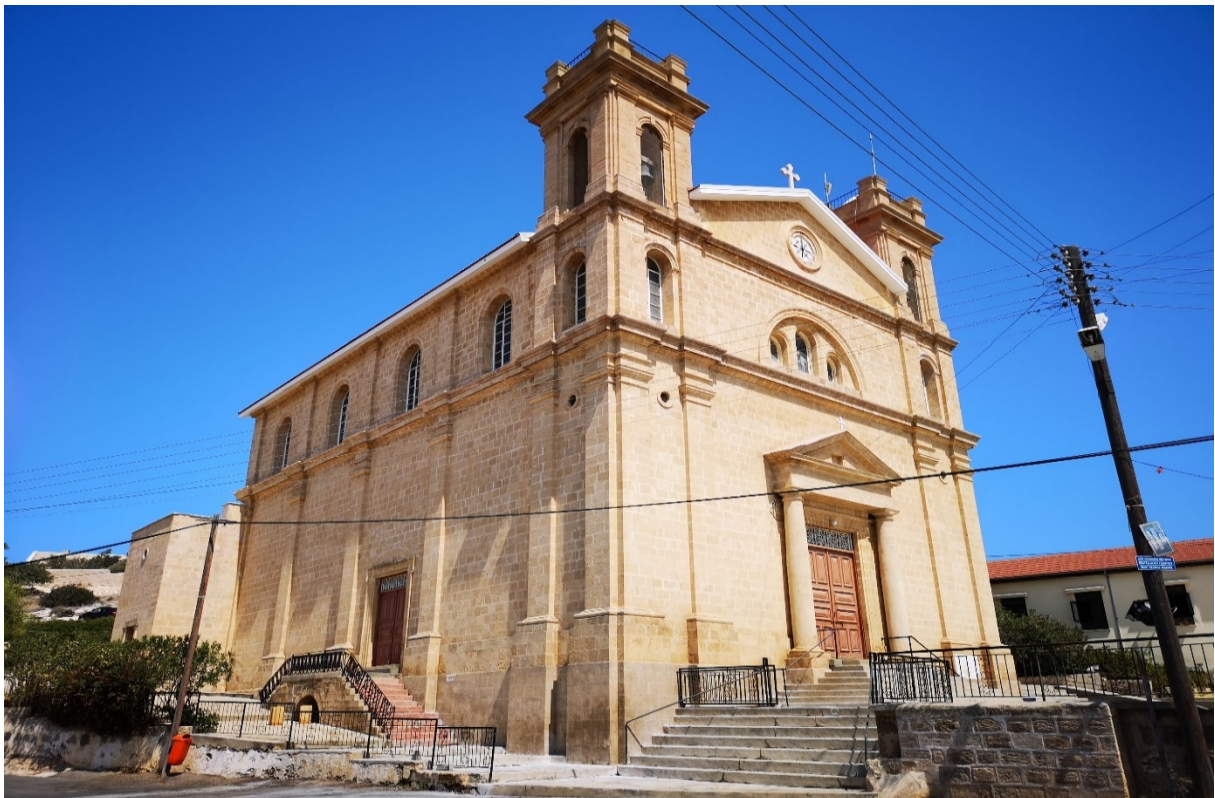
Fig. KYR-K9b: Ag. Georgios Church (view from southwest; Sept. 2018)

External condition: *good*; the external condition of the church is very good.

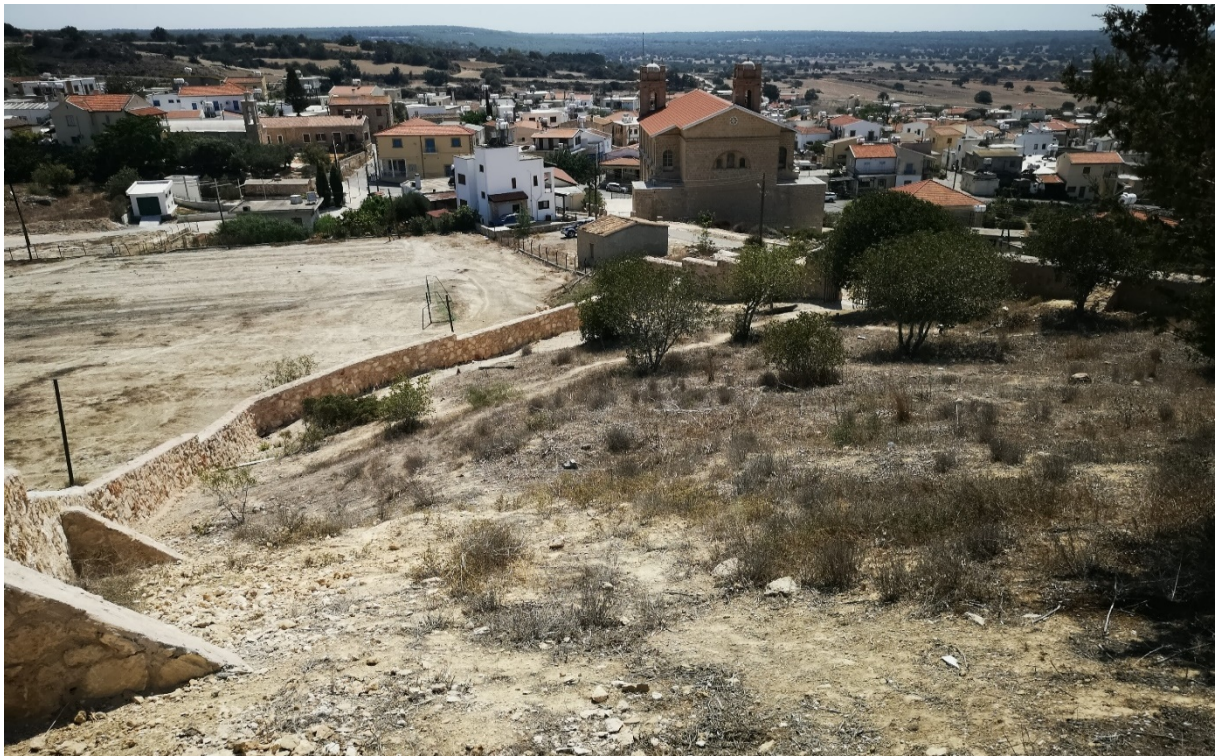
Fig. KYR-K9c: Old Maronite cemetery (view from north; Sept. 2018)

Condition: both cemeteries are in a *good* condition; the enclosure walls and the gates are sound (a renovation of the walls of the old cemetery had taken place short time ago).

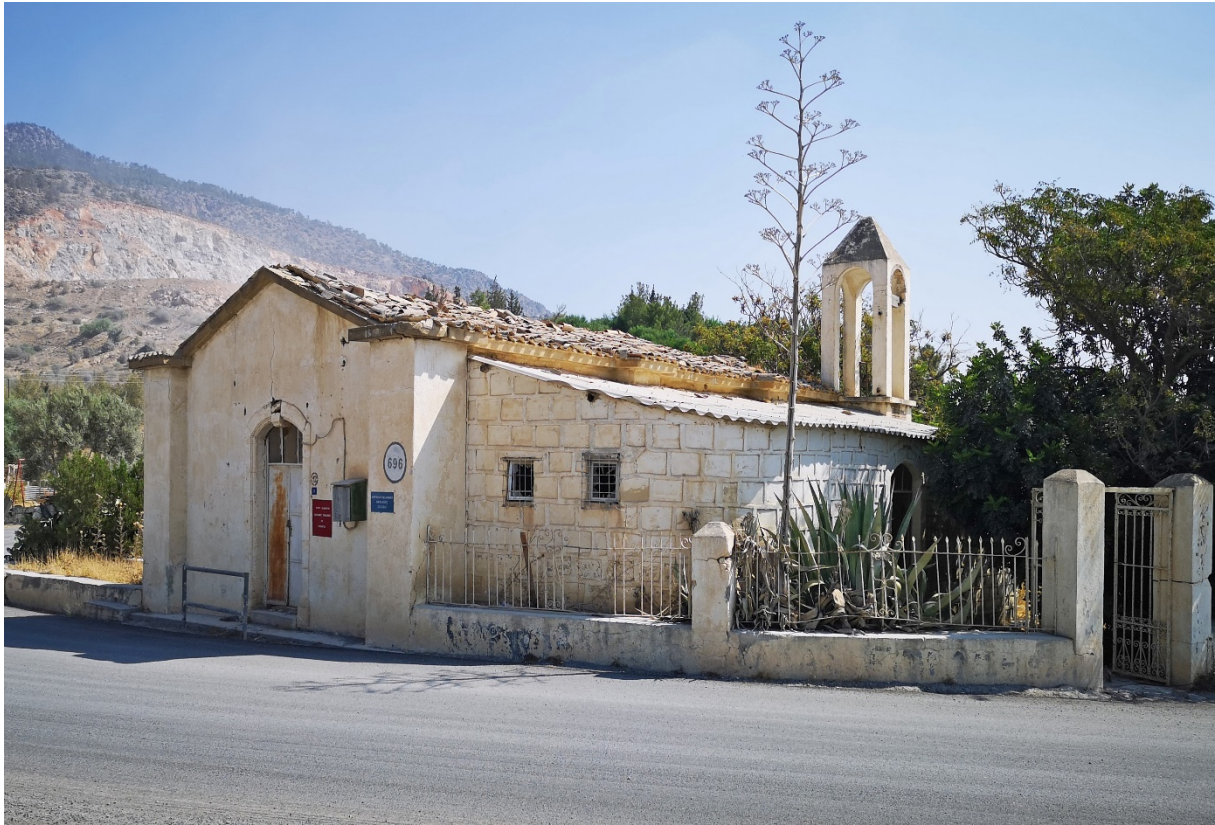
Fig. KYR-K10a: Ag. Photini Church (view from southwest; Sept. 2018)

External condition: *poor, near to ruin;* the bell, and all crosses were removed. The roof has partly collapsed and large cracks are visible in the walls.

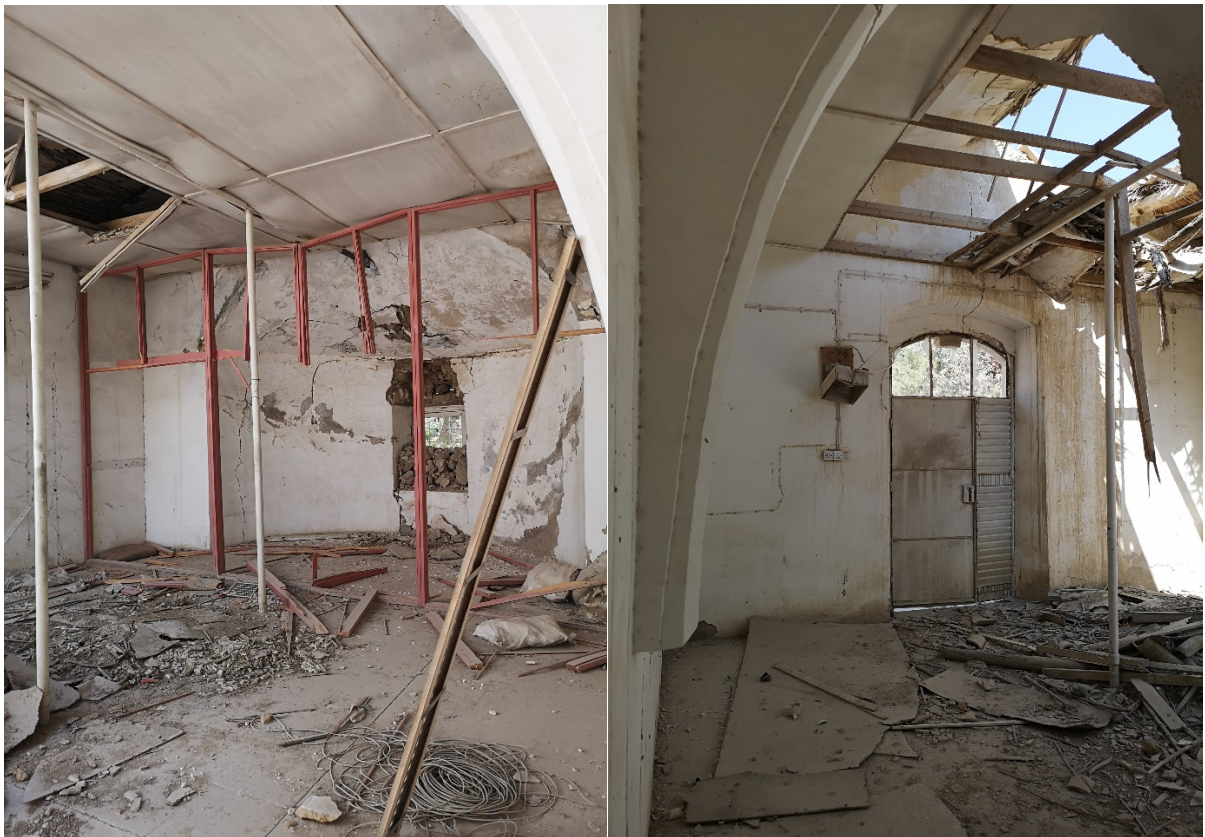
Fig. KYR-K10b-c: Ag. Photini Church (view from west / east; Sept. 2018)

Interior condition: *poor;* all furnishings of a Greek Orthodox church have been removed; the roof has partly collapsed.

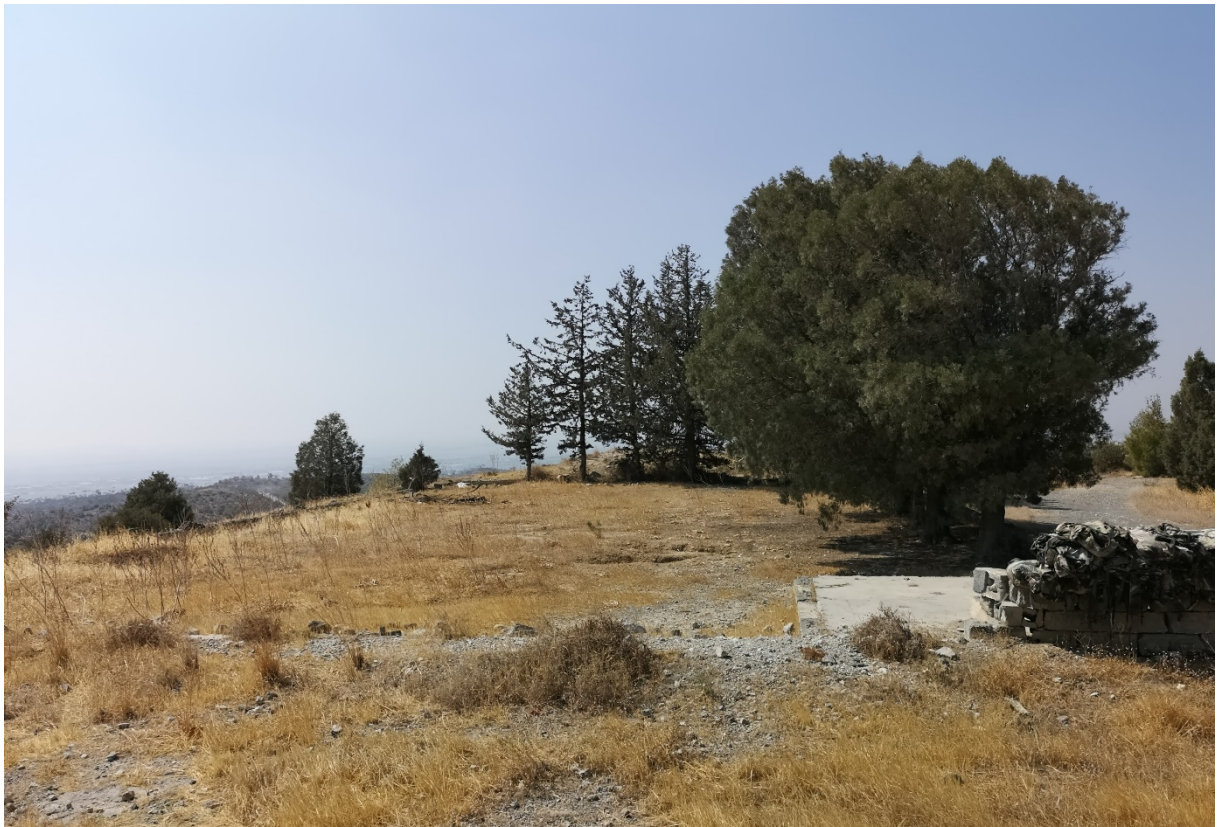
Fig. KYR-K10d: Greek Orthodox cemetery (view from north; Sept. 2018)

Condition: *ruin;* only the foundations of the former enclosure wall are visible; no traces of graves or sepulchres are detectable.

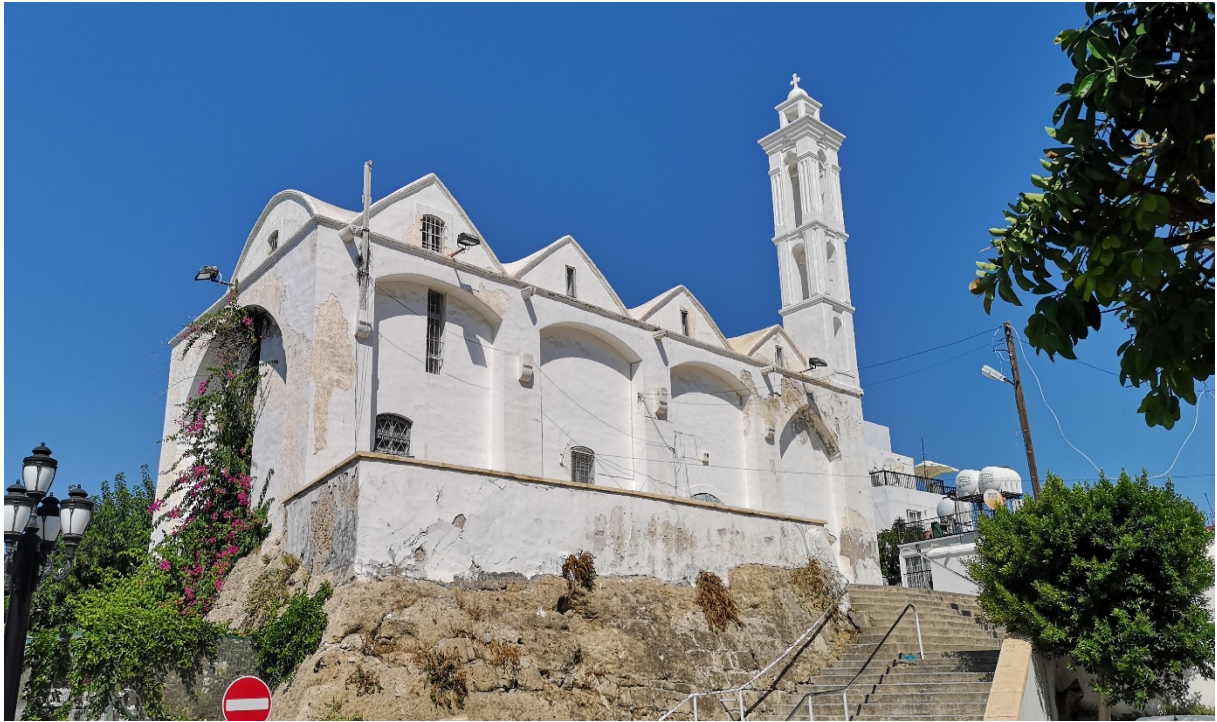
Fig. KYR-K11a: Archangelos Michael church (view from southwest; Sept. 2018)

External condition: The *Chrysopolitissa* church lies in *ruins* while the condition of the *Archangelos Michael* church is *fair*. The *Ag. Varvara* church lies within a military post and has been converted into a mosque; from the distance the church seems to be in a rather *fair* state of preservation. The condition of the *Ag. Georgios* church and the *Ag. Grigorios* church is also *fair*.

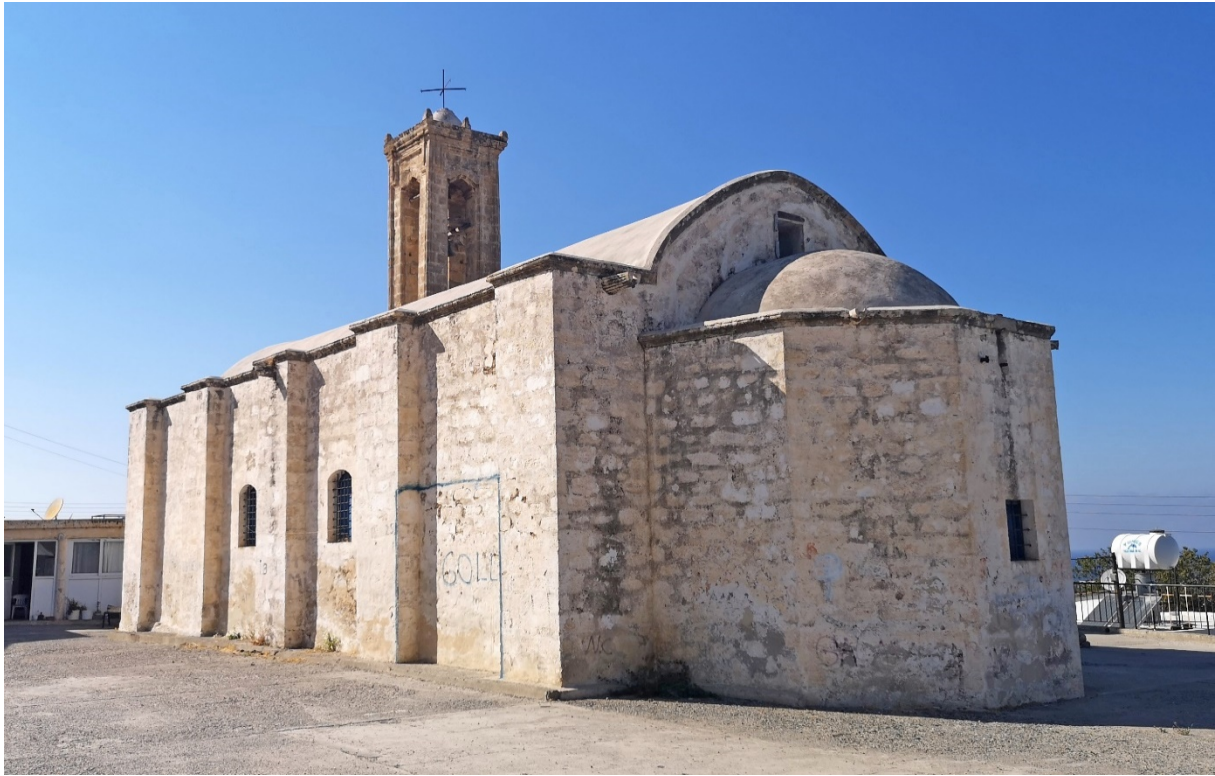
Fig. KYR-L1a: Ag. Theodoros Church (view from southeast; Sept. 2018)

External condition: The *Agios Theodoros (AT)* church in the north-western area of the village is in a *good* condition; the *Agia Paraskevi (AP)* church in the south-western area is also in *good* condition – it has been converted into a mosque; the *Timos Prodromos (TP)* church in the centre is in *good* condition, as well as the *Agios Loukas (AL)* church in the north-eastern area; this church has been converted into a music and ballet school.

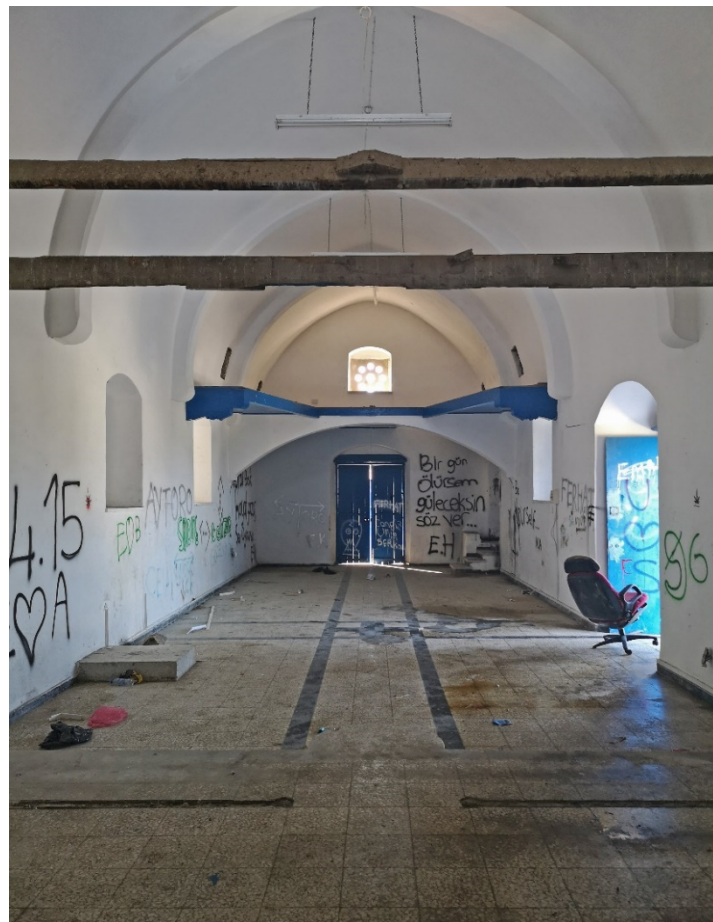
Fig. KYR-L1b: Ag. Theodoros Church (view from east; Sept. 2018)

Interior condition: The *Agios Theodoros* church is in a rather *fair* condition; all furnishings of a Greek-Orthodox church, however, have been removed and many graffiti could be found on the walls. All doors of the *Agia Paraskevi* church, the *Timos Prodromos* church, and the *Agia Anastasia* church were locked on the day of visit. Some parts of the furnishings of a Greek Orthodox church are still preserved in the *Agios Loukas* church (e.g. the wooden framework of the iconostasis); the interior of that church is in a *good* condition. The *Agios Minas* church is in a *poor* condition.

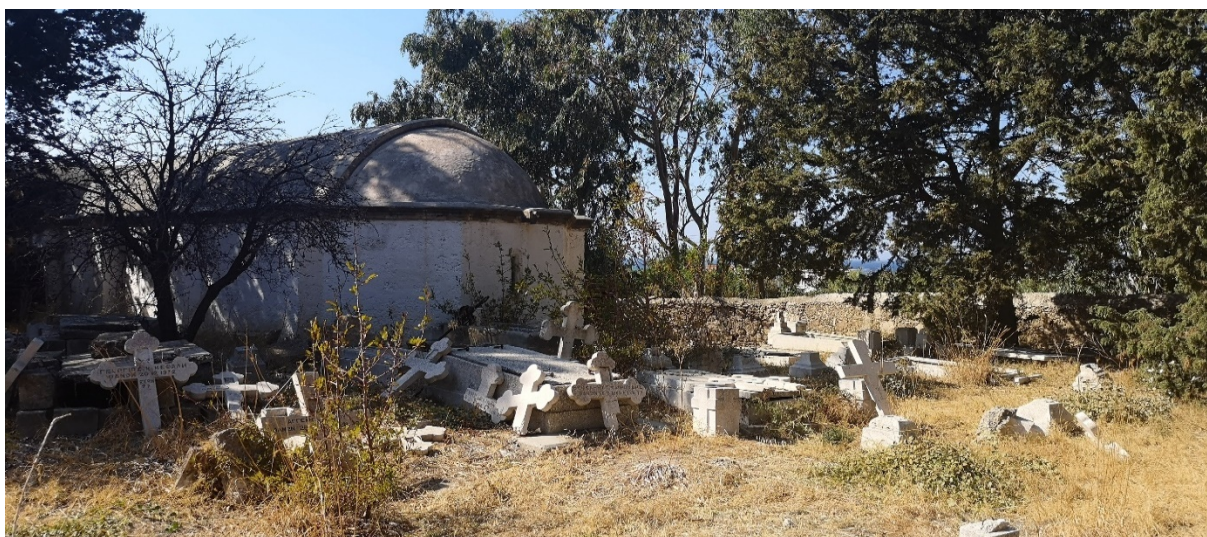
Fig. KYR-L1e: Greek Orthodox 'Agios Theodoros cemetery' (view from southeast; Sept. 2018)

The 'Agios Theodoros cemetery' (ATC) is also in a *poor* condition. Many of the traditional crosses are scattered around. Only a few seem to be re-erected at their original places. Most of the slabs originally covering the bigger sepulchres are missing or were moved.

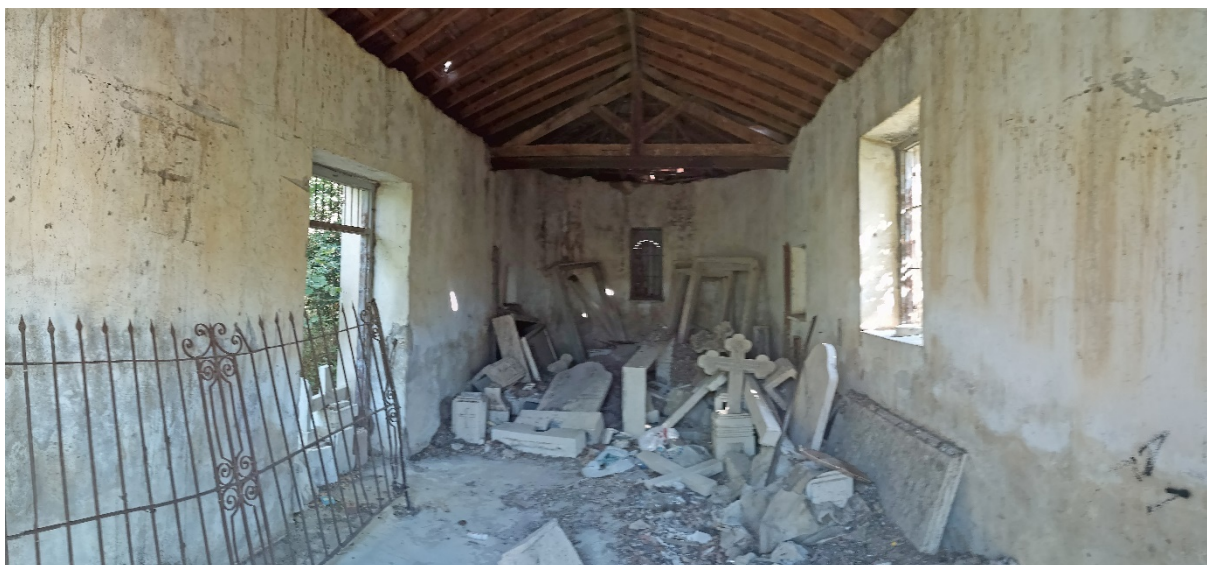
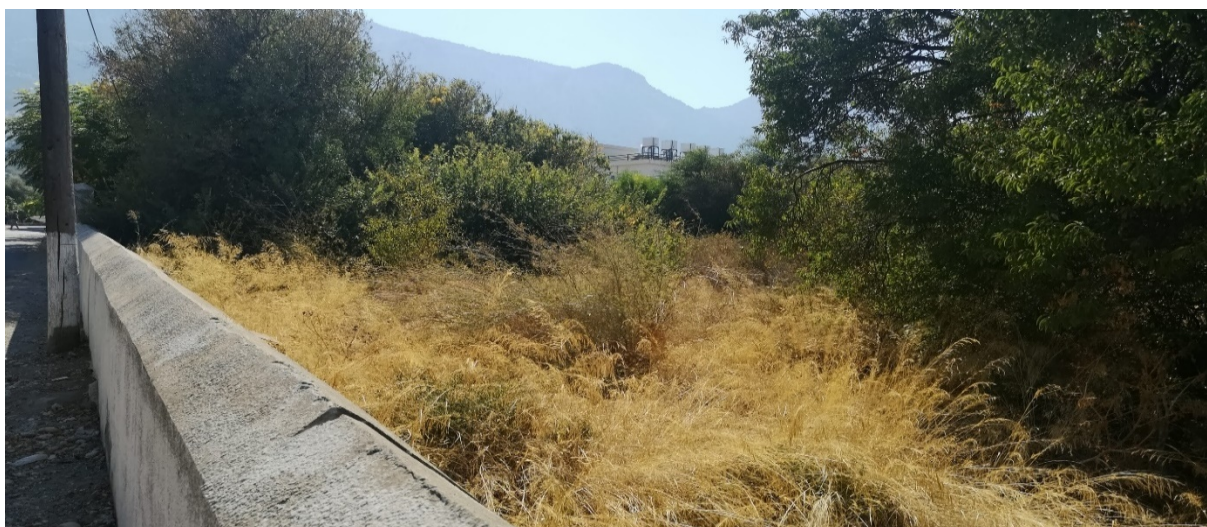
Fig KYR-L1f: Greek Orthodox 'Agios Mamas cemetery' chapel (view from west; Sept. 2018)

Condition: The 'Agios Mamas cemetery' (AMC) is in a *poor* condition. The area is totally overgrown with weeds and thorny scrub. So, no graves could be identified. In the small chapel some of the traditional grave crosses could be found as well as elements of the bigger sepulchres.

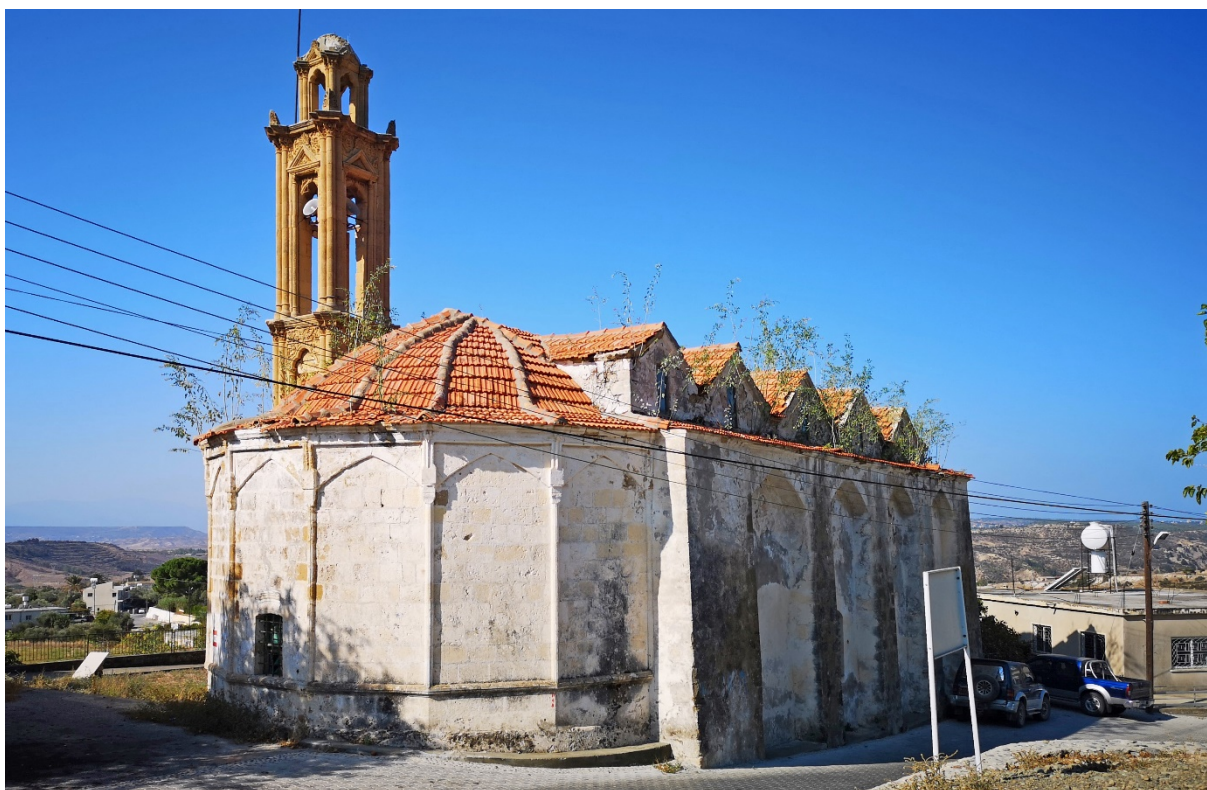
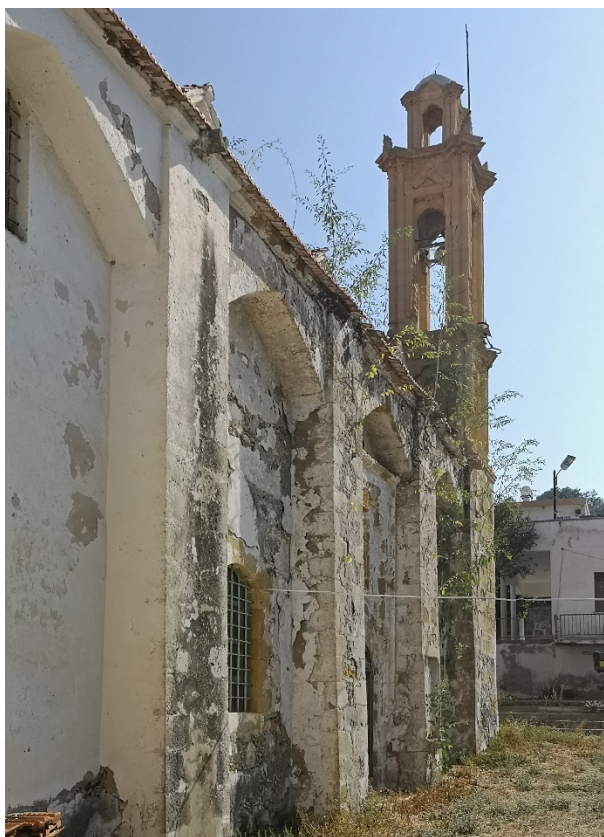
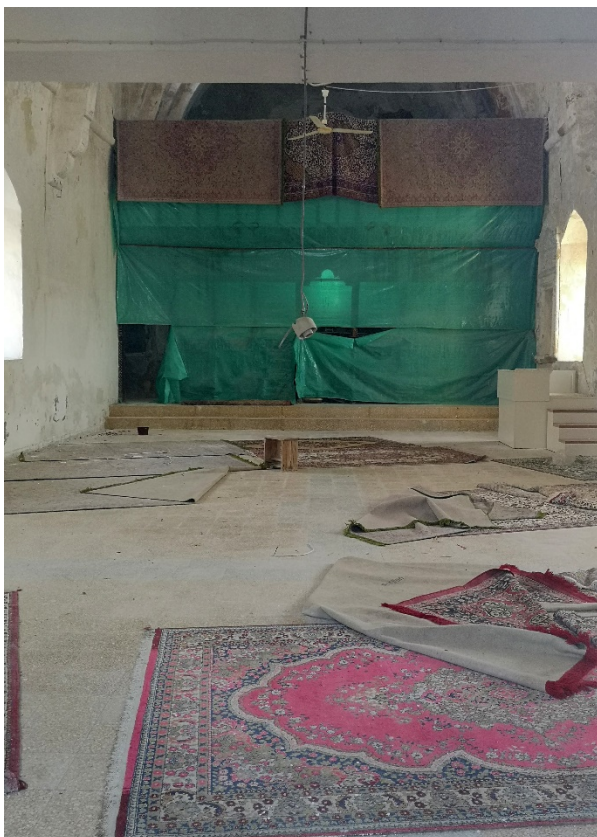
Fig. KYR-L2a: Ag. Dimitrianos Church (view from northeast; Sept. 2018)

External condition: *poor*; the bell, and all crosses were removed. Shrubs growing on the roof and from the masonry; the latter is also affected by dampness.

Interior condition: *fair*; however, nearly all furnishings of a Greek Orthodox church have been removed since the church was converted into a mosque; the wooden scaffold of the iconostasis is still there. The inside walls are affected by dampness, too.

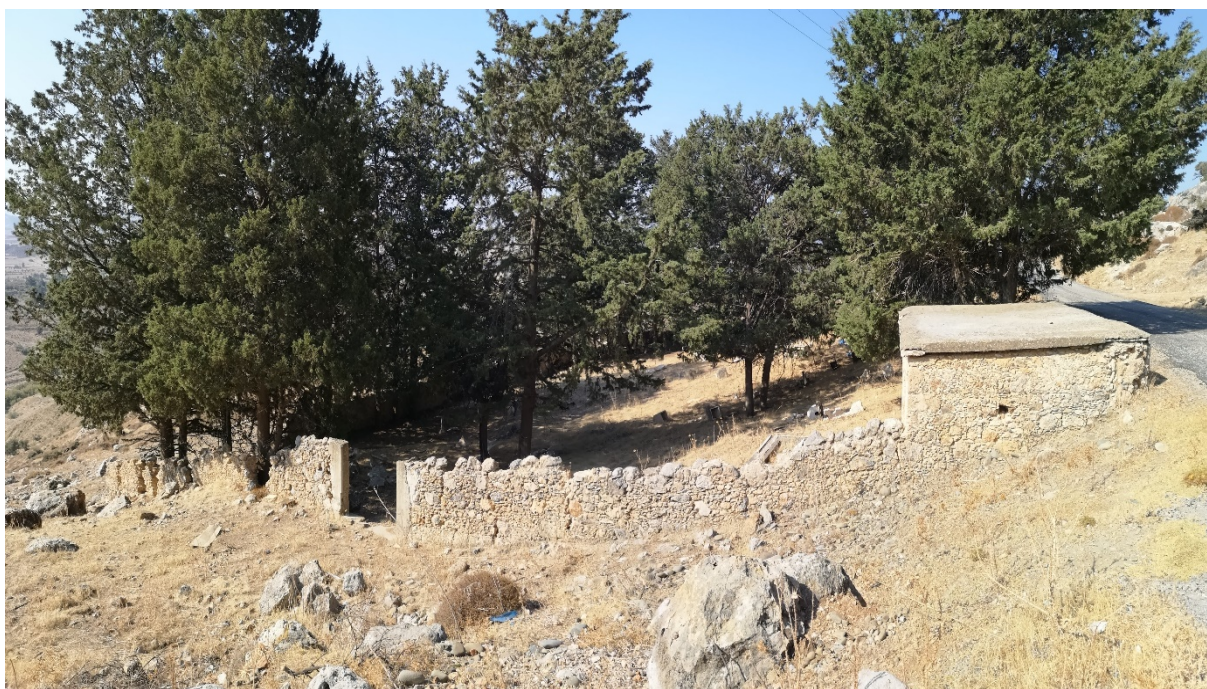
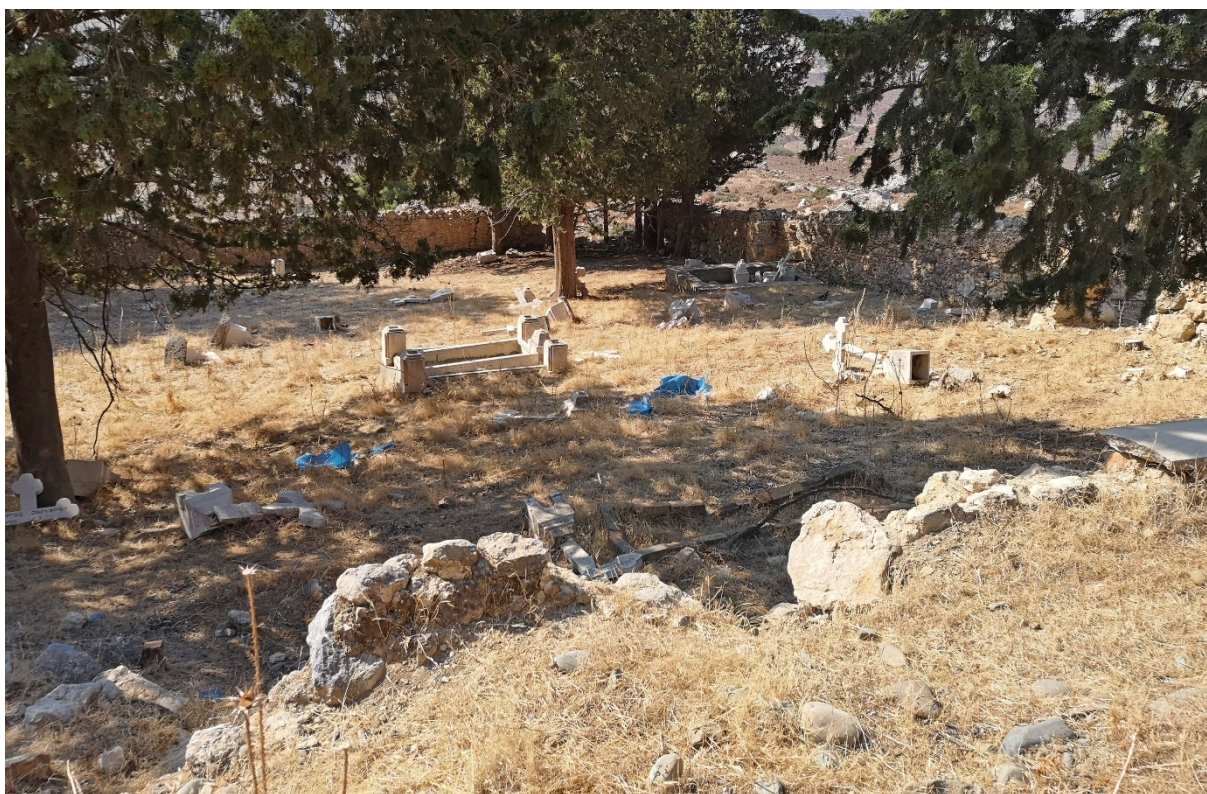
Fig. KYR-L2d: Greek Orthodox cemetery (view from northeast; Sept. 2018)

Condition: *poor*; the cemetery is near to ruin; the enclosure wall is considerably damaged by natural decay; the traditional grave crosses are scattered across the cemetery and the large sepulchres are in a bad condition.

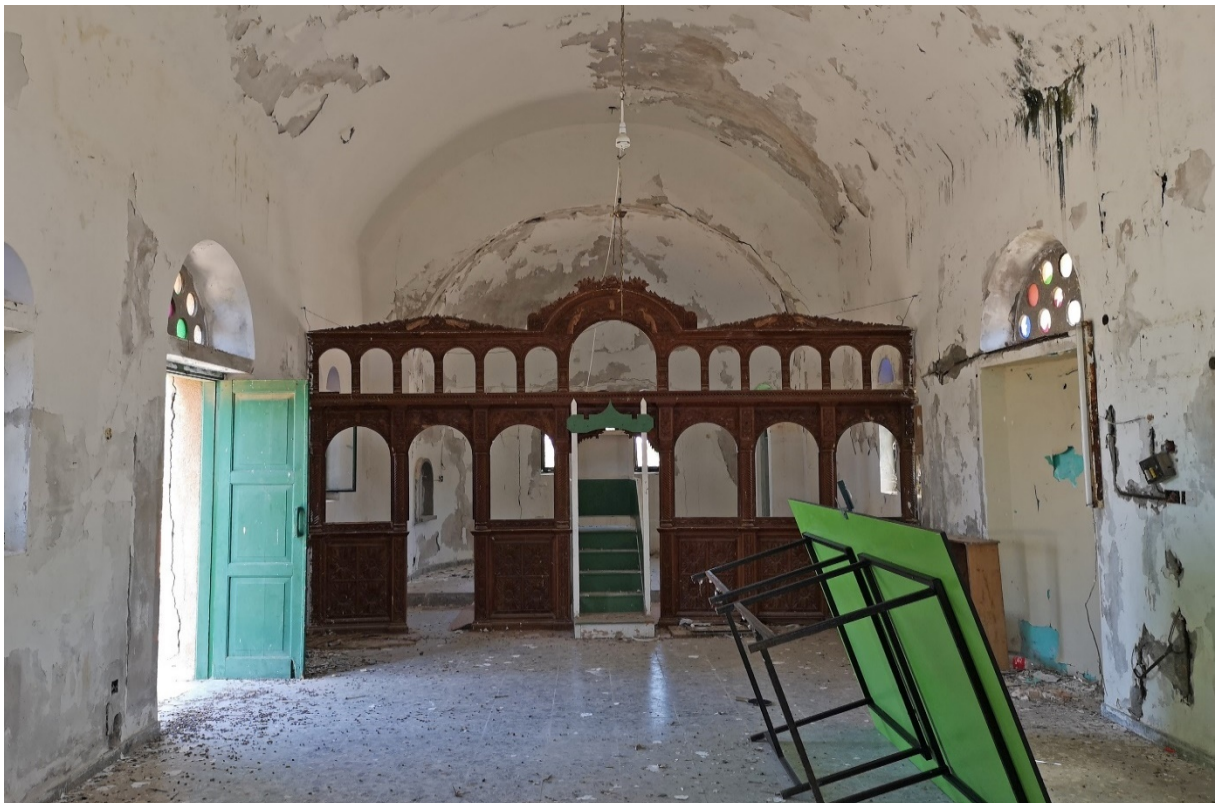
Fig. KYR-L3b: Ag. Konstantinos and Eleni Church (view from east; Sept. 2018)

External condition: *poor*; the bell, and all crosses were removed. The plaster on the walls is crumbling and the corroding reinforcing steel becomes visible.

Interior condition: *poor*; since the building was converted into a mosque most furnishings of a Greek Orthodox church have been removed; the wooden scaffold of the iconostasis is still *in situ*. The walls show signs of damages caused by moisture.
