# The religious heritage of Cyprus

a survey in the districts of Kyrenia and Larnaca

Dr. Thorsten Kruse, M.A.  
Institut für Interdisziplinäre Zypern-Studien  
Westfälische Wilhelms-Universität Münster  
Schlaunstr. 2  
48143 Münster  
Germany  
Email: Th.Kruse@wwu.de

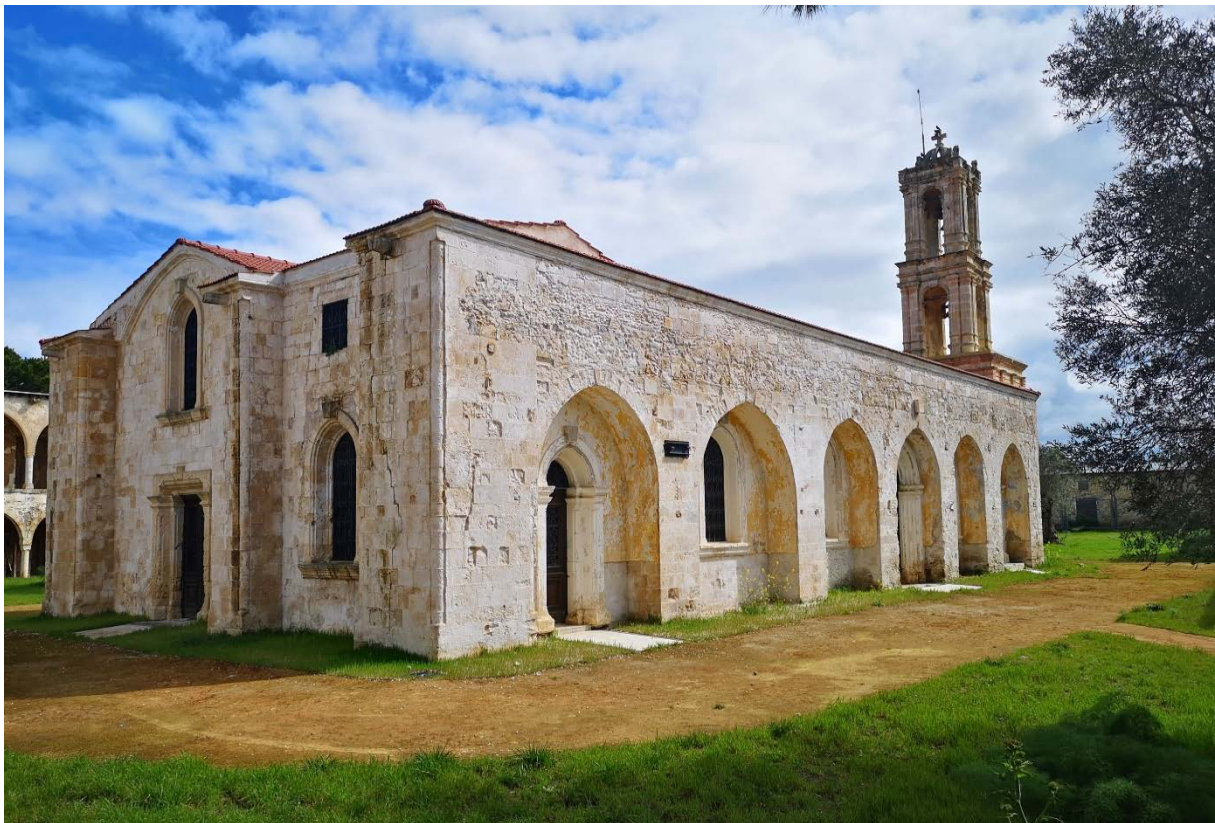
Fig. KYR-M2b: The church of Ag. Panteleimonas monastery (view from southwest; Sept. 2018)

External condition: *good*; the condition of the church is good.

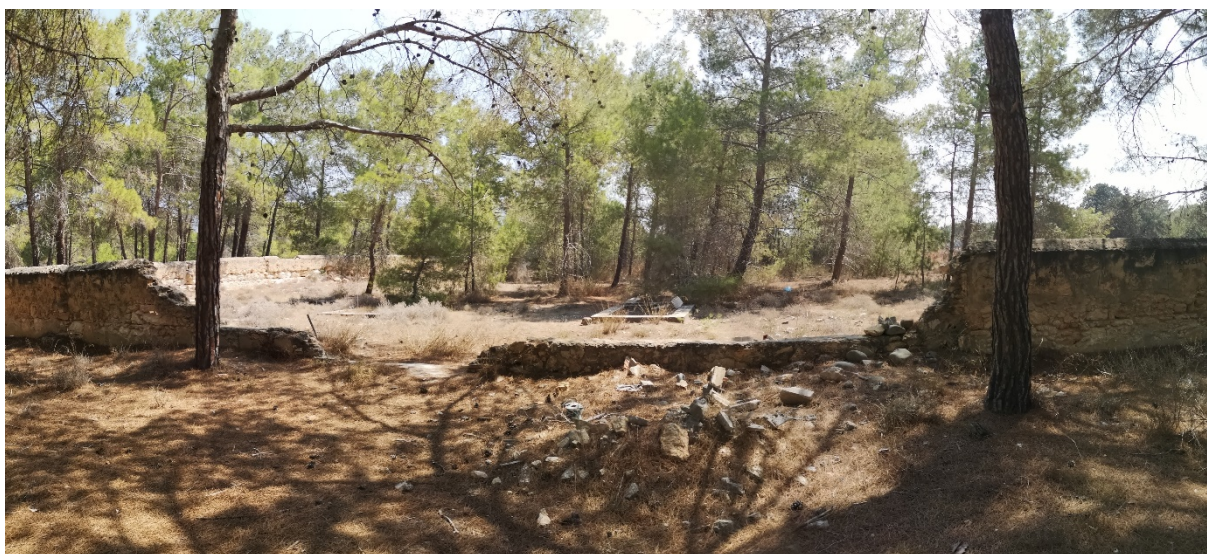
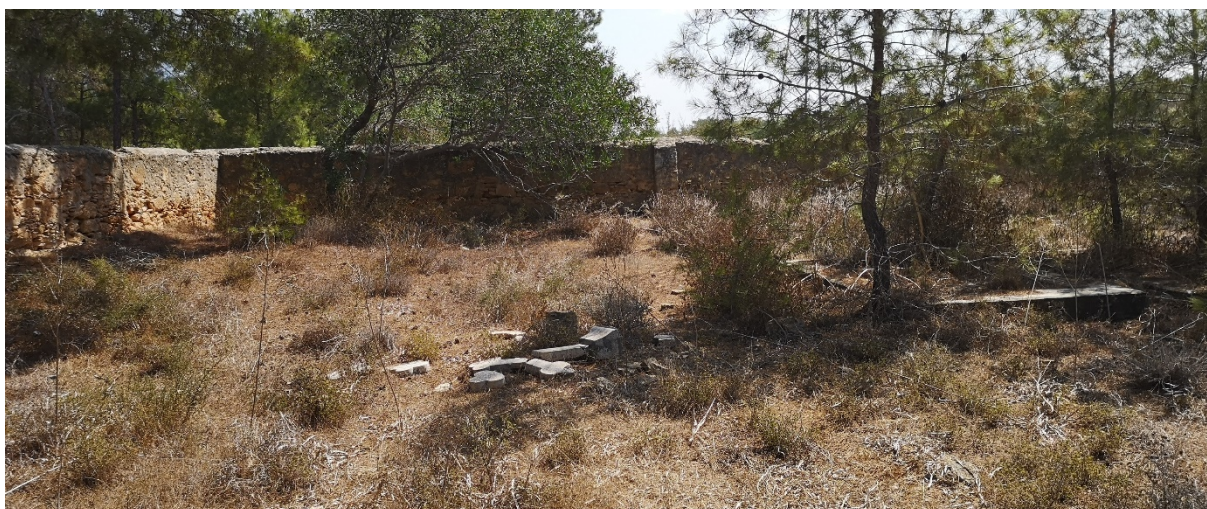
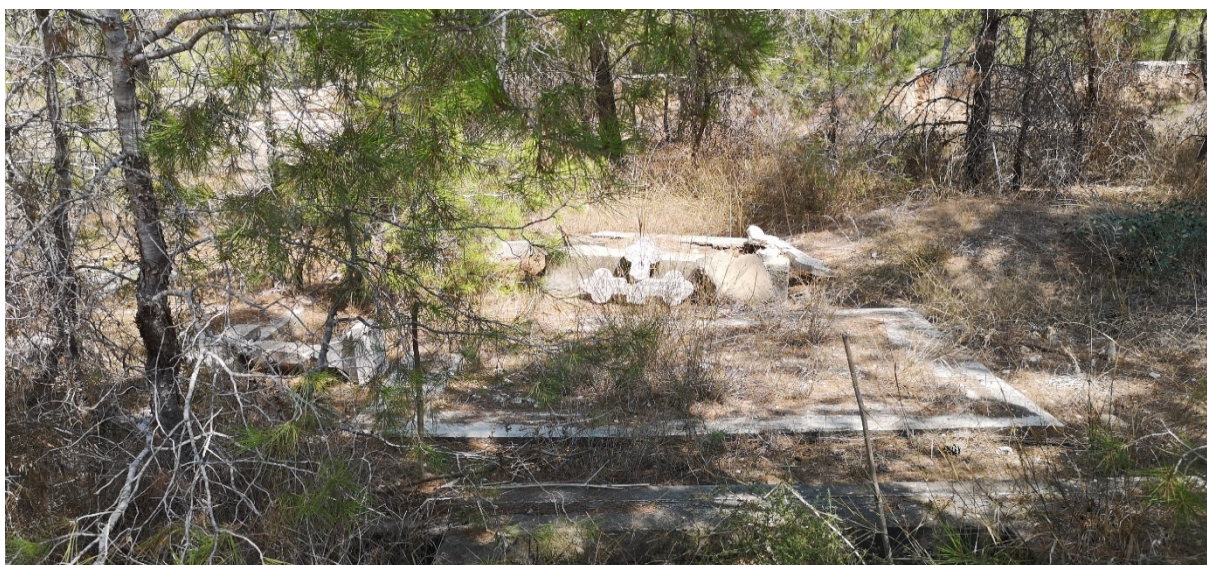
Fig. KYR-M2c: Greek Orthodox cemetery (view from west; Sept. 2018)

Condition: *poor*; the cemetery is near to *ruin*, the enclosure wall has partly been falling apart; the traditional crosses, of which only a few larger parts could be found, are scattered around, so it is difficult to identify individual graves. Some basements of large sepulchres are visible.

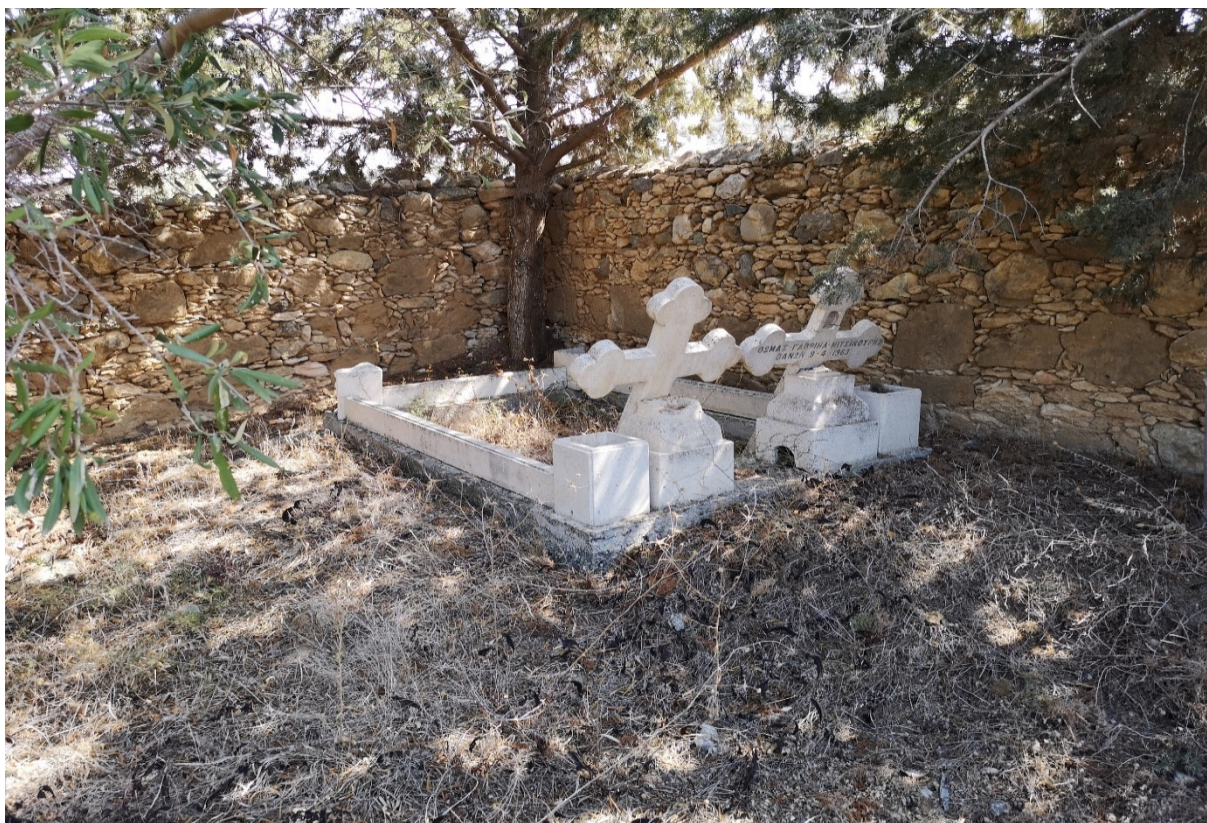
Fig. KYR-O1d: Greek Orthodox cemetery (view from southeast; Sept. 2018)

Condition: *good*; the enclosure wall is sound and new metallic entrance gates were installed some time ago; most of the traditional crosses are in place or were re-erected. The few larger sepulchres are in a relatively good condition.

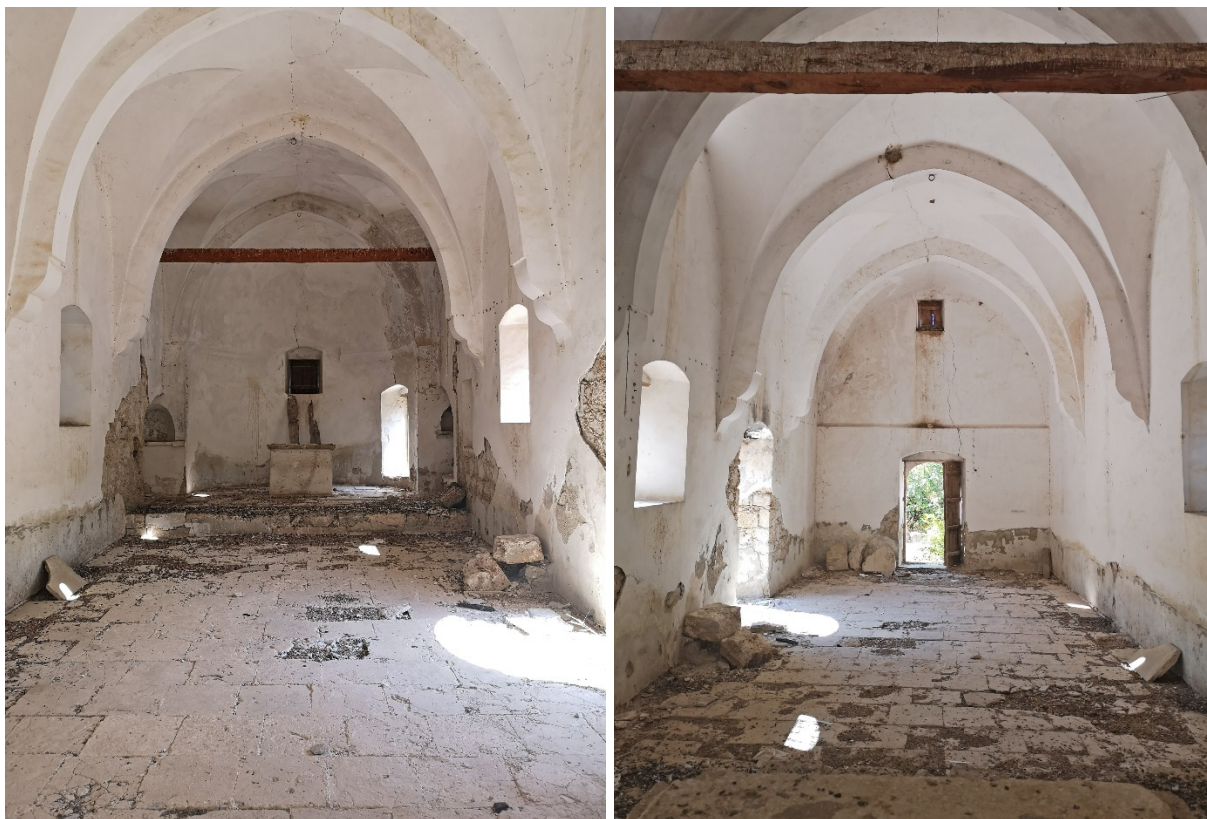
Fig. KYR-P1b-c: Agia Paraskevi Church (Sept. 2018)

External condition: *poor*; the bell, and all crosses were removed. The plaster on the walls is crumbling and the corroding reinforcing steel becomes visible.

Interior condition: *poor*; nearly all furnishings of a Greek Orthodox church have been removed. The doors and windows are open; on the walls large cracks are visible.

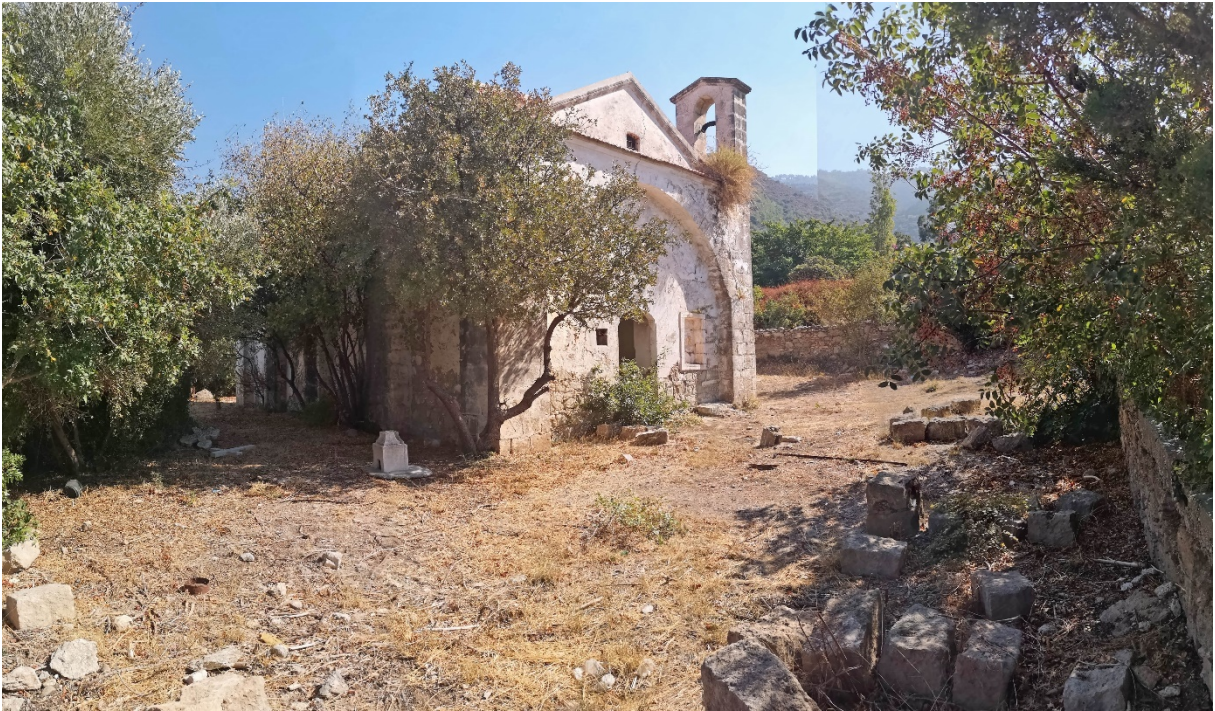
Fig. KYR-P1d: Greek Orthodox cemetery (view from northwest; Sept. 2018)

Condition: *ruin*; there are some basements and parts of the traditional crosses visible. Most of them are scattered around, so it is hardly possible to locate the original graves.

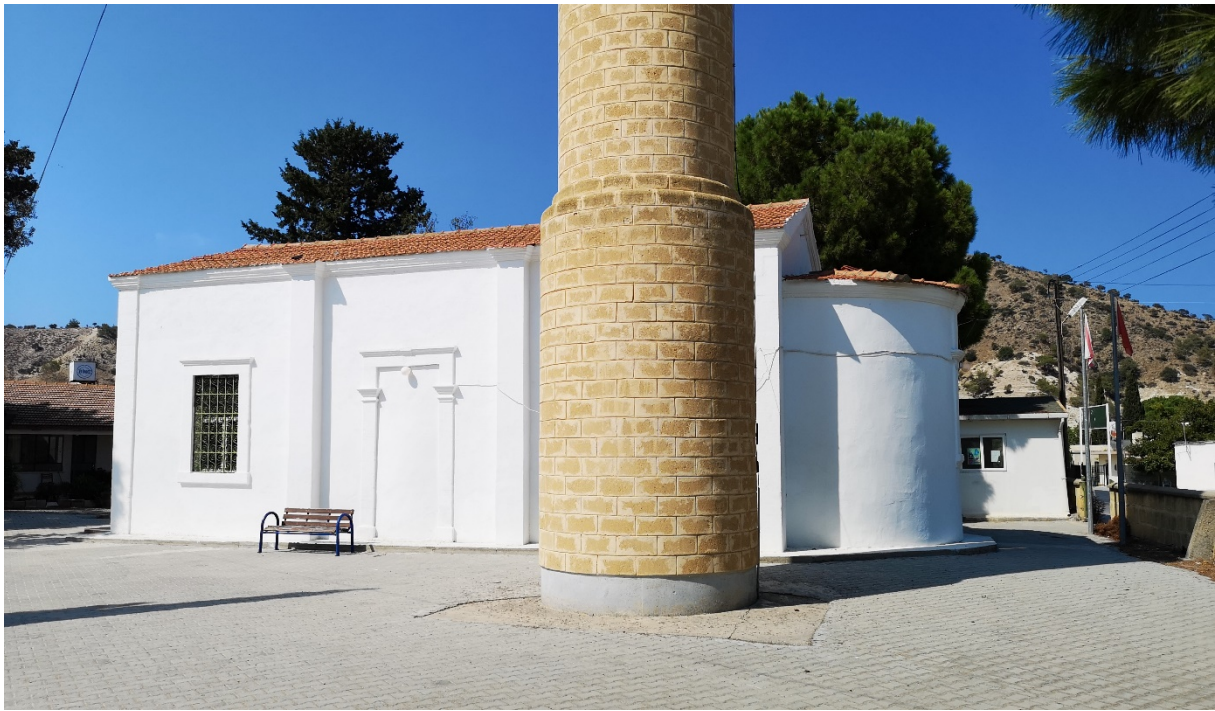
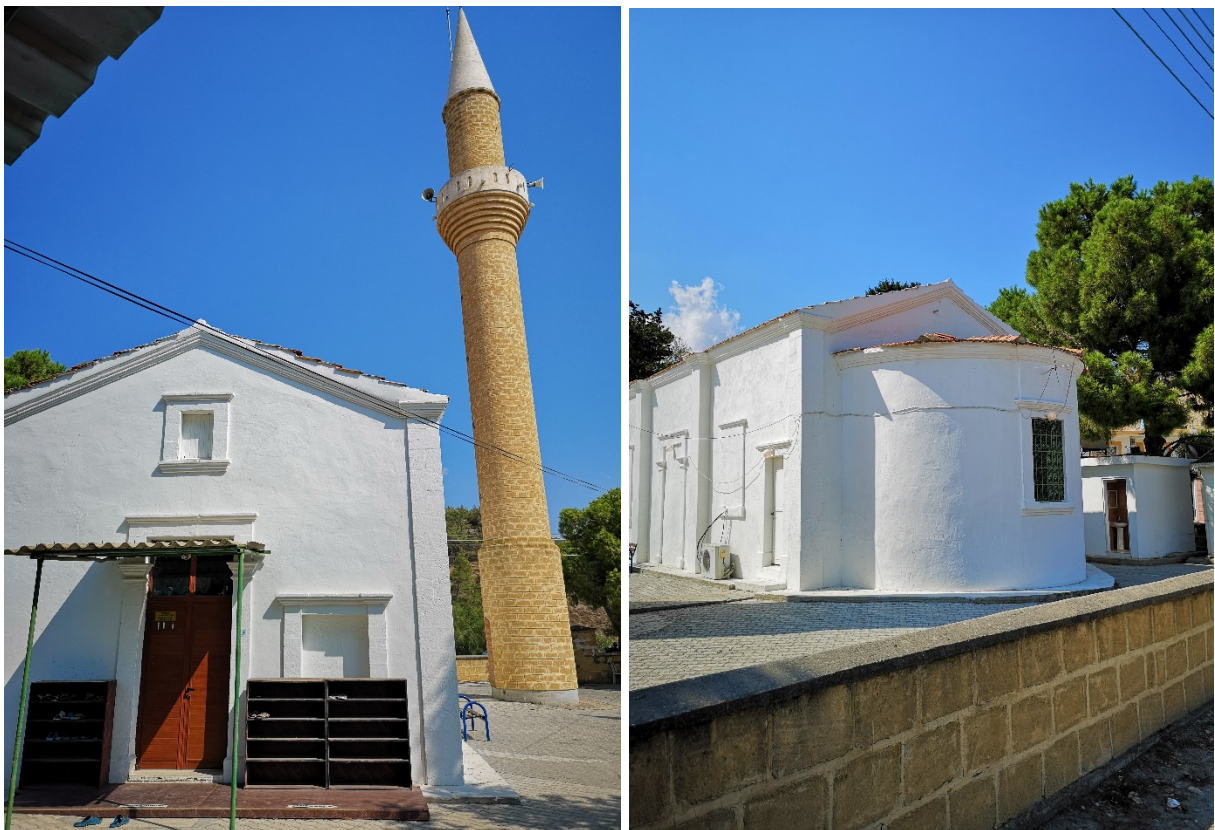
Fig. KYR-P2a: Apostolos Andreas Church, converted into a mosque (view from south; Sept. 2018)

External condition: *good*; all crosses were removed; all walls of the church were painted in white colour.

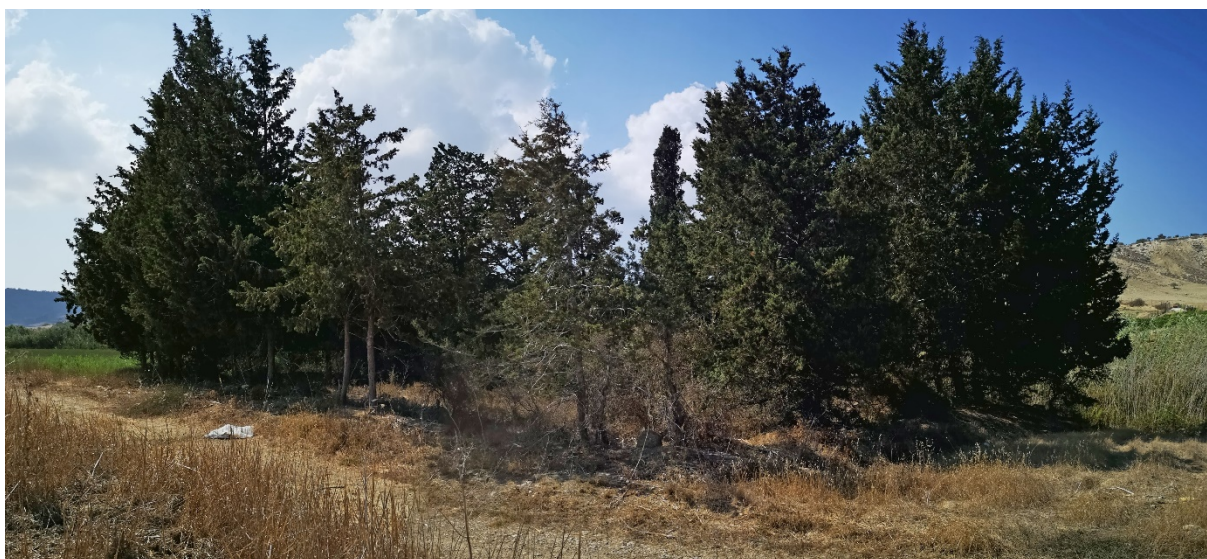
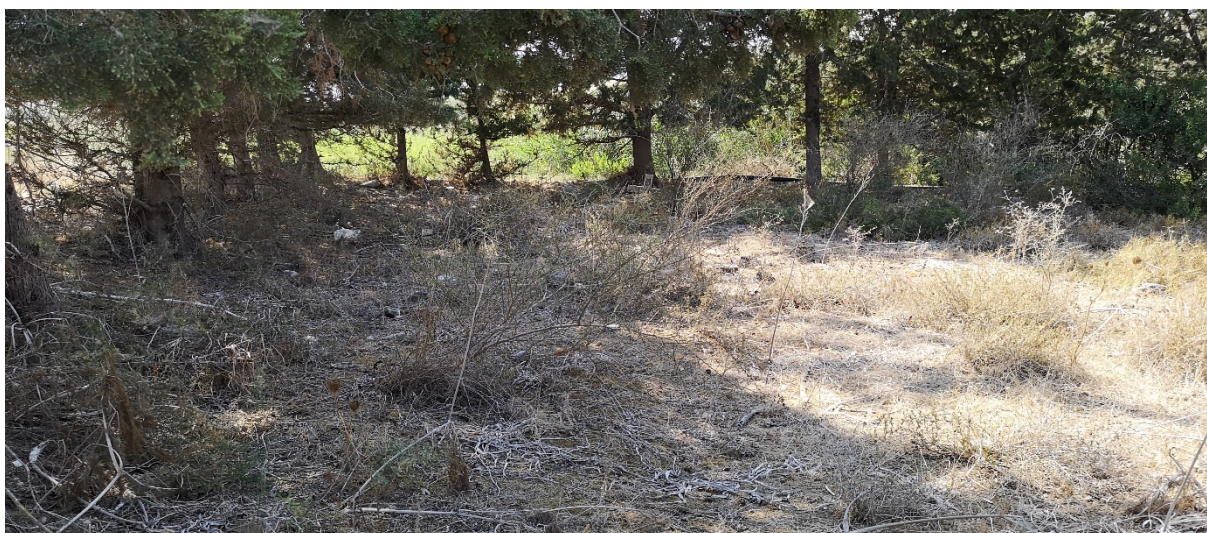
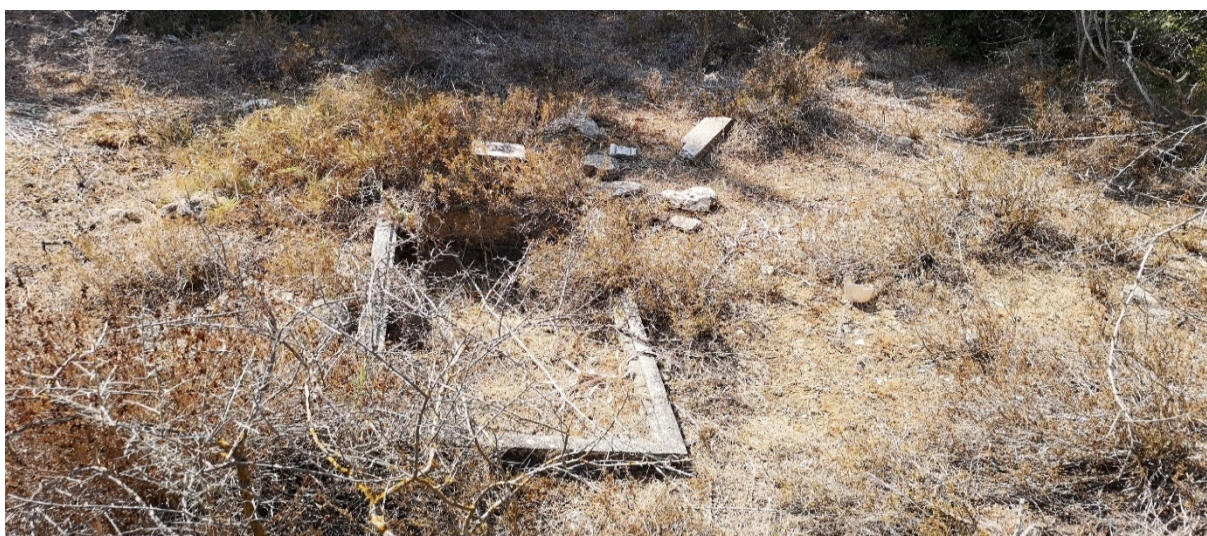
Fig. KYR-P2d: Greek Orthodox cemetery (view from southeast; Sept. 2018)

Condition: *ruin*; the enclosure wall has totally fallen apart; the area is overgrown with weeds and bushes; there are some basements of larger sepulchres visible; also, some parts of the traditional crosses could be found. Most of them are scattered around, so it is hardly possible to locate the original graves.

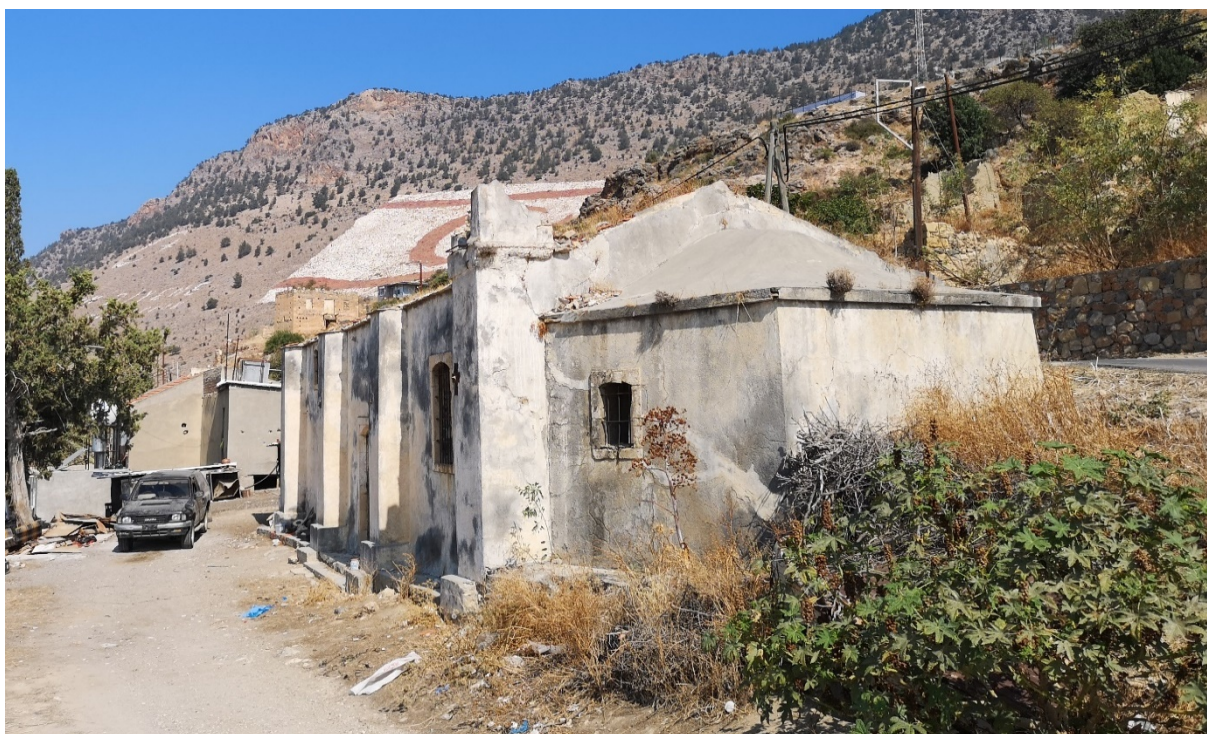
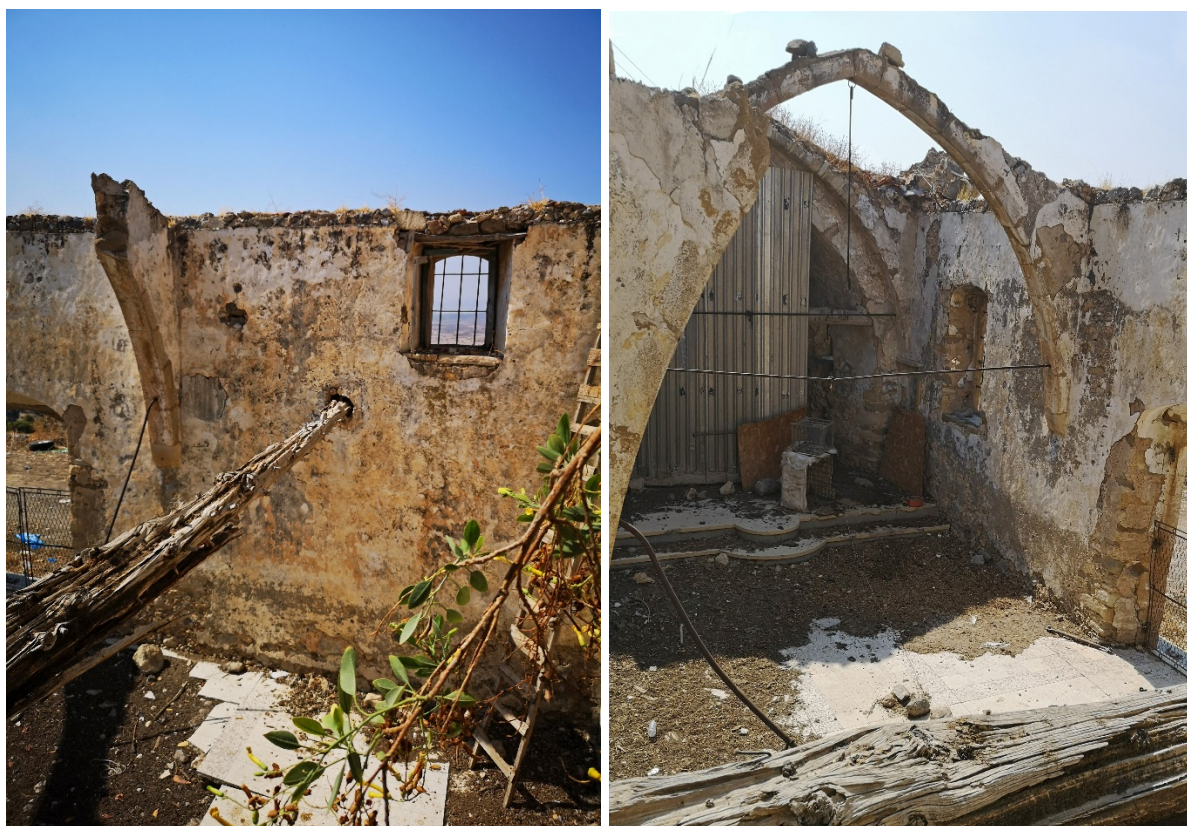
Fig. KYR-S1a: Agios Mamas Church (view from southeast; Sept. 2018)

External condition: *ruin*; the bell tower, the bell and all crosses are missing; the roof has collapsed some time ago.

Interior condition: *ruin*; all furnishings of a Greek Orthodox church have been removed. The interior space has been used as a storage place.

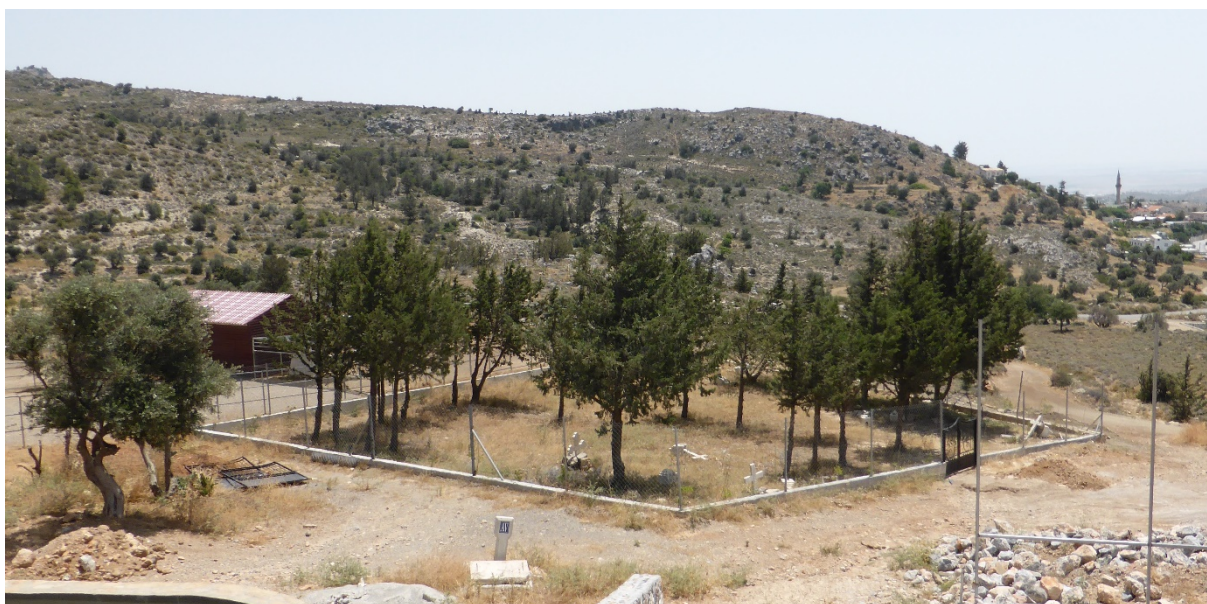
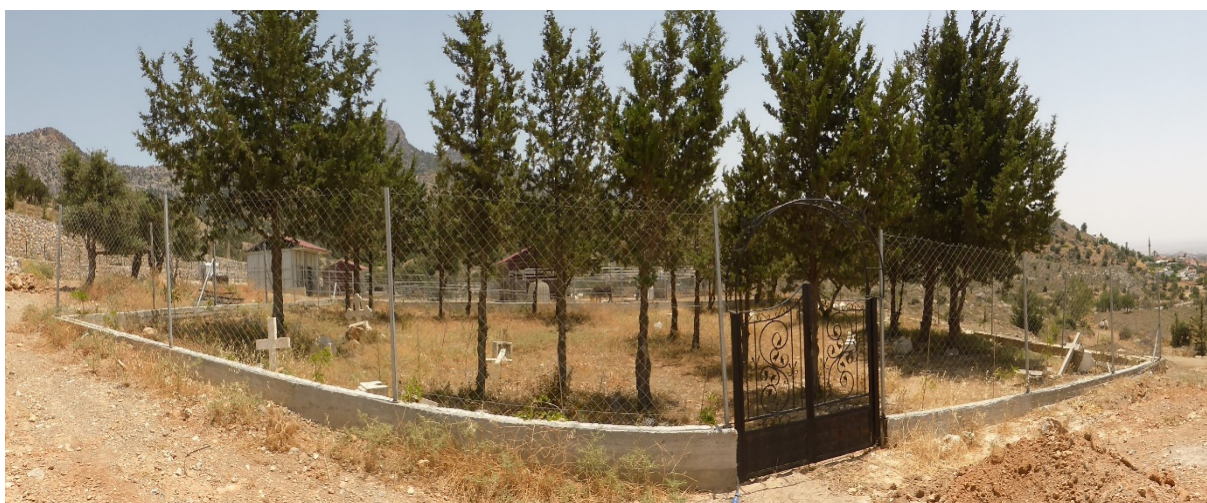
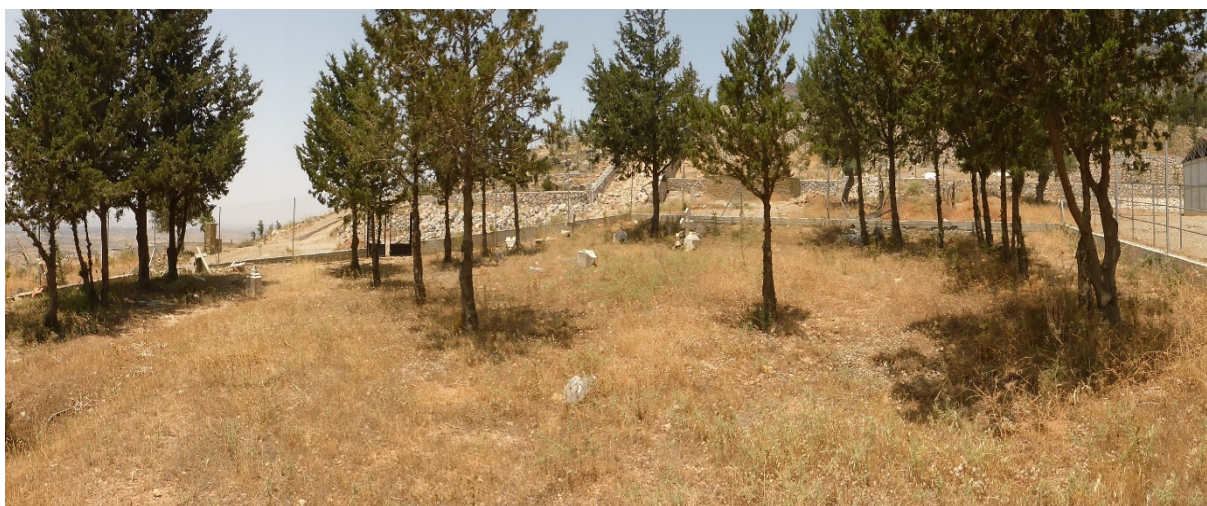
Fig. KYR-S1d: Greek Orthodox cemetery (view from northwest; June 2017)

Condition: *poor*; there are some larger parts and basements of the traditional crosses visible. Most of them are scattered around, so it is hardly possible to locate the original graves.

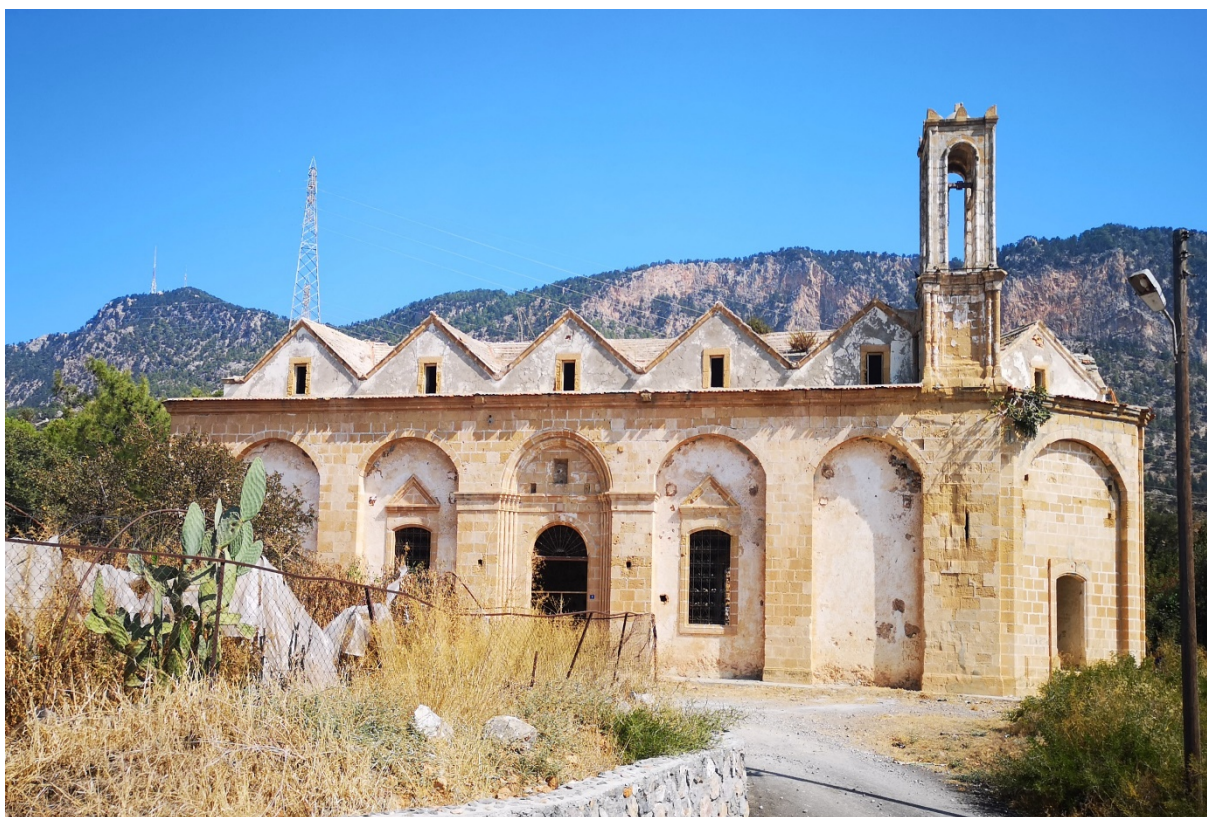
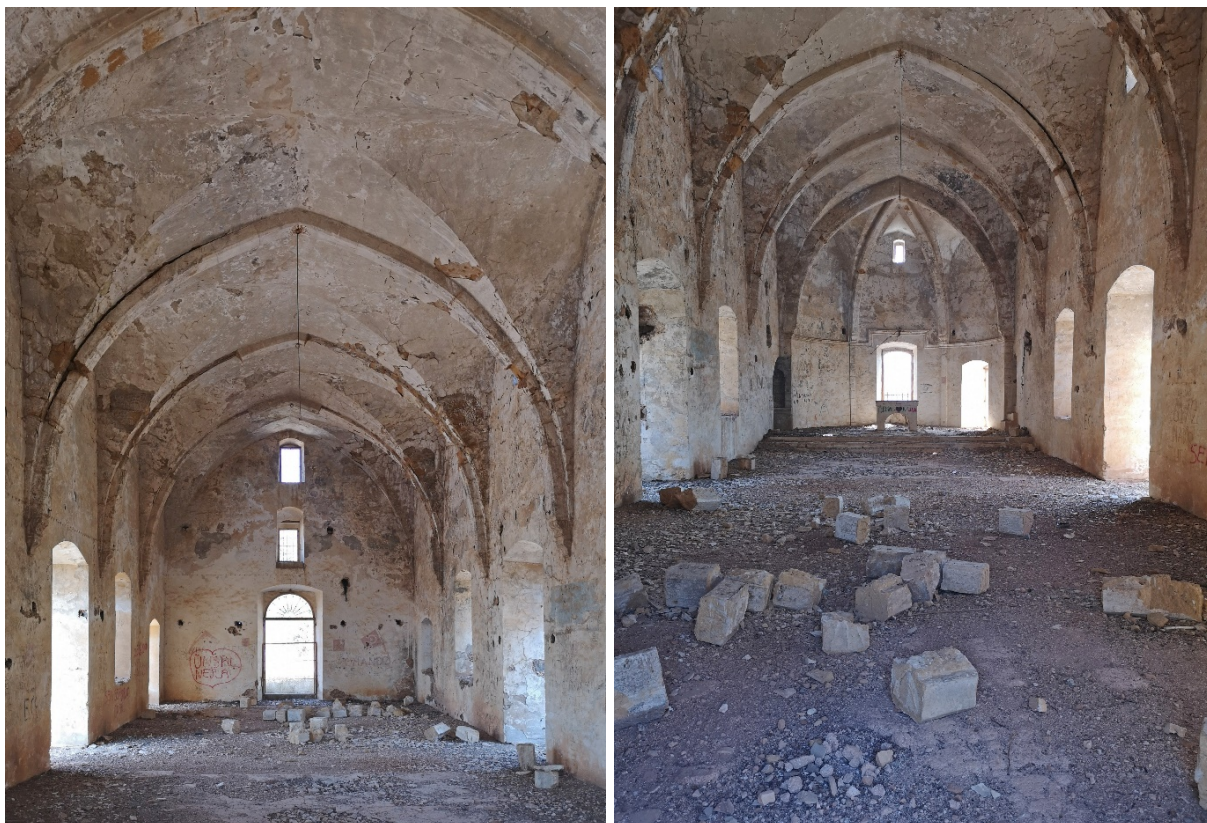
Fig. KYR-S2a: Panagia Chryseleousa Church (view from southwest; Sept. 2018)

External condition: *poor*; the bell and all crosses were removed.

Interior condition: *ruin*; nearly all furnishings of a Greek Orthodox church have been removed – only the altar is still *in situ*; the walls and the roof are affected by dampness.

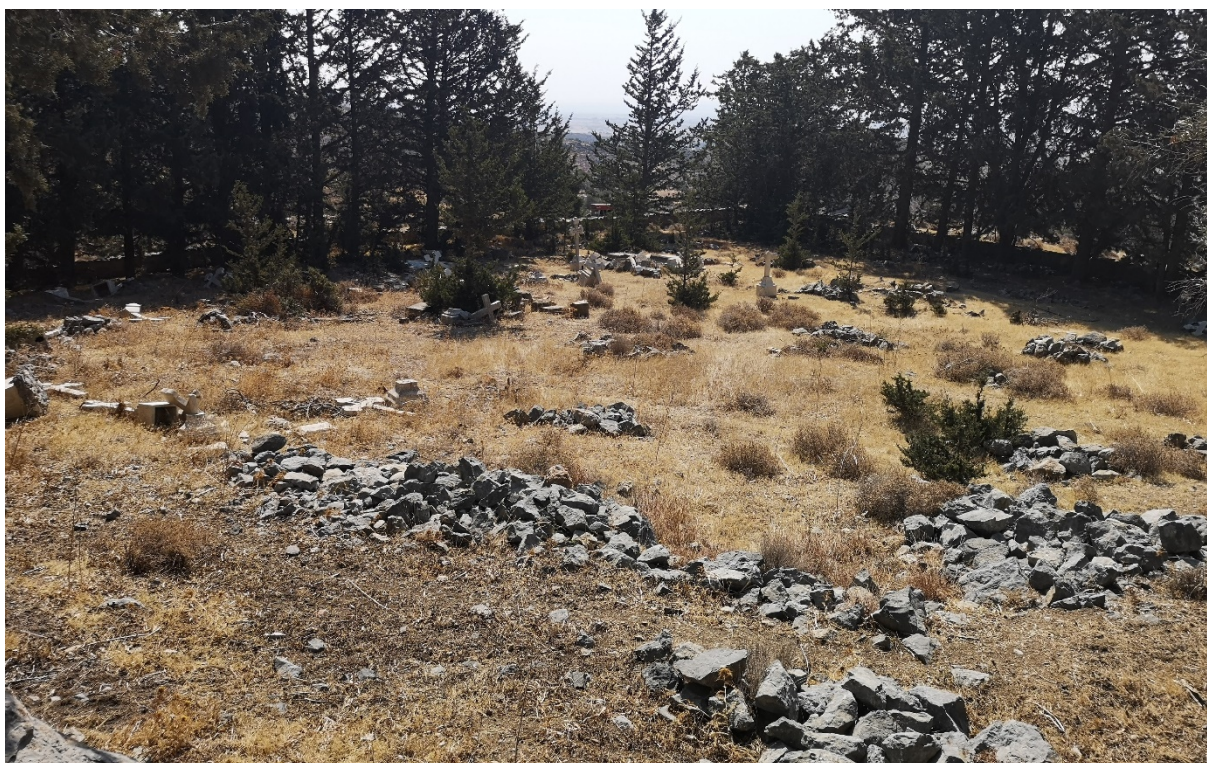
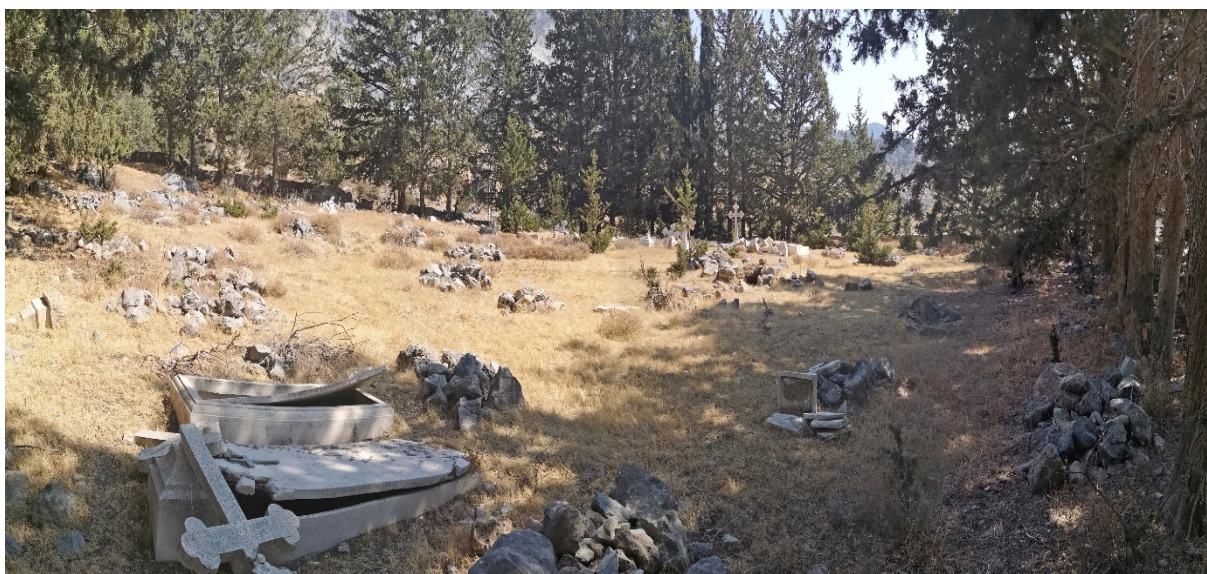
Fig. KYR-S2d: Greek Orthodox cemetery (view from northwest; Sept. 2018)

Condition: *fair*; the enclosure wall built of natural stones has fallen apart in some places; on this cemetery, most of the graves were covered by rip-rap revetments, which are still intact. Most of the existing traditional crosses are scattered around; the larger sepulchres show signs of damage.

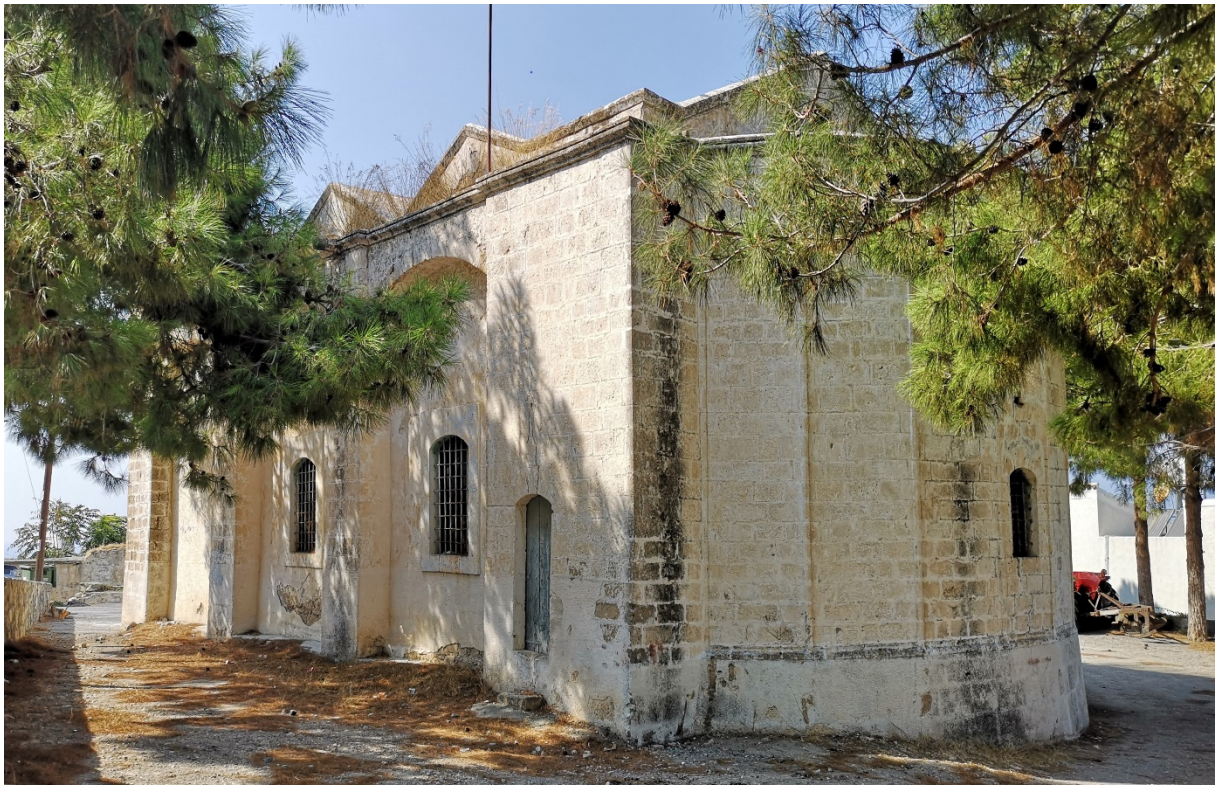
Fig. KYR-V1a: Agios Konstantinos Church, used as a mosque (view from southeast; Sept. 2018)

External condition: *good*; however, all crosses and the bell were removed

Interior condition: *fair*; since the church was used as a mosque all furnishings of a Greek-Orthodox church were removed. The inside walls are affected by dampness and the plaster starts to crumble. Doors and windows are open; as a result, pigeons went in. The interior condition is on the way to a *poor* state.

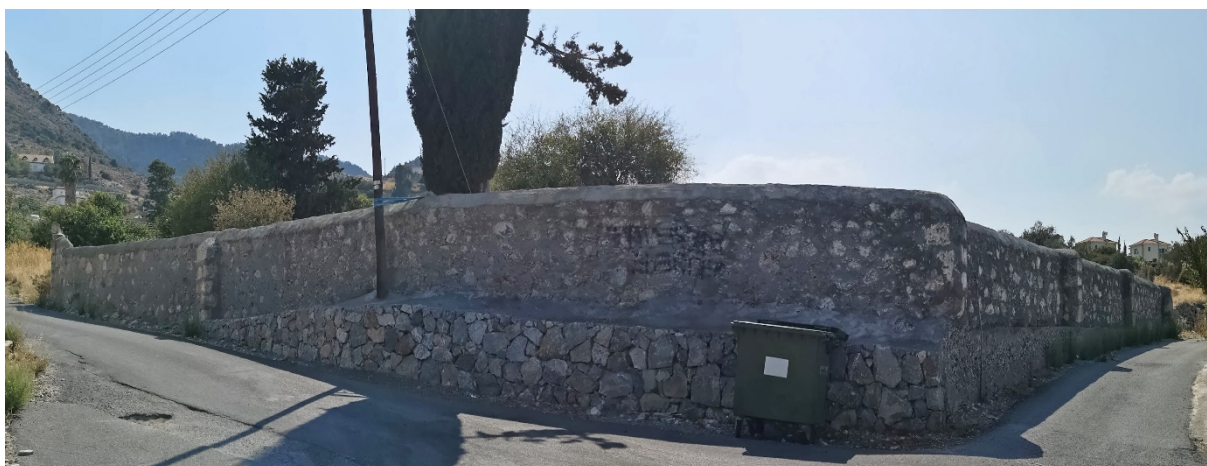
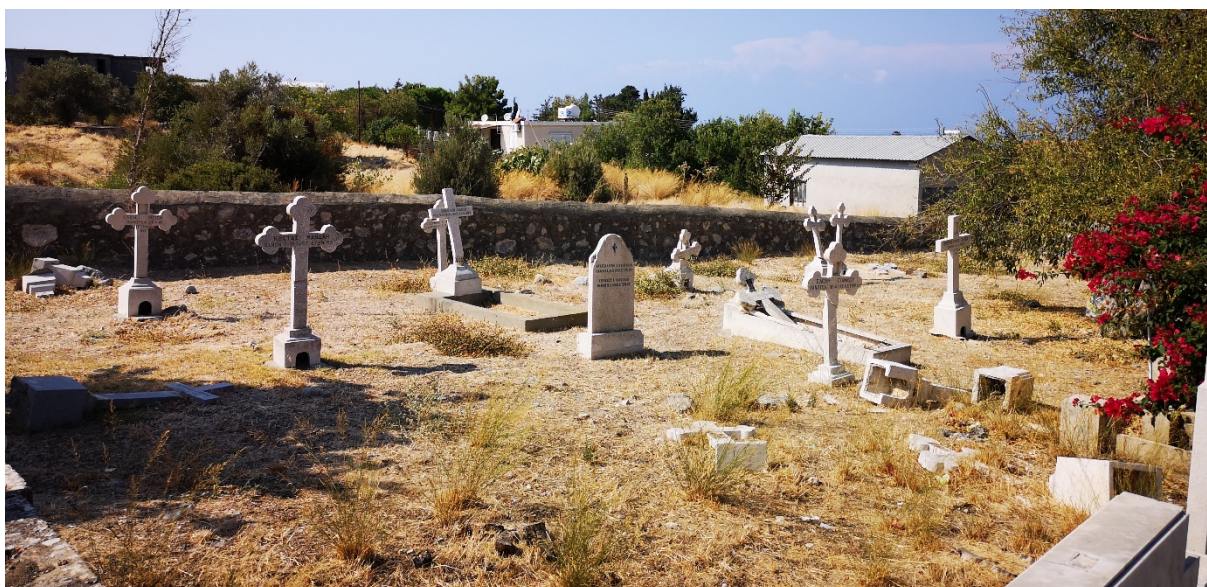
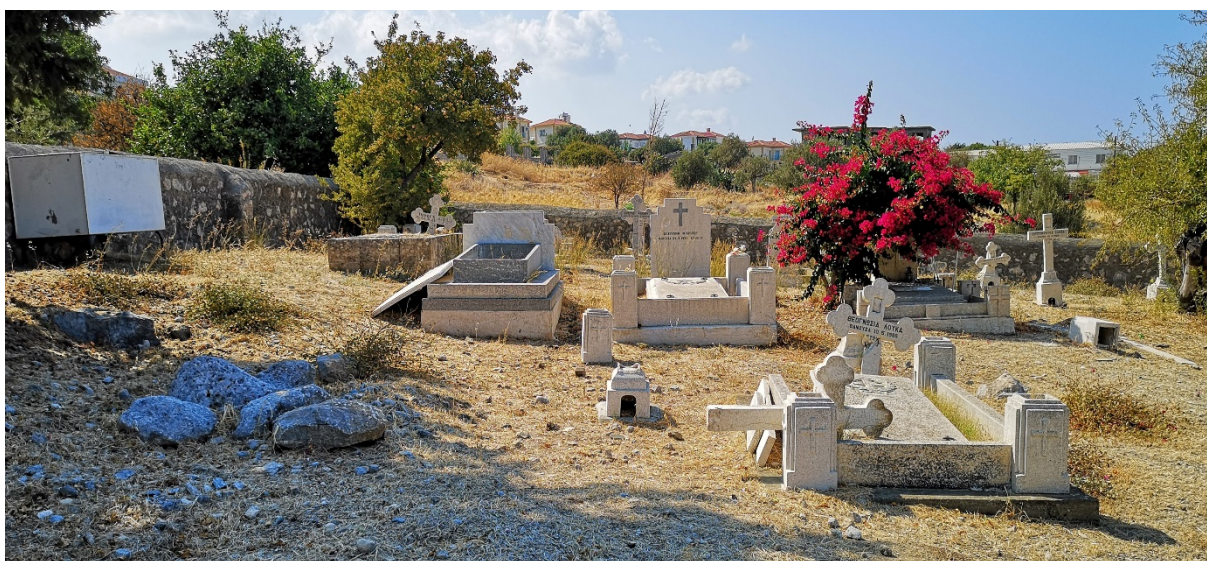
Condition: *good*; the enclosure wall and the entrance gates are sound and it seems as if the vegetation is maintained regularly; obviously many of the traditional grave crosses were provisionally re-erected at their places, while a few crosses are scattered around. Many of the bigger sepulchres are in a *fair* condition.

Fig. KYR-V1d: Greek Orthodox cemetery (view from northeast; Sept. 2018)

Fig. KYR-V1e: Greek Orthodox cemetery (view from southeast; Sept. 2018)

Fig. KYR-V1f: Greek Orthodox cemetery (view from east; Sept. 2018)

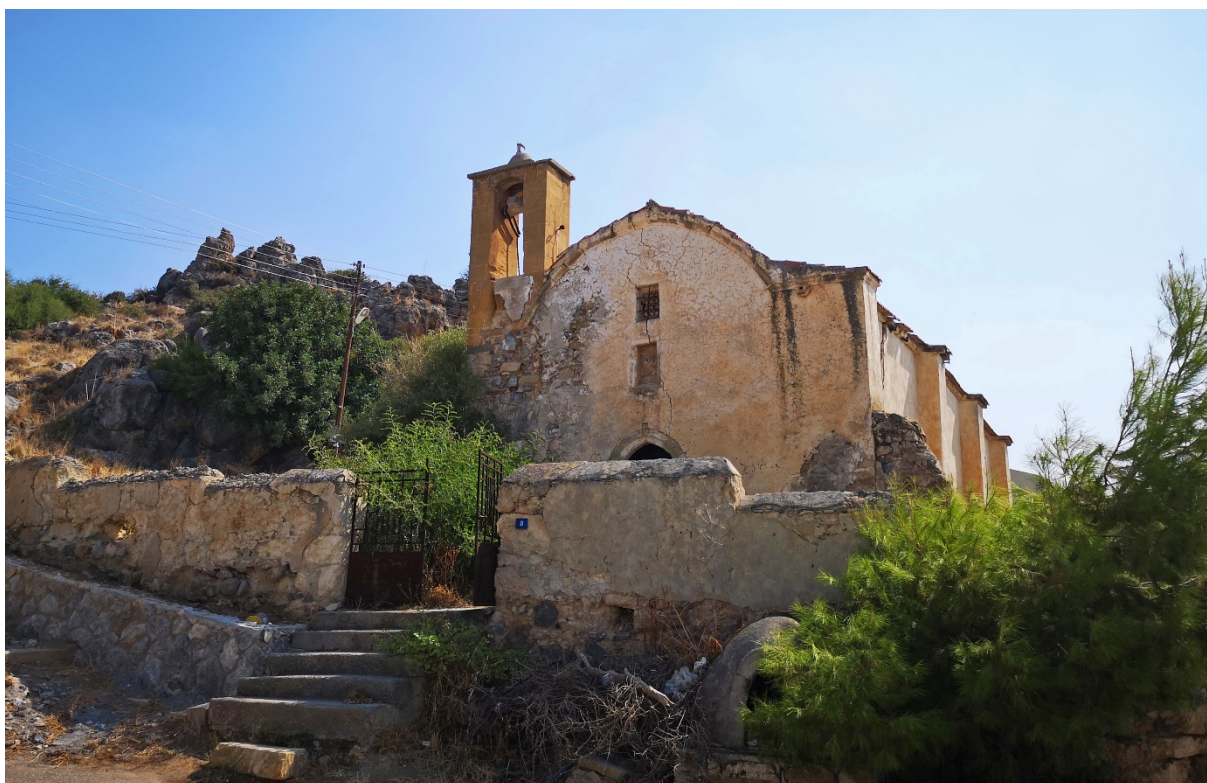
Fig. KYR-V2a: Agios Georgios Church (view from southwest; Sept. 2018)

External condition: *poor*, near to ruin; the bell and all crosses are missing; massive cracks are visible in the whole masonry.

Interior condition: *ruin*; nearly all furnishings of a Greek Orthodox church have been removed. Only the wooden frame of the iconostasis and parts of the altar are still *in situ*. Massive cracks are visible on the ceiling.
