# The religious heritage of Cyprus

a survey in the districts of Kyrenia and Larnaca

Dr. Thorsten Kruse, M.A.  
Institut für Interdisziplinäre Zypern-Studien  
Westfälische Wilhelms-Universität Münster  
Schlaunstr. 2  
48143 Münster  
Germany  
Email: Th.Kruse@wwu.de

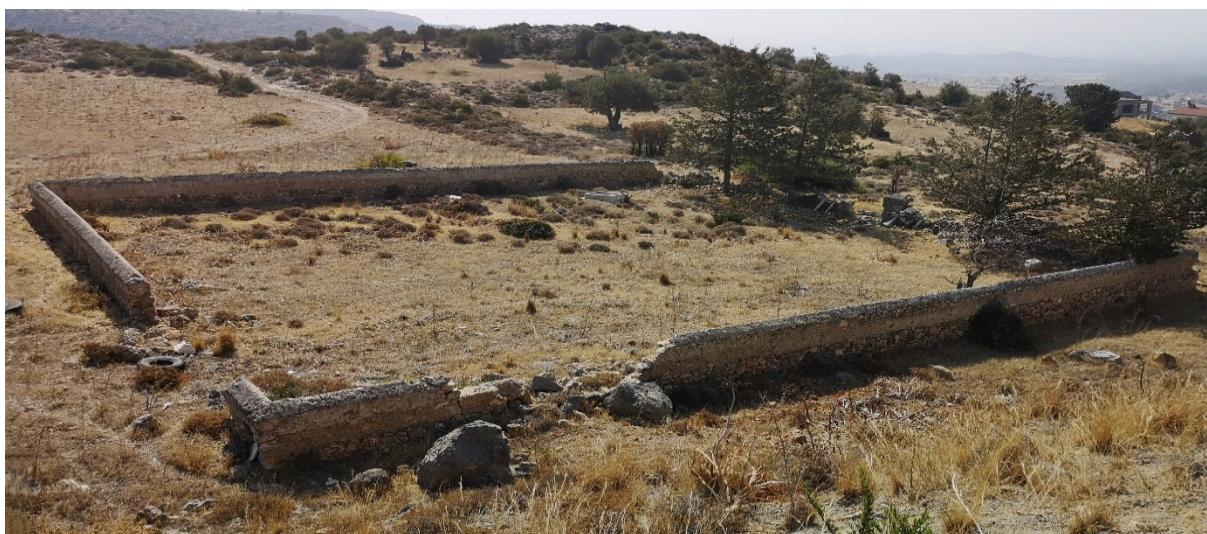
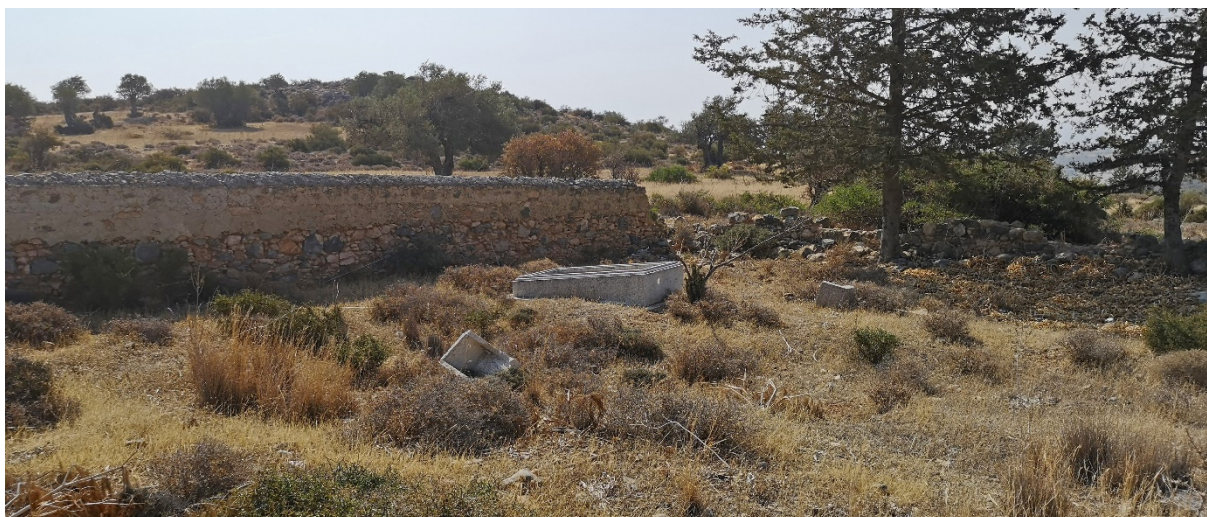
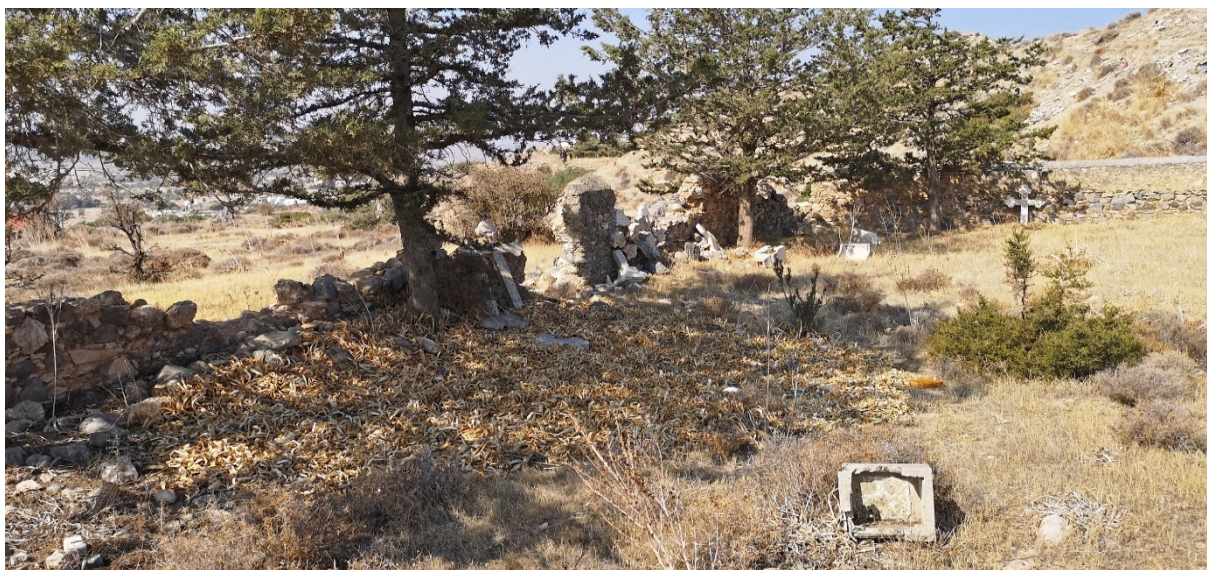
Condition: *ruin*; some parts of the enclosure wall have collapsed in parts. On the cemetery itself, only one bigger sepulchre could be identified. Some of the traditional grave crosses are leaning against the remains of the southern enclosure wall. So, it is hardly possible to locate the original graves.

Fig. KYR-V2c: Greek Orthodox cemetery (view from northwest; June 2018)

Fig. KYR-V2d: Greek Orthodox cemetery (view from south; June 2018)

Fig. KYR-V2e: Greek Orthodox cemetery (view from south; June 2018)

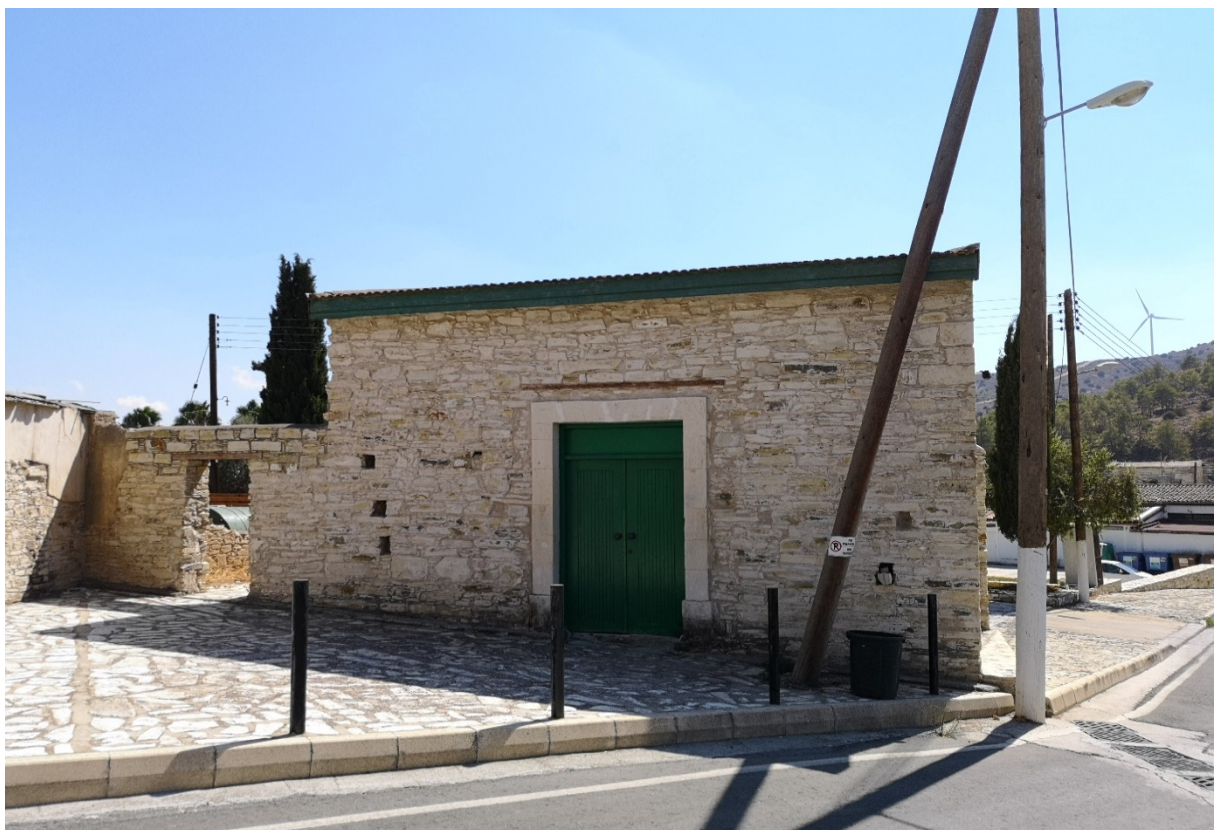
Fig. LAR-A1b: Mosque (view from north; Sept. 2018)

External condition: *good*; the door of the mosque was locked.

Interior condition: *good*; plain stone floor and white painted walls with minor traces of grime (visit in 2017).

Remarks: A fountain for ablution is missing.

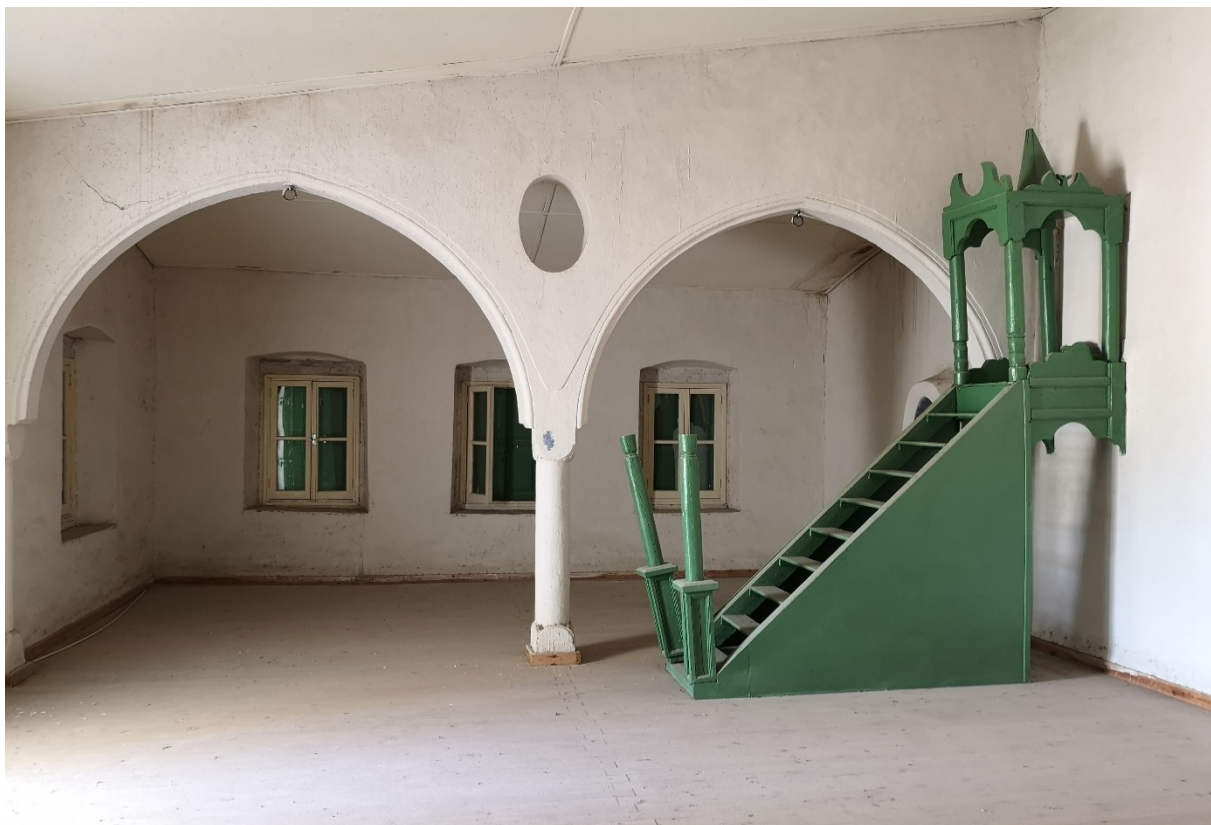
Fig. LAR-A2b: Mosque (Sept. 2018)

External condition: *good*; the doors of the mosque are properly closed but not locked.

Interior condition: *good*; mihrab and minbar were painted recently, and are in a good condition.

Remarks: renovation works on the exterior façade started in 2018. The entrance area (stairs to the 1<sup>st</sup> floor etc.) is in a *poor* condition. The fountain for ablution in the entrance area is not working.

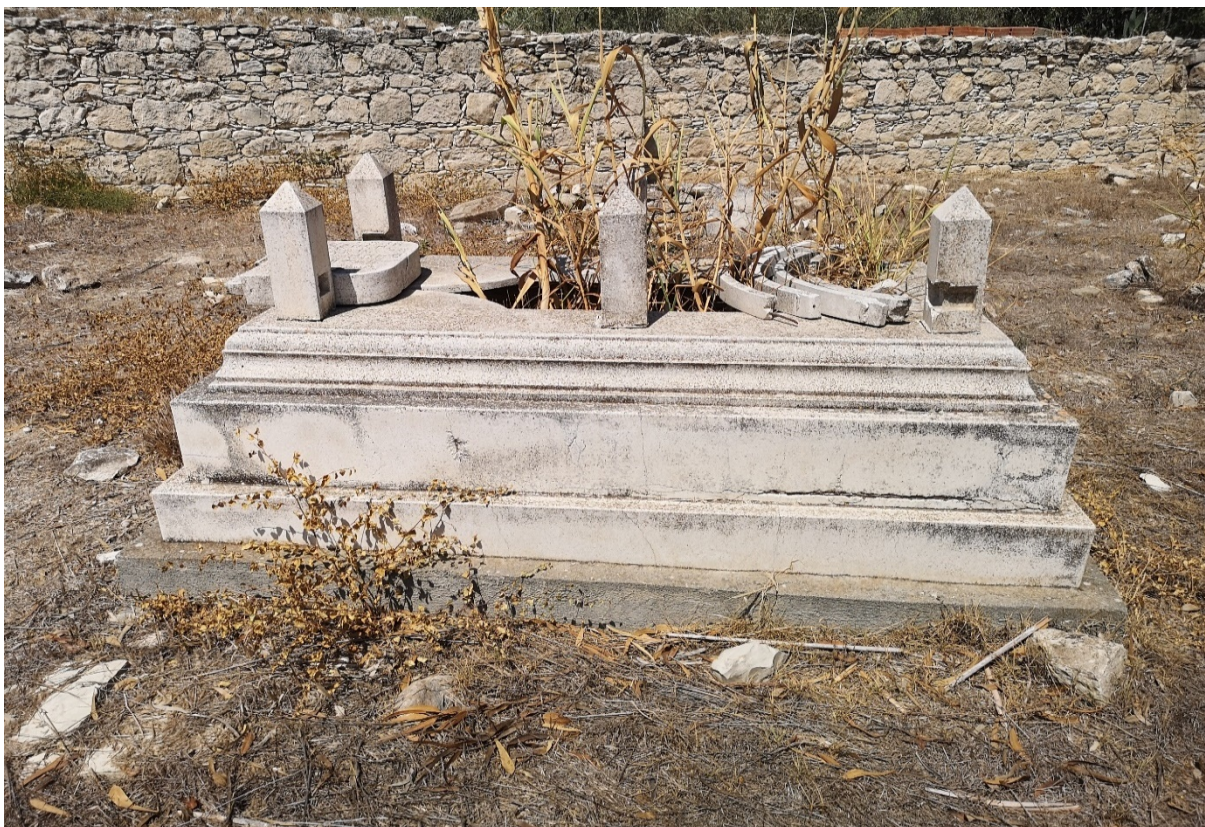
Fig. LAR-A2d: Muslim cemetery (Sept. 2018)

Condition: *good*; in 2018 the entrance gate was renovated and painted; only low vegetation (grass seems to be cut regularly); the large sepulchres show signs of natural decay; smaller stones used as grave markers are still *in situ*. The enclosure wall is sound.

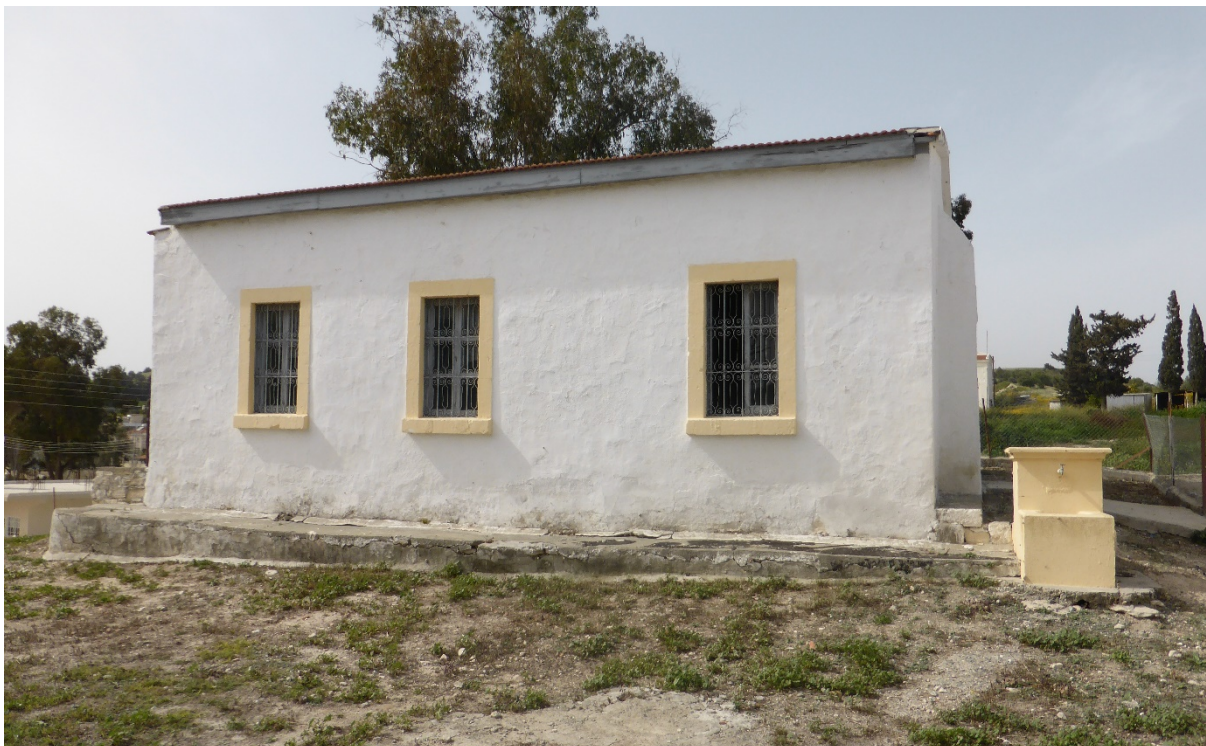
Fig. LAR-A3a: Mosque (view from south; March 2018)

External condition: *good*; the mosque was locked.

Interior condition: *good*; plain stone floor and white painted walls.

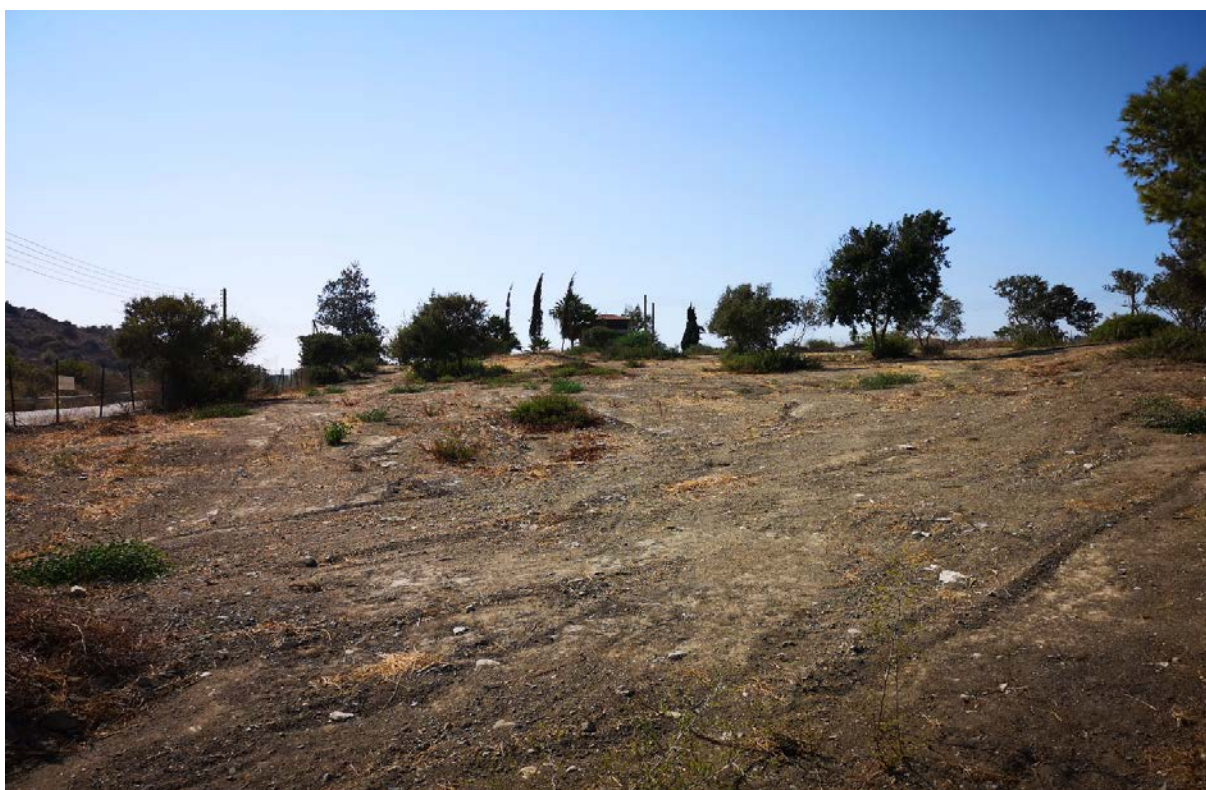
Fig. LAR-A3d: Muslim cemetery (view from south; Sept. 2018)

Condition: *poor*; during the last years the cemetery was cleaned with heavy tools on a regular basis, with the effect that nothing is left from the former burial places. The cemetery is fenced, with major defects on the southern side.

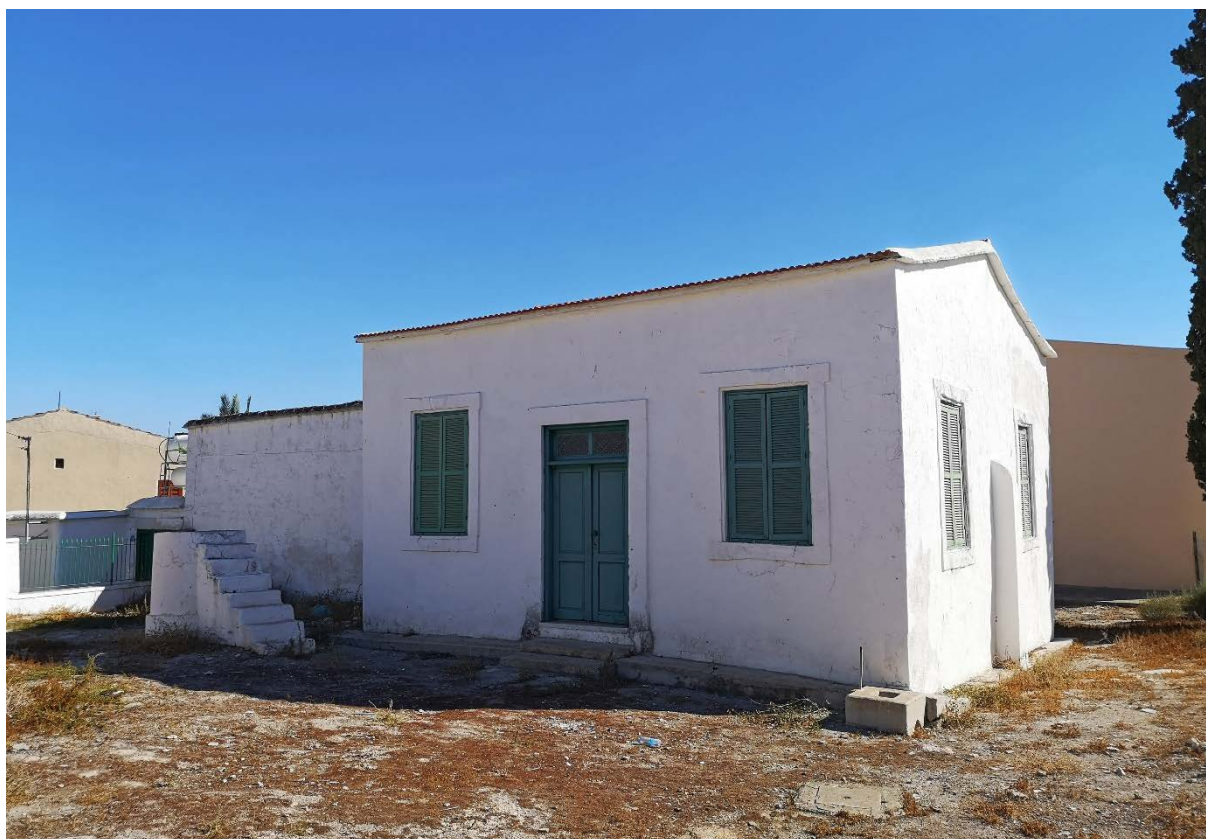
Fig. LAR-A5a: Mosque, with rudimentary minaret (view from north, Sept. 2018)

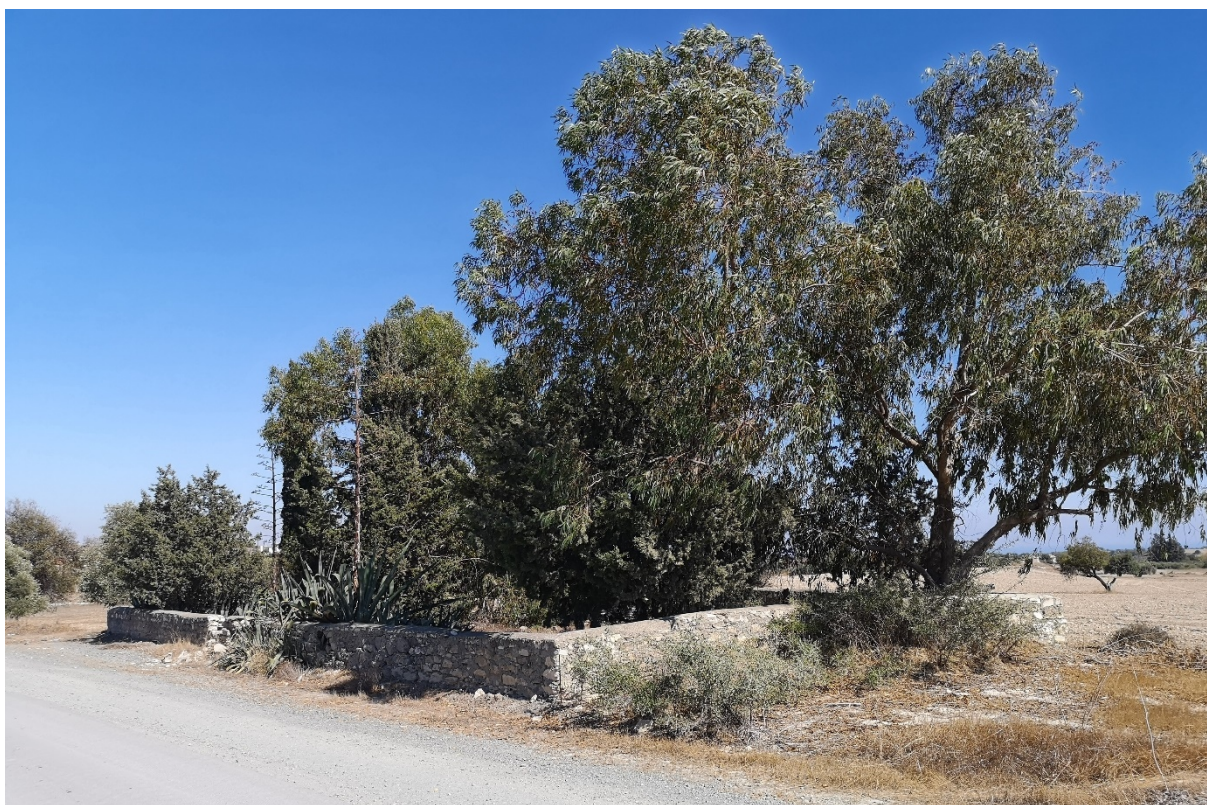
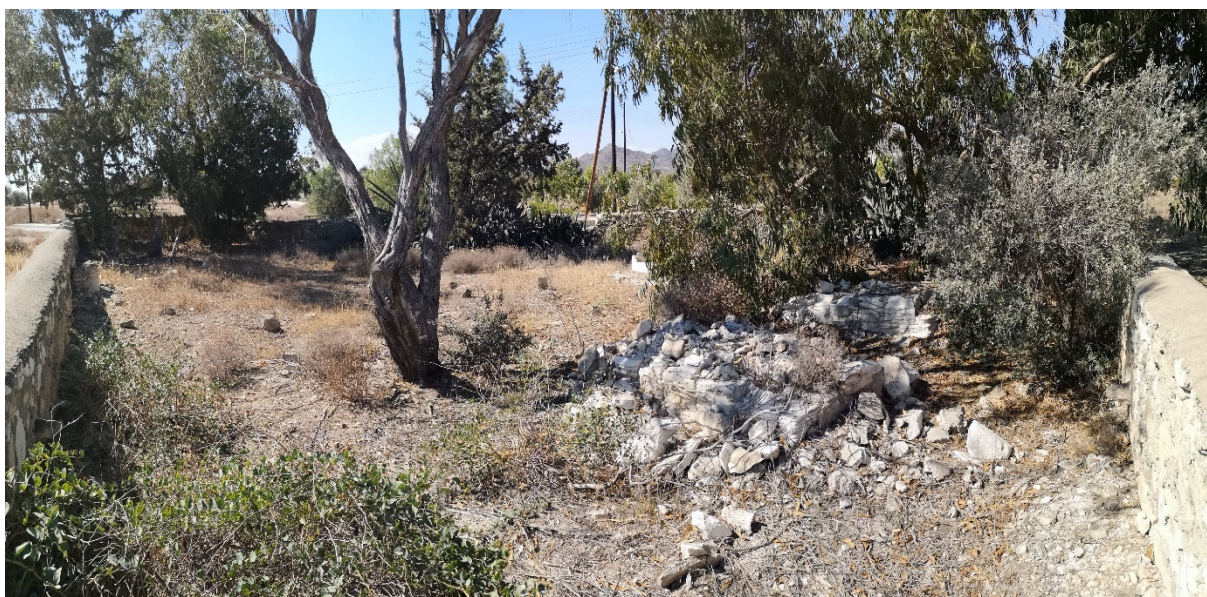
Condition: *fair to poor*, the cemetery is affected by the growth of plants and natural decay. Parts of the north-western wall have collapsed due to the growth of agaves. On the cemetery itself weeds, shrubs and trees are growing, thus favouring natural decay.

Fig. LAR-A6a: Muslim cemetery (view from west; Sept. 2018)

Fig. LAR-A6b: Muslim cemetery (view from east; Sept. 2018)

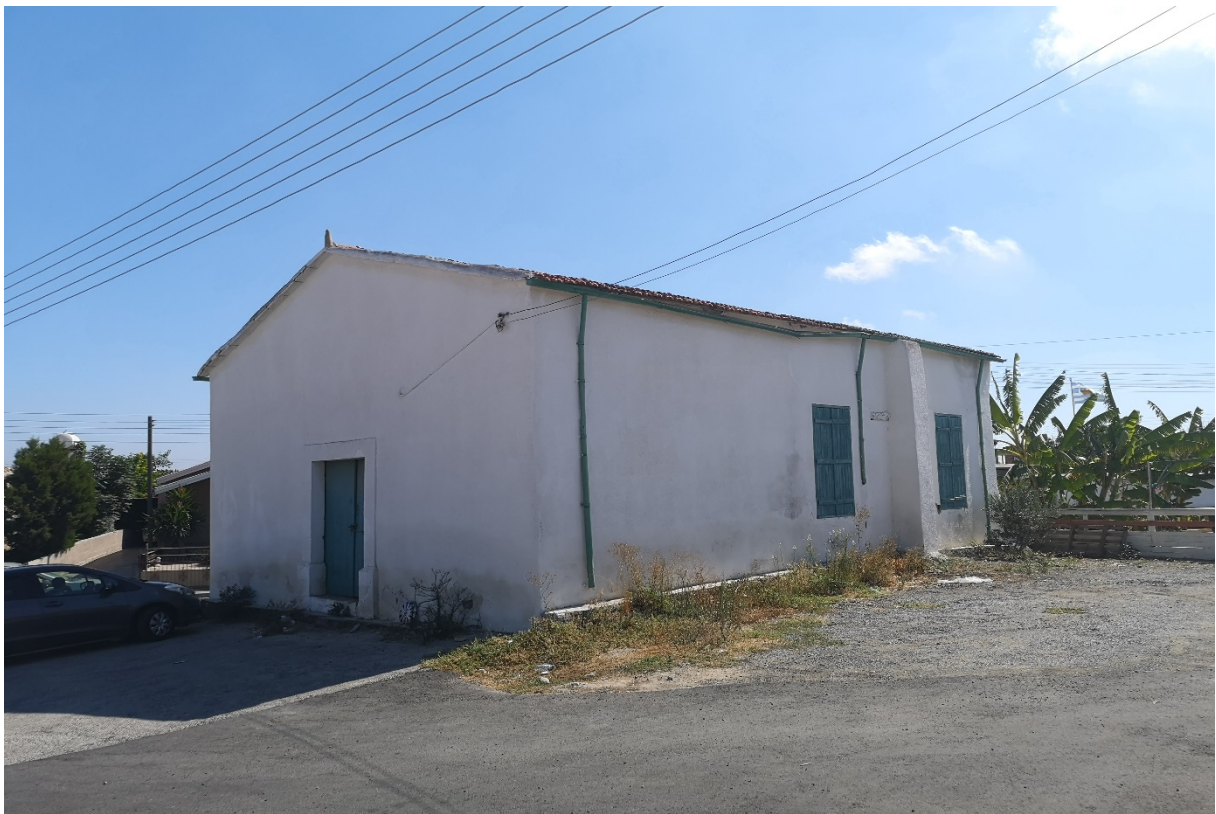
Fig. LAR-D1a: Mosque (view from northeast; Sept. 2018)

External condition: *fair*, the gutters are in a poor condition, while the façade shows clear signs of damp, and there are some graffiti.

Interior condition: *./.*; on the day of visit the door was locked.

A fountain for ablution is missing.

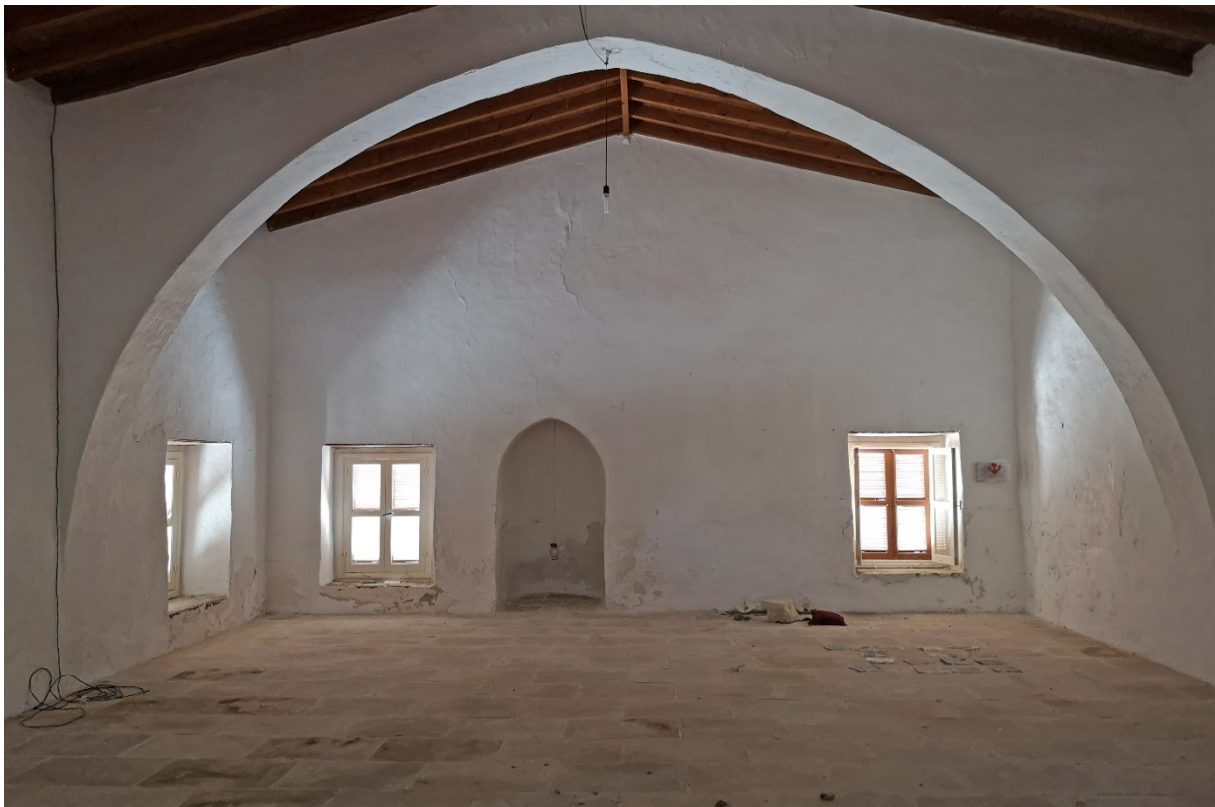
Fig. LAR-K1b: Mosque (Sept. 2018)

External condition: *good*; parts of the vestibule are affected by residues of nesting birds.

Interior condition: *good*; the walls are affected by dampness to a minor extent.

Remarks: The door is locked with a chain and a padlock leaving a slot free, so it was possible to document the interior. A fountain for ablution is missing.

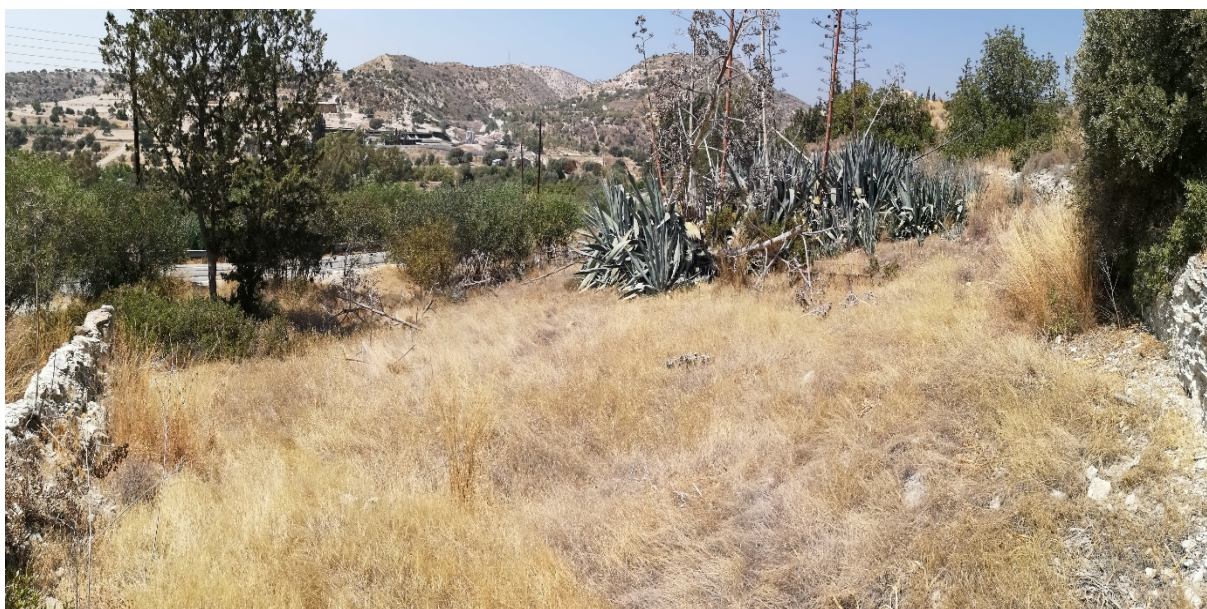
Fig. LAR-K1: Muslim cemetery (view from southeast; Sept. 2018)

Condition: *poor*; although a new enclosure wall was built on the western part of the cemetery to prevent erosion of the site, the condition of the cemetery is *poor*. The rest of the enclosure wall is affected by natural deterioration. The area is overgrown by weeds, scrub and agaves. Only a few of the small graves and some of the bigger sepulchres are still visible.

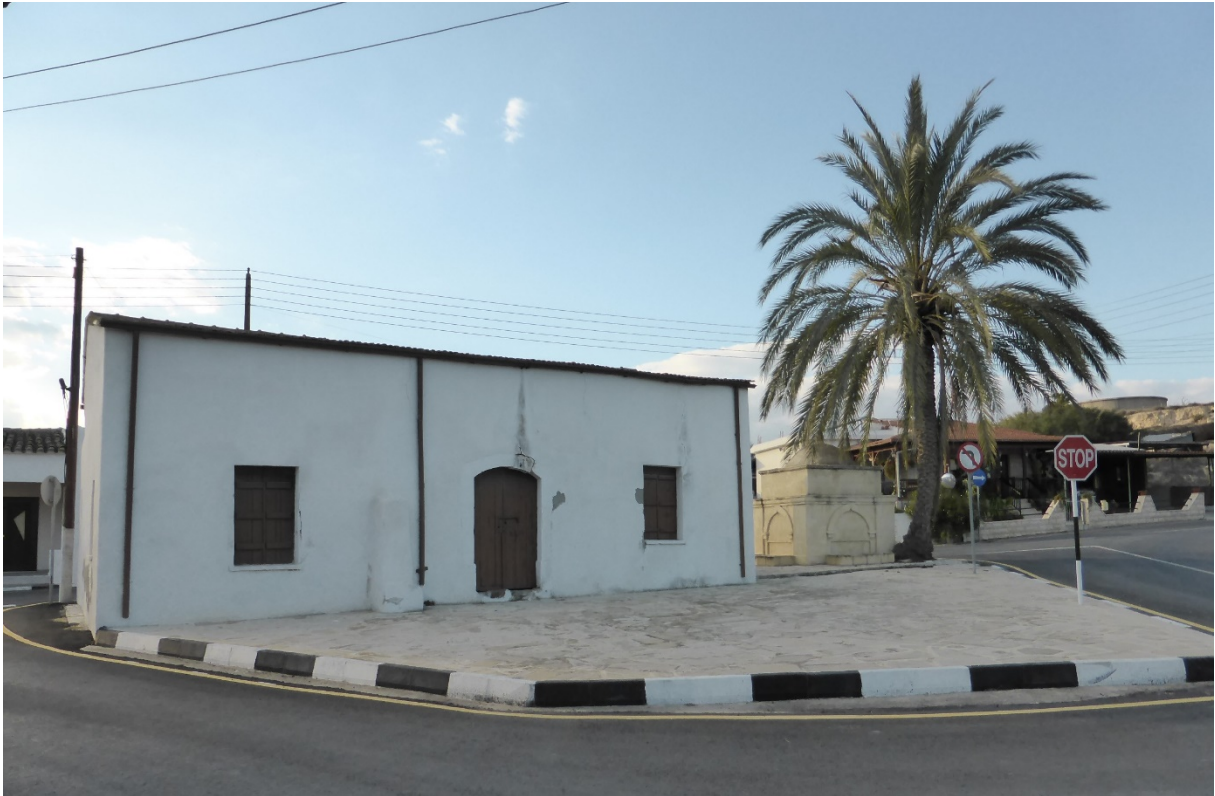
External condition: *good*; the building is in a relatively good condition. The gutters are in a bad condition, which leads to an impact of moisture at eastern façade. The doors of the mosque are properly closed.

Interior condition: *good*; the walls, the mihrab and the wooden minbar are all painted in white. The walls and the floor are affected by moisture.

Fig. LAR-K3a: Mosque, with the fountain next to the palm tree (view from east; Nov. 2017)

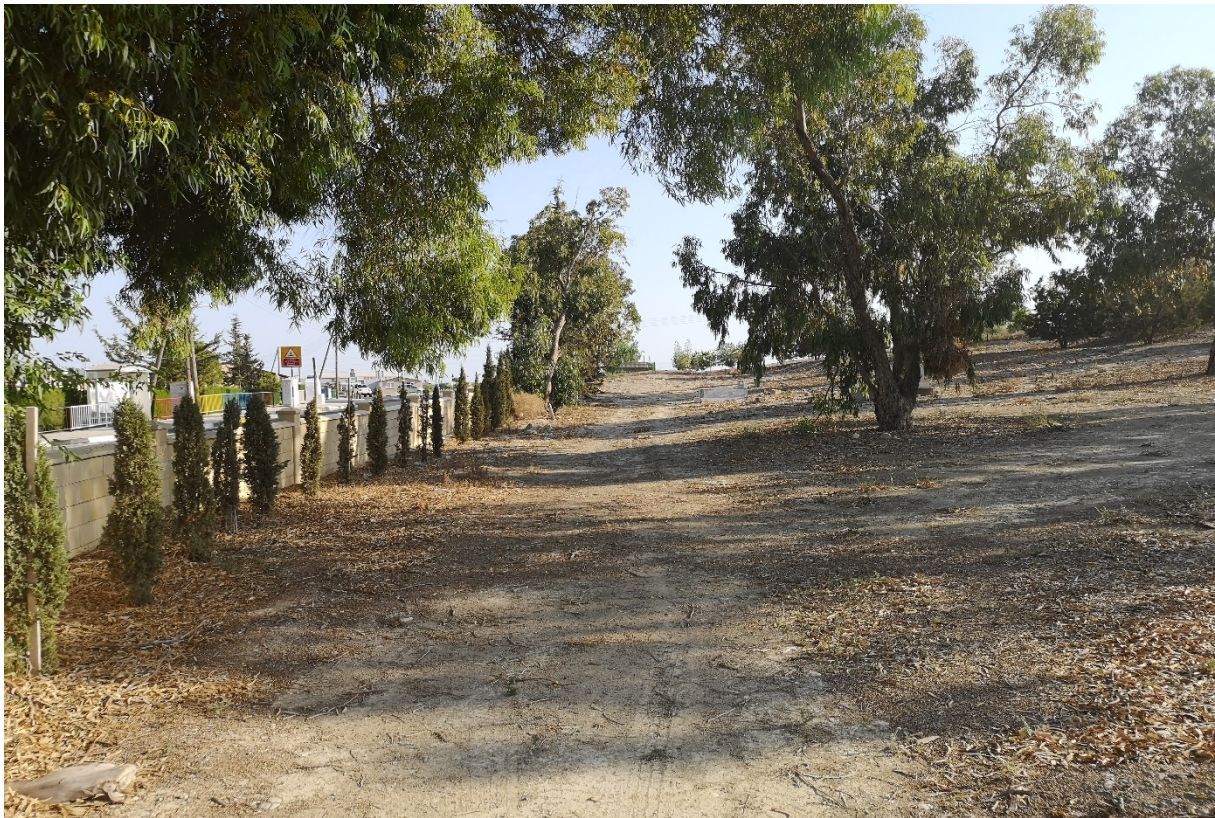
Fig. LAR-K3c: Muslim cemetery (view from north; Sept. 2018)

Condition: *fair*; it is obvious that cleaning measures were carried out, but with the effect that no traces were left of the modest graves marked with stones only. Just a few of the bigger sepulchres are still visible. The cemetery is fenced (no defects are visible; on the eastern side a new wall replaces the older fence).

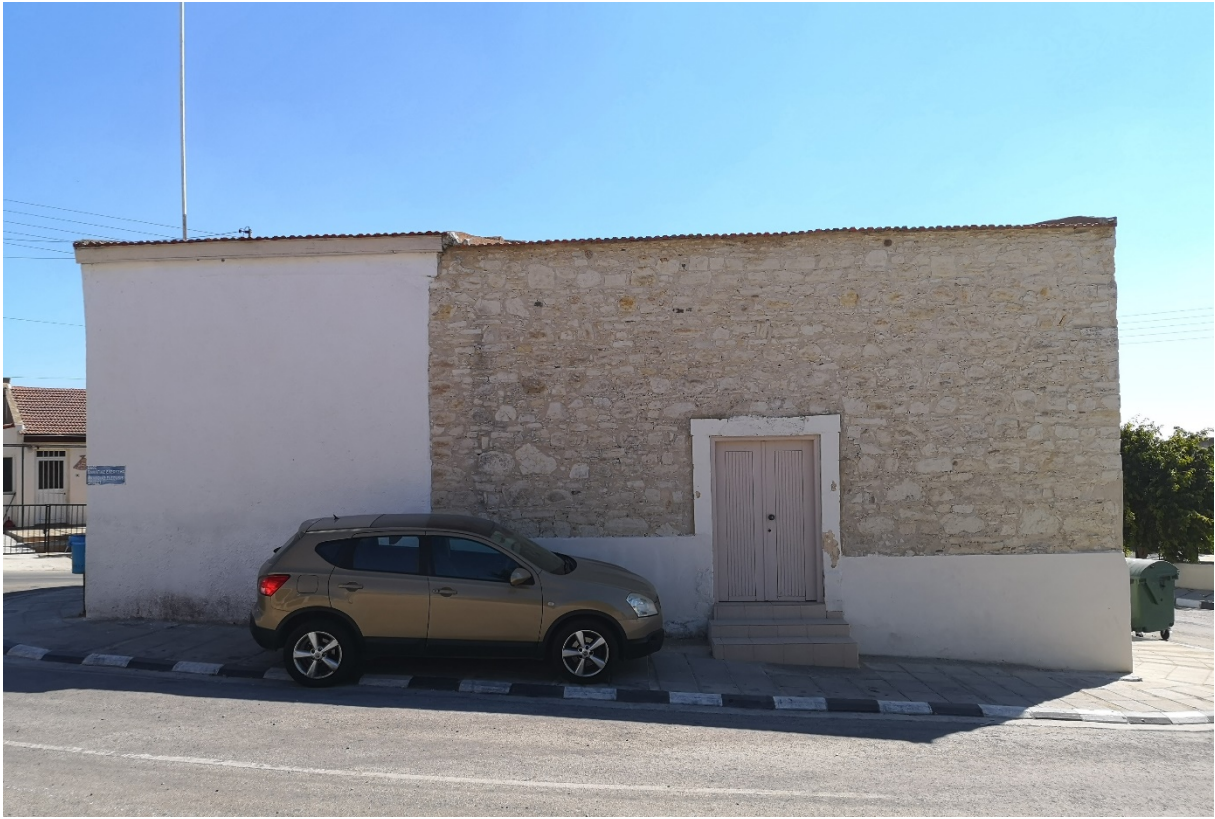
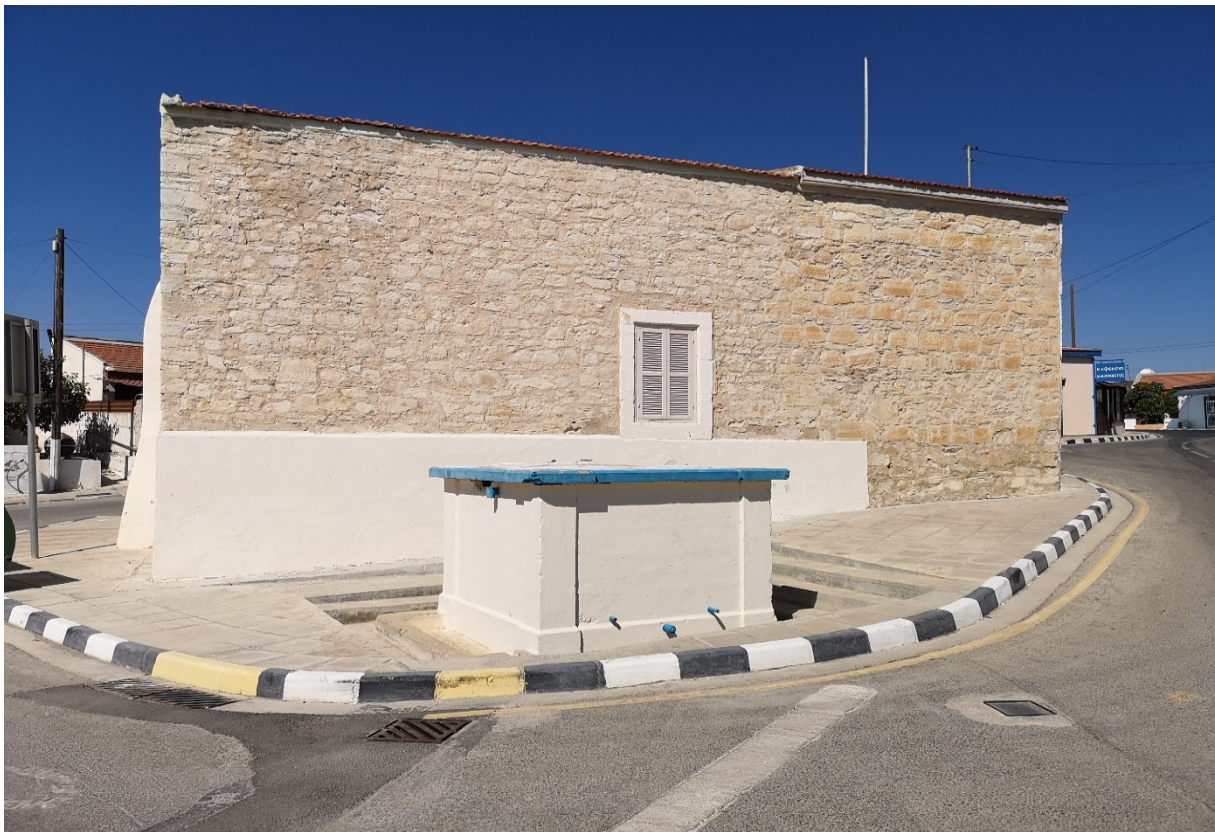
External condition: good; the building is in a very good condition.

Interior condition: ./.; the doors are locked; so, it was not possible to see the mosque from inside.

Fig. LAR-K4a: Molla Ahmet Efendi bin Hacı Ali Mosque (r.) with school (view from north; Sept. 2018)

Fig. LAR-K4b: Molla Ahmet Efendi bin Hacı Ali Mosque (left part), with the fountain in front of the building (view from south; Sept. 2018)

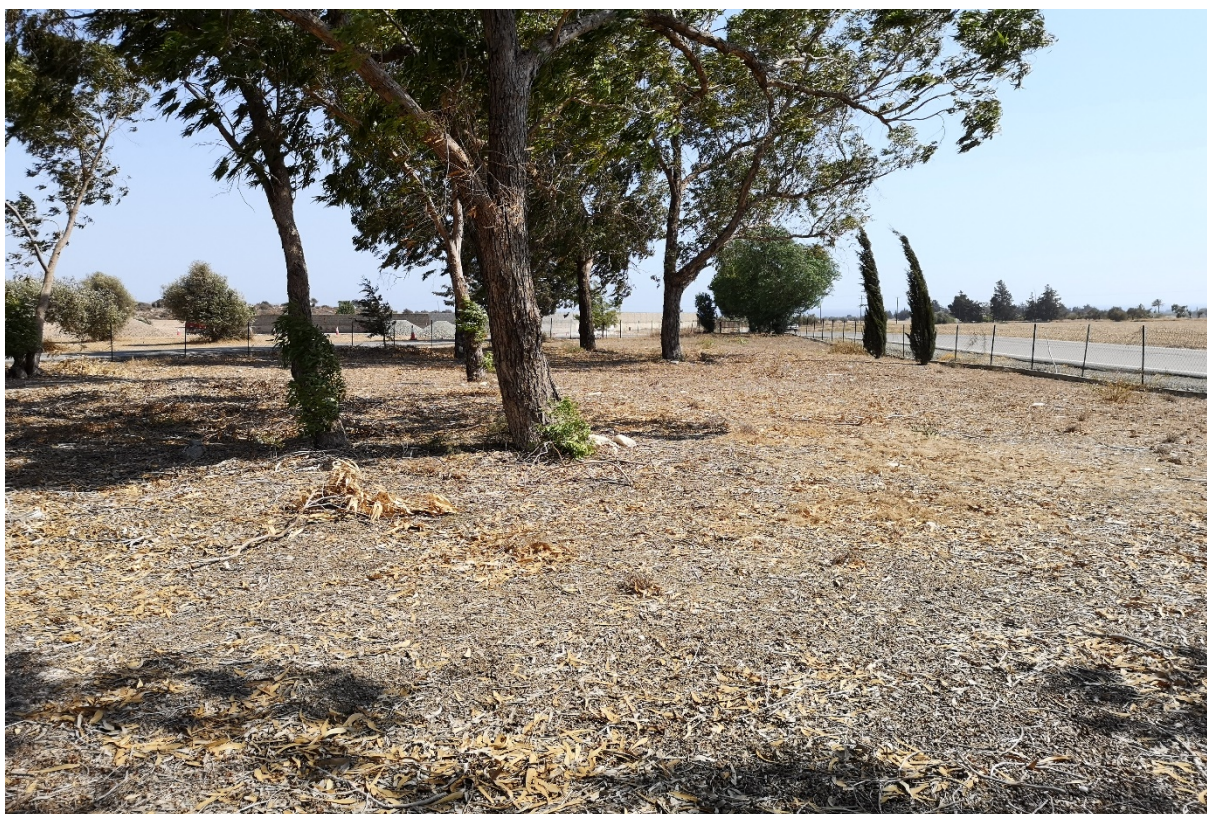
Fig. LAR-K4d: Muslim cemetery (view from north; Sept. 2018)

Condition: fair; it seems that cleaning measures were carried out some time ago, but with the effect that no traces were left of the modest graves marked with stones only. Just a few of the bigger sepulchres are still visible; the fence around the cemetery has several defects.

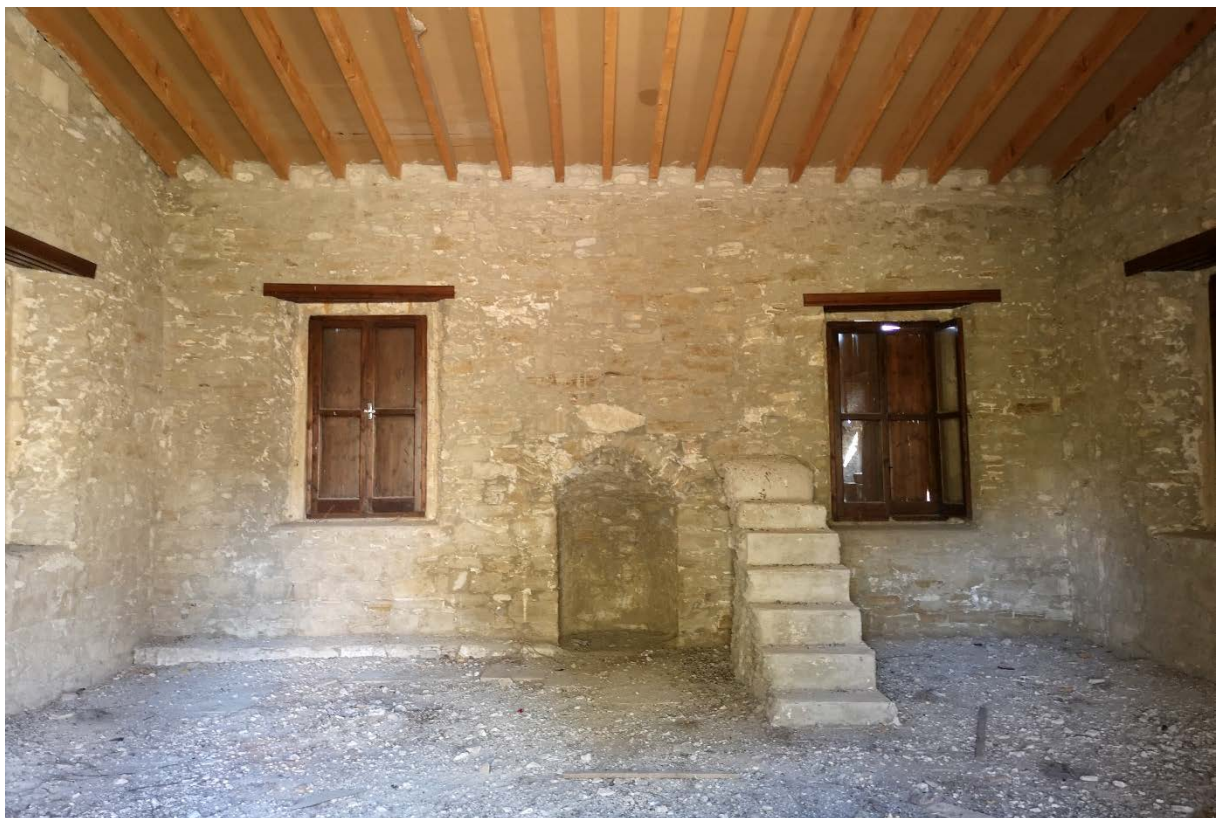
Fig. LAR-M2a: Mosque (Sept. 2018)

External condition: *good*; after restoration the external condition is good.

Interior condition: *fair*; after the restoration the condition of the interior is fair.

Remarks: The front door of the mosque is open and some of the new window panes are broken. As a consequence, pigeons went in and the ground is covered with pigeon droppings. A fountain for ablution is missing.

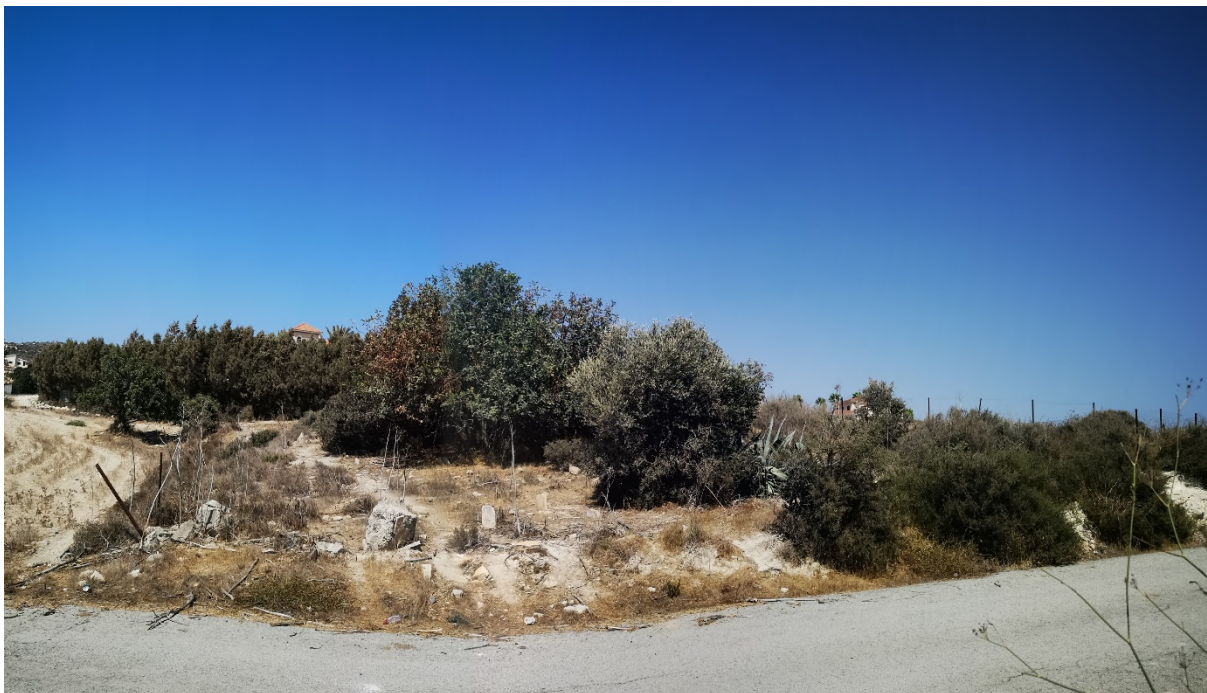
Fig. LAR-M2c: Muslim cemetery (Sept. 2018; view from south)

Condition: *ruin*; only the foundation of the former fence line and a few deteriorated grave markers are visible; the cemetery itself is overgrown by weeds and shrubs.

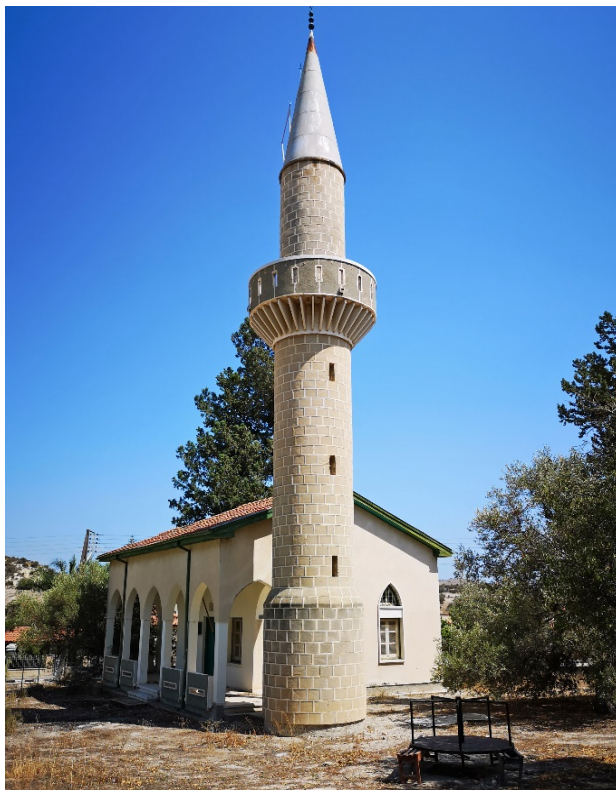
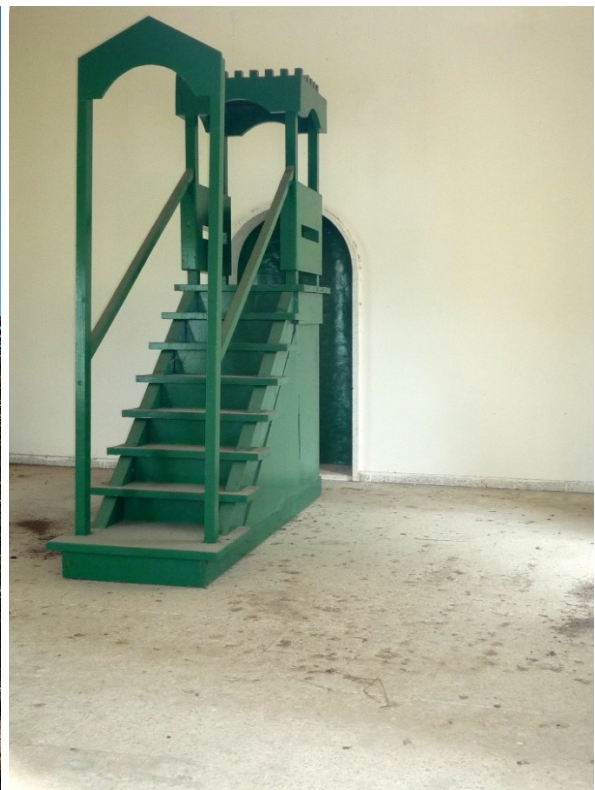
Fig. LAR-M4b-c: Mosque (view from west; Sept. 2018)

External condition: *good*; the building is in a *good* condition. The doors of the mosque are locked. The underroof cladding in the vestibule is affected by deterioration.

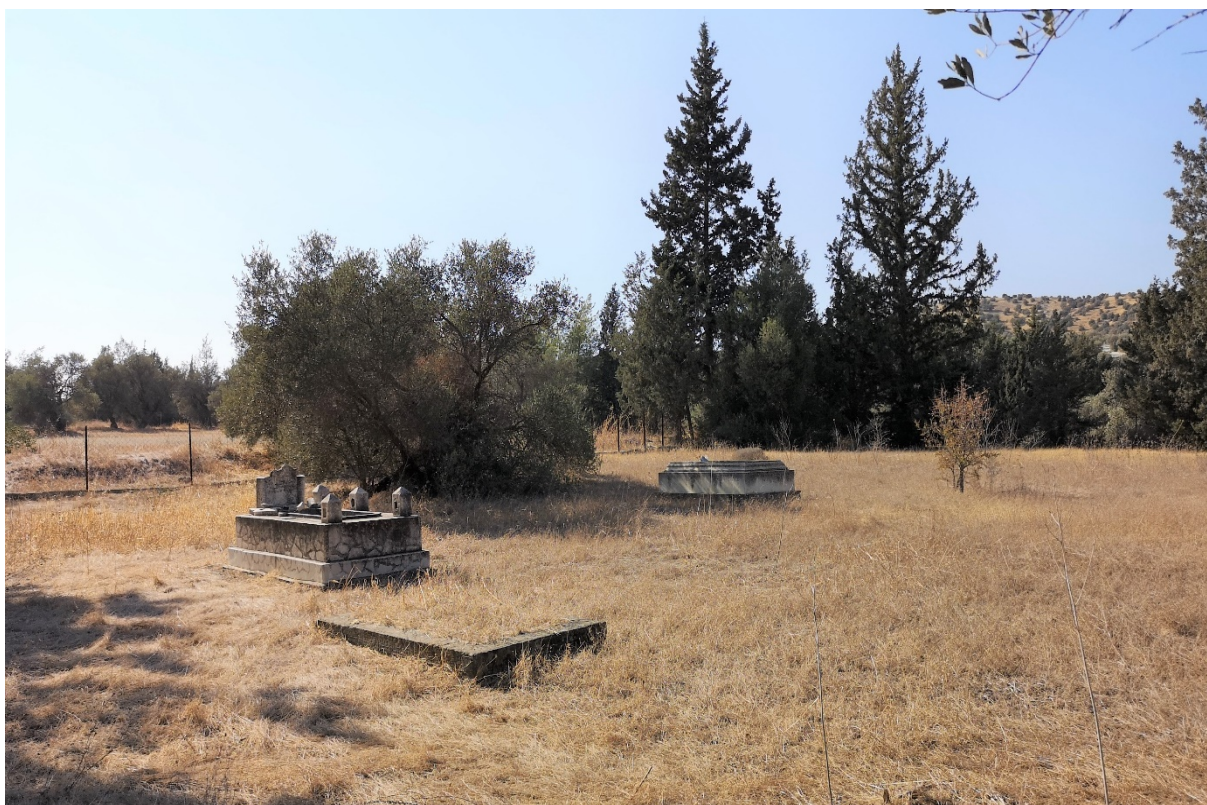
Fig. LAR-M4d: Muslim cemetery (view from southeast; Sept. 2018)

Condition: *fair*; it is obvious that cleaning measures were carried out, but with the effect that no traces were left of the modest graves, which were marked by smaller stones. Just a few of the bigger sepulchres are still visible. The cemetery is fenced (no defects visible).
