# The religious heritage of Cyprus

a survey in the districts of Kyrenia and Larnaca

Dr. Thorsten Kruse, M.A.  
Institut für Interdisziplinäre Zypern-Studien  
Westfälische Wilhelms-Universität Münster  
Schlaunstr. 2  
48143 Münster  
Germany  
Email: Th.Kruse@wwu.de

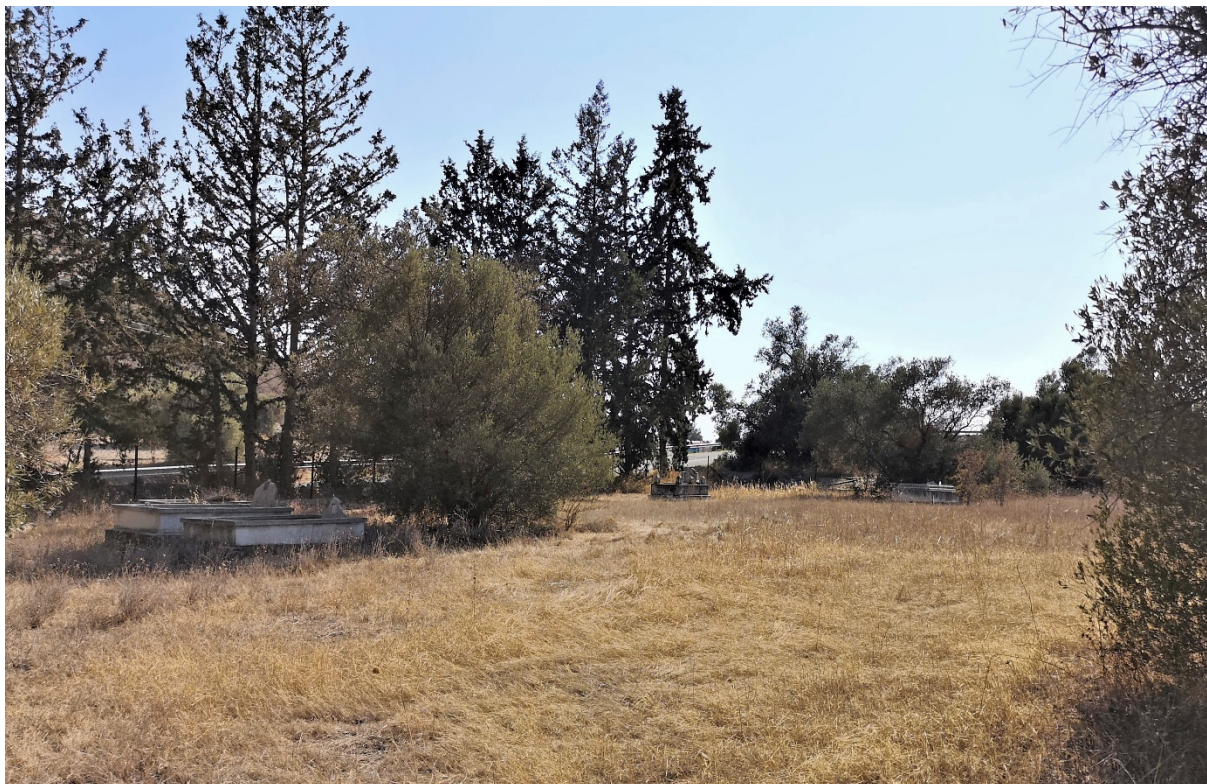
Fig. LAR-M4e: Muslim cemetery (view from northeast; Sept. 2018)

Condition: *fair*; it is obvious that cleaning measures were carried out, but with the effect that no traces were left of the modest graves, which were marked by smaller stones. Just a few of the bigger sepulchres are still visible. The cemetery is fenced (no defects visible).

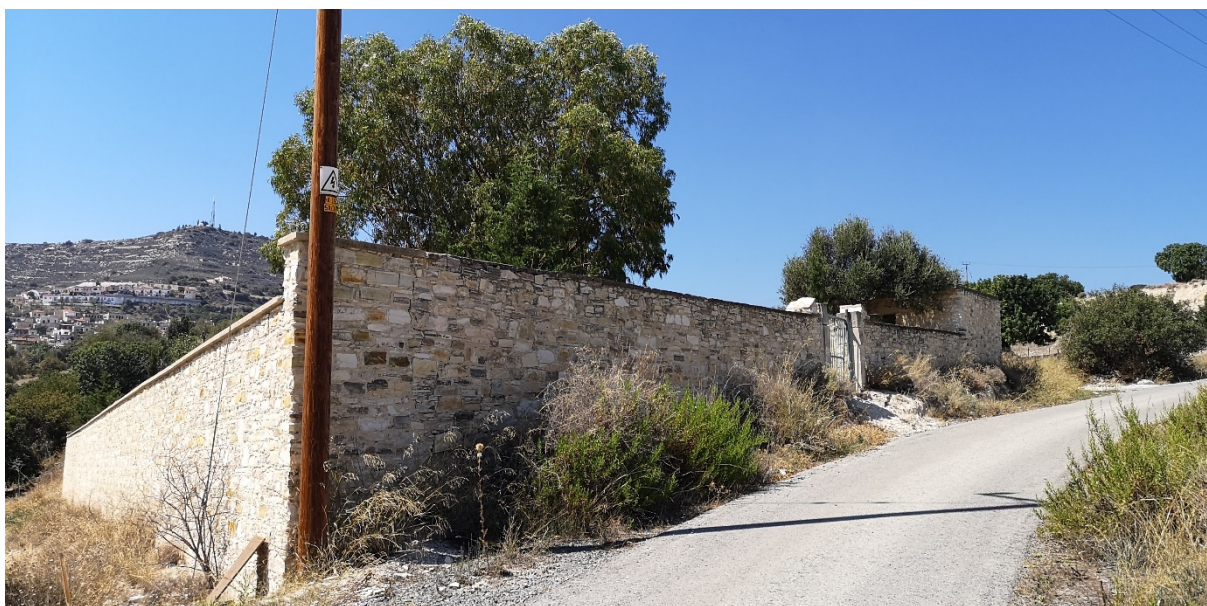
Fig. LAR-P1c: Muslim cemetery (view from southeast; Sept. 2018)

Condition: *good*; cleaning measures were carried out some time ago, but with the effect that the markers of some of the modest graves are not *in situ* anymore. The bigger sepulchres are still visible and in an acceptable condition. The enclosing wall is sound and was obviously renovated some time ago.

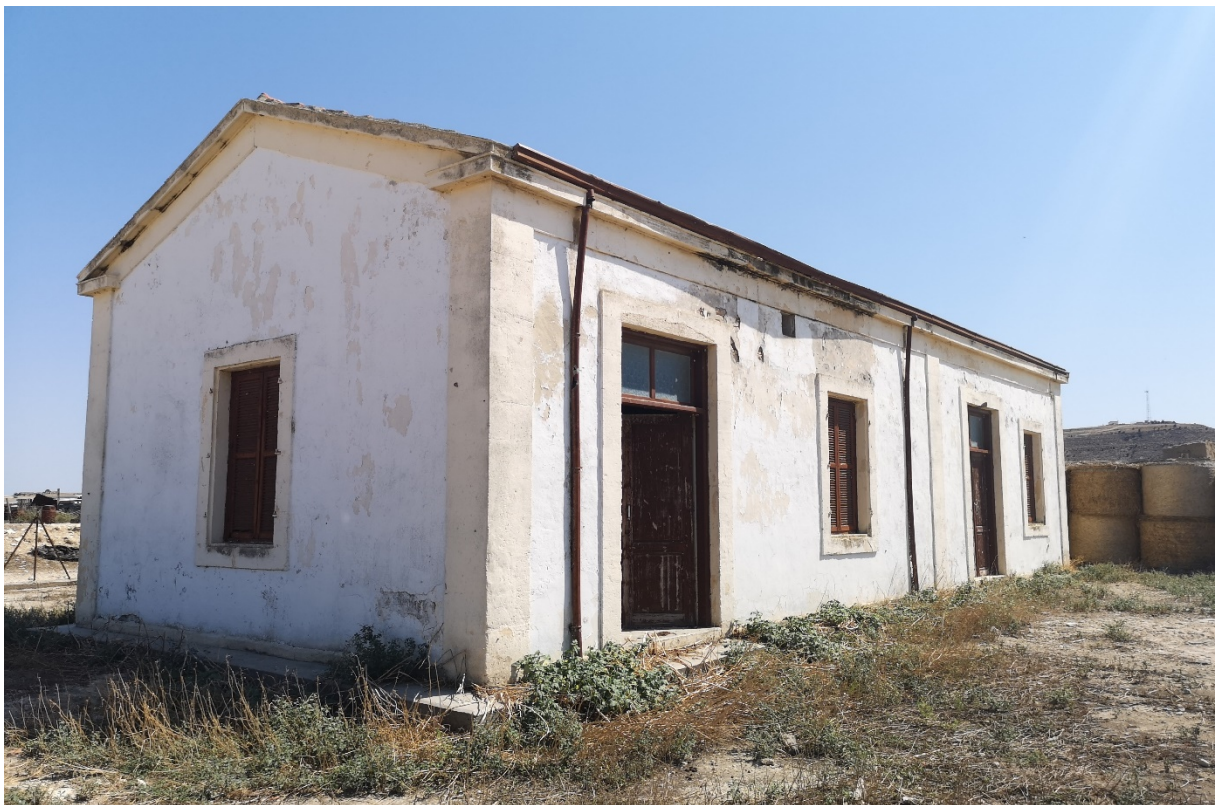
Fig. LAR-P3a: Mosque (front part) and school (view from northwest; Sept. 2018)

External condition: *fair*; the building needs some attention. There are clear signs of moisture on the western edge of the roof. The doors of the mosque are open, and the area around the mosque is grown over with scrub. The fence around the area is in a bad condition.

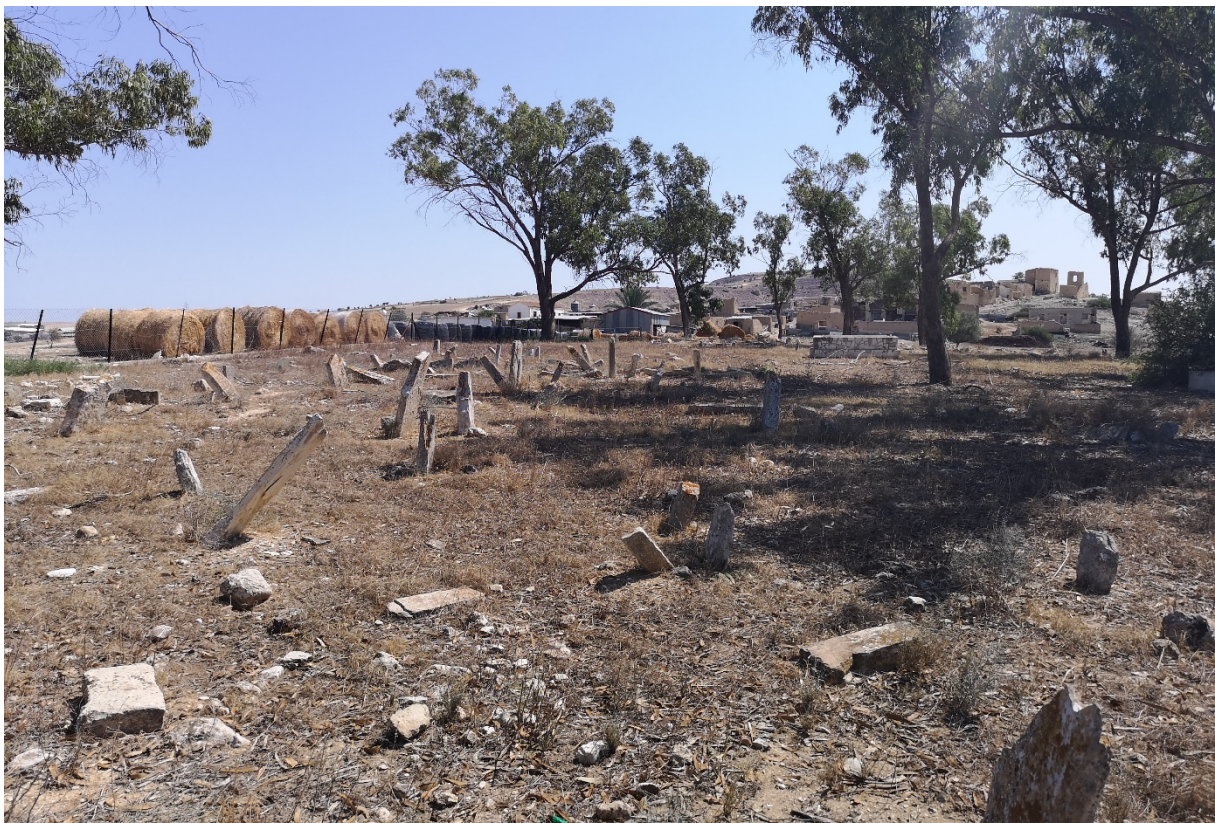
Fig. LAR-P3d: Muslim cemetery (view from northwest; Sept. 2018)

Condition: *good*; many modest graves marked with stones only are still visible. Just a few larger sepulchres were built on this cemetery. The fence is intact and the gates are locked.

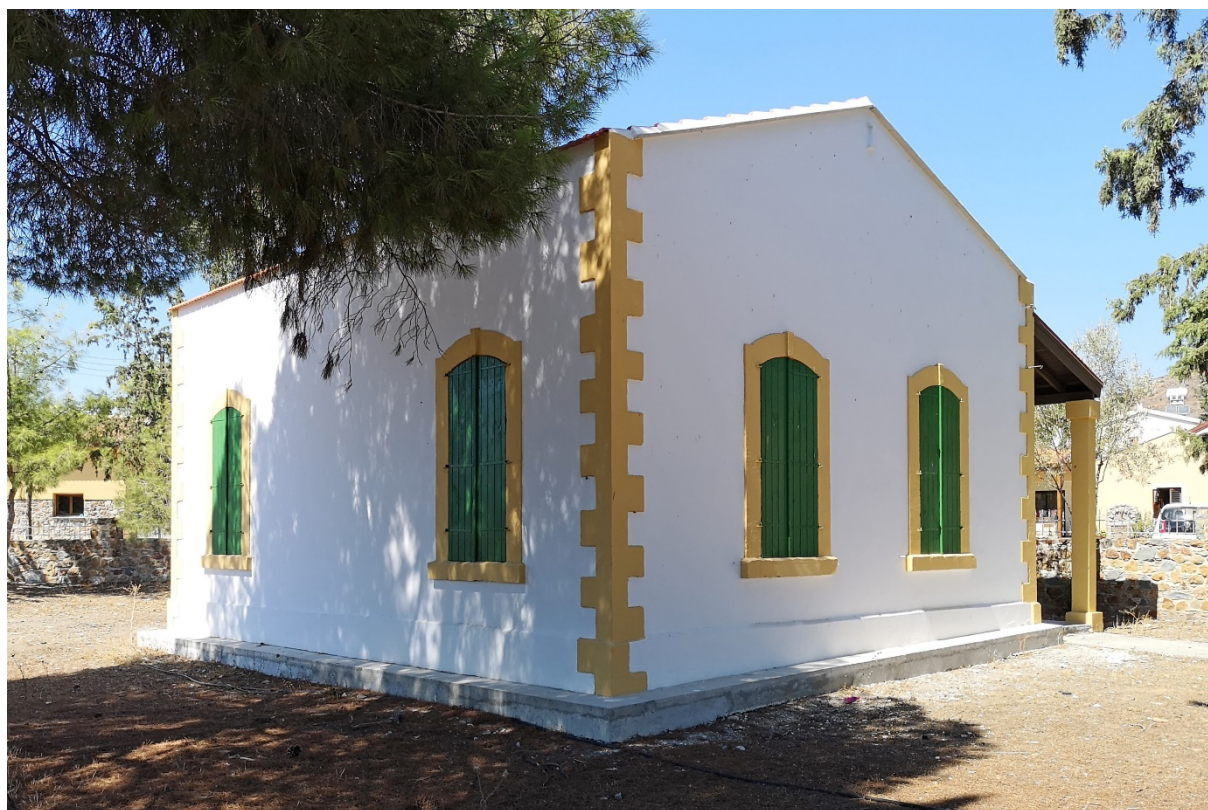
Fig. LAR-P4: Mosque (Sept. 2018)

External condition: *good*; the building is in a *good* condition. A renovation took place in 2017.

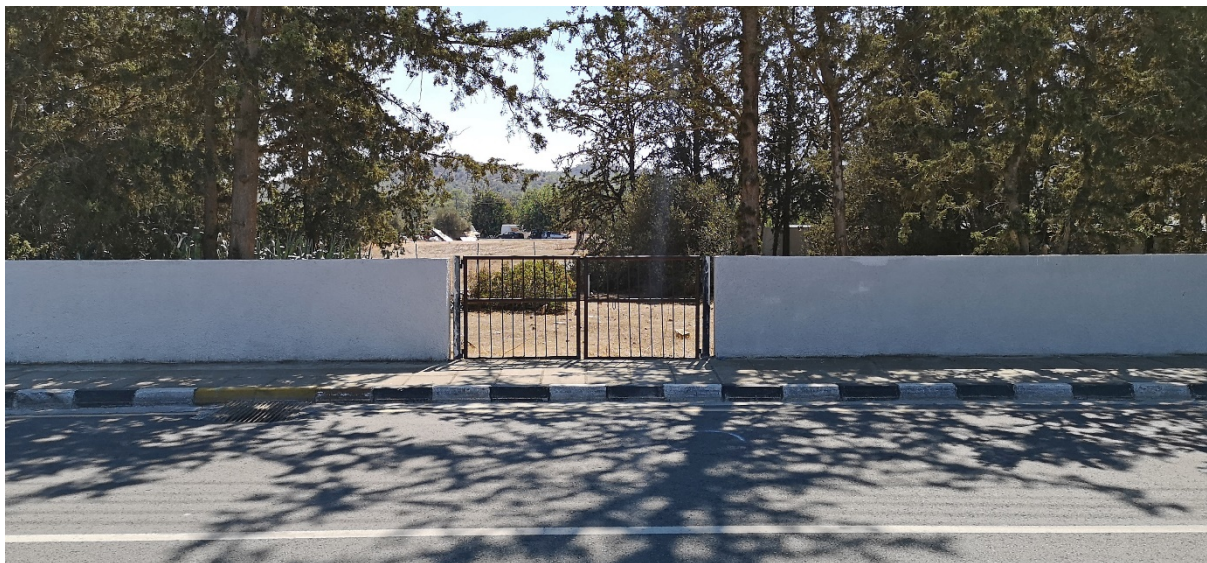
Fig. LAR-P4c: Muslim cemetery (view from north; Sept. 2018)

Condition: *fair*; it is obvious that cleaning measures were carried out some time ago, but with the effect that only a few traces were left of the modest graves marked with stones only.

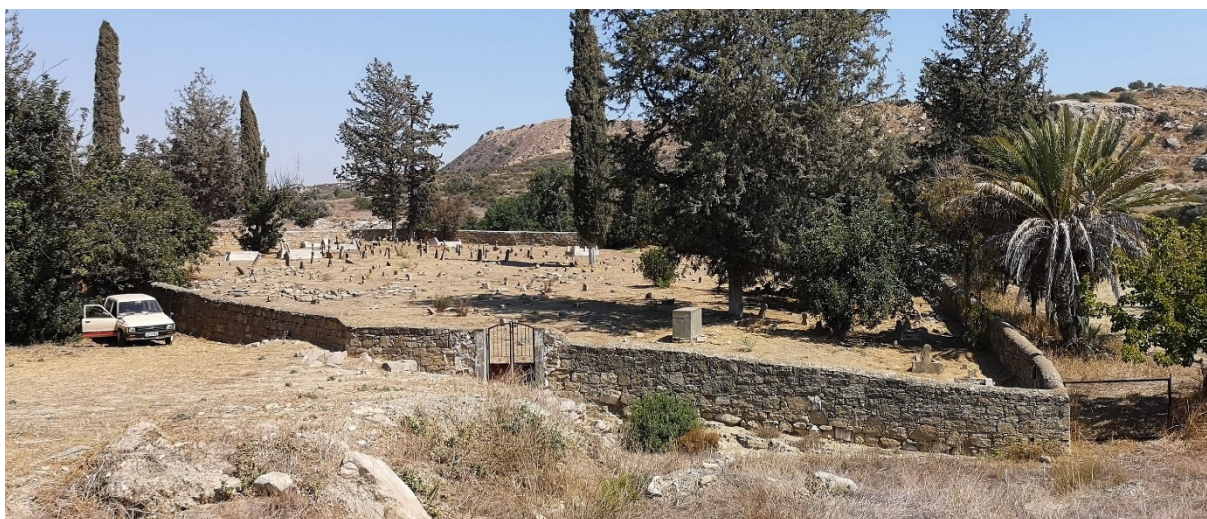
Fig. LAR-T1c: Muslim cemetery (view from southwest; Sept. 2018)

Condition: *good*; the enclosure wall and the gates are sound. Obviously, the site is regularly cleaned – and cleaning is done in a proper way. Most of the modest graves and larger sepulchres are still in a relatively good condition.
